## Intertidal Morphodynamics of the Avon River Estuary

Final report submitted to the  
Nova Scotia Department of Transportation and Public Works (NSTPW)

Prepared by  
Dr. Danika van Proosdij, Department of Geography, Saint Mary's University  
& Greg Baker, MP\_SpARC, Saint Mary's University  
923 Robie, St. Halifax, N.S., B3H 3C3

September 30, 2007

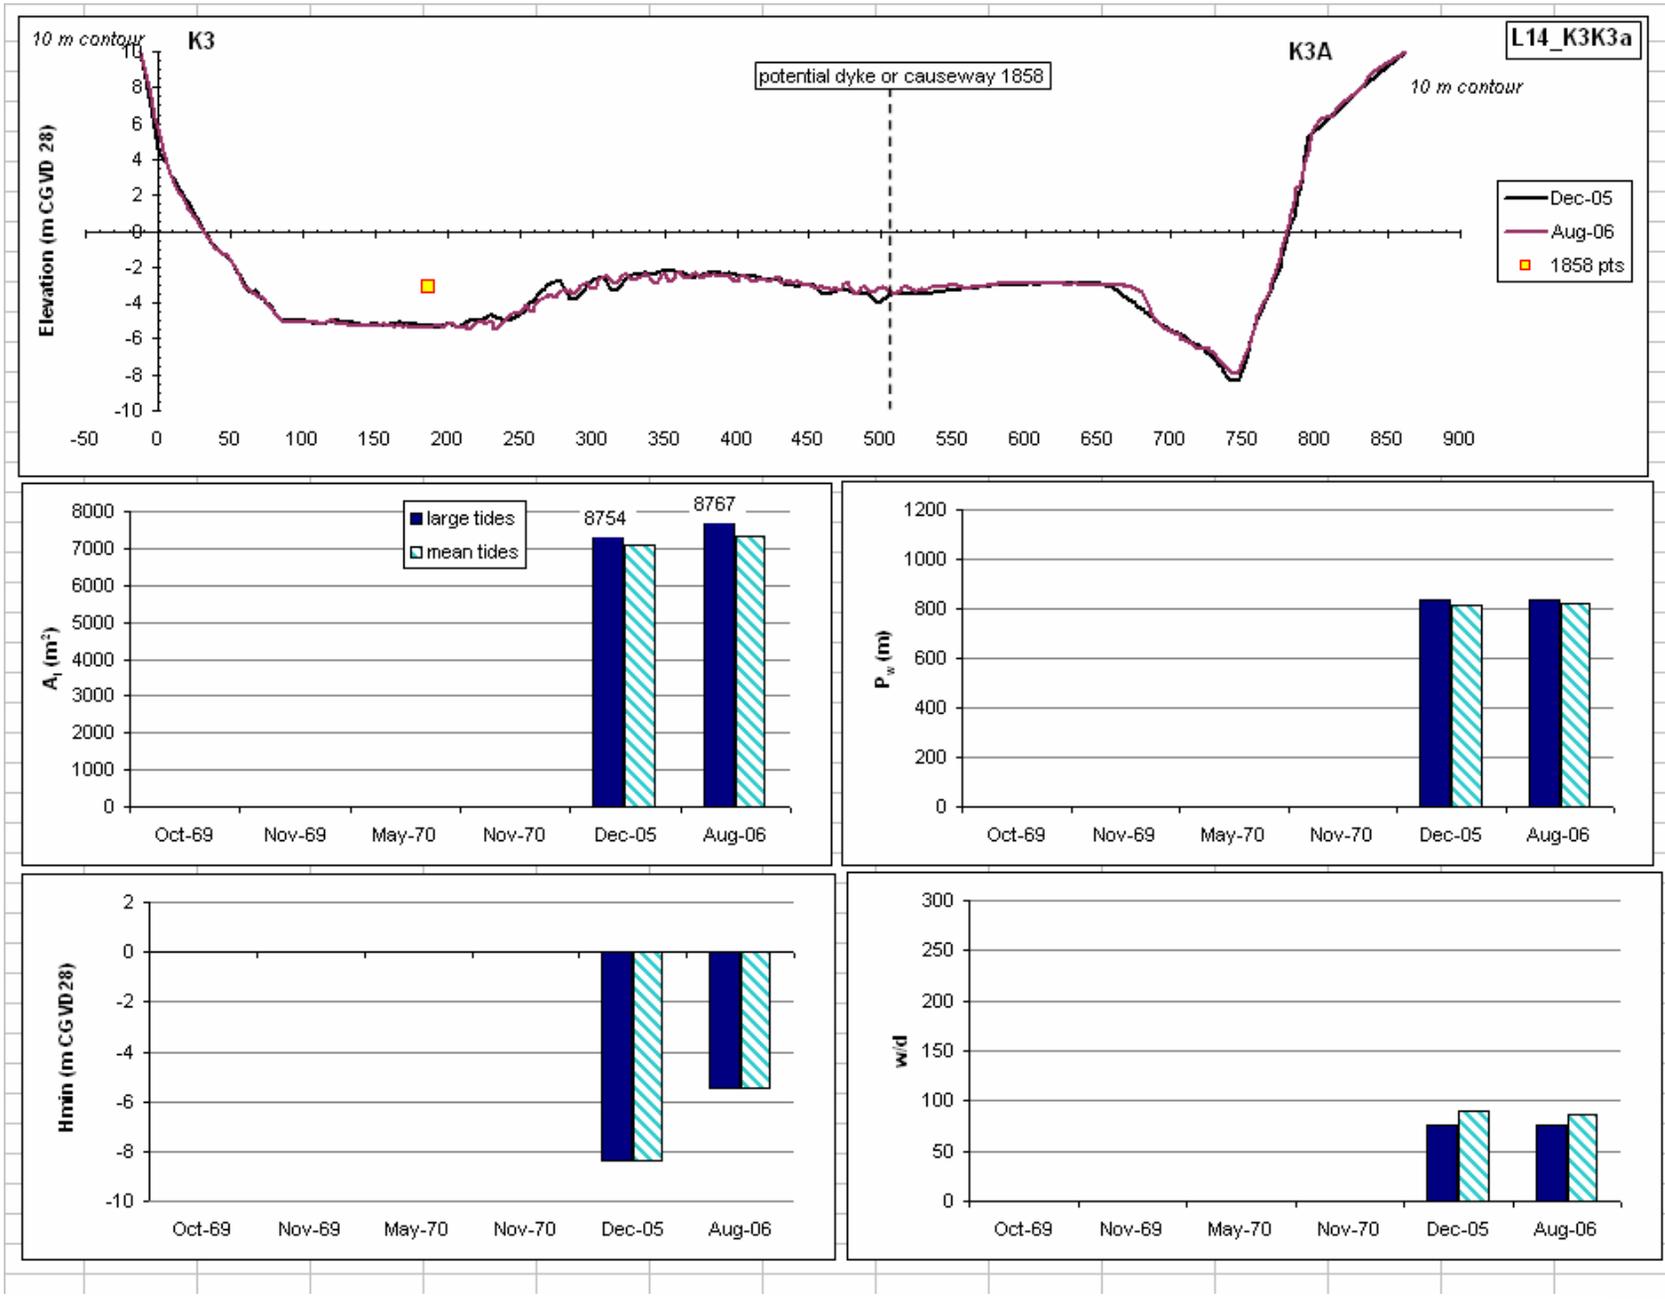
Figure 4.4c: Cross sectional profile for Line14\_DS\_K3K3A and associated hydraulic geometry parameters along the Kennetcook River. Vertical exaggeration on cross sectional profile = 42.5. Distance on cross sectional profile in metres. Note potential dyke or causeway that was visible on 1858 map. The position or existence of this dyke could not be verified and however since the thalweg was indicated as being along the opposite shore, it is possible.

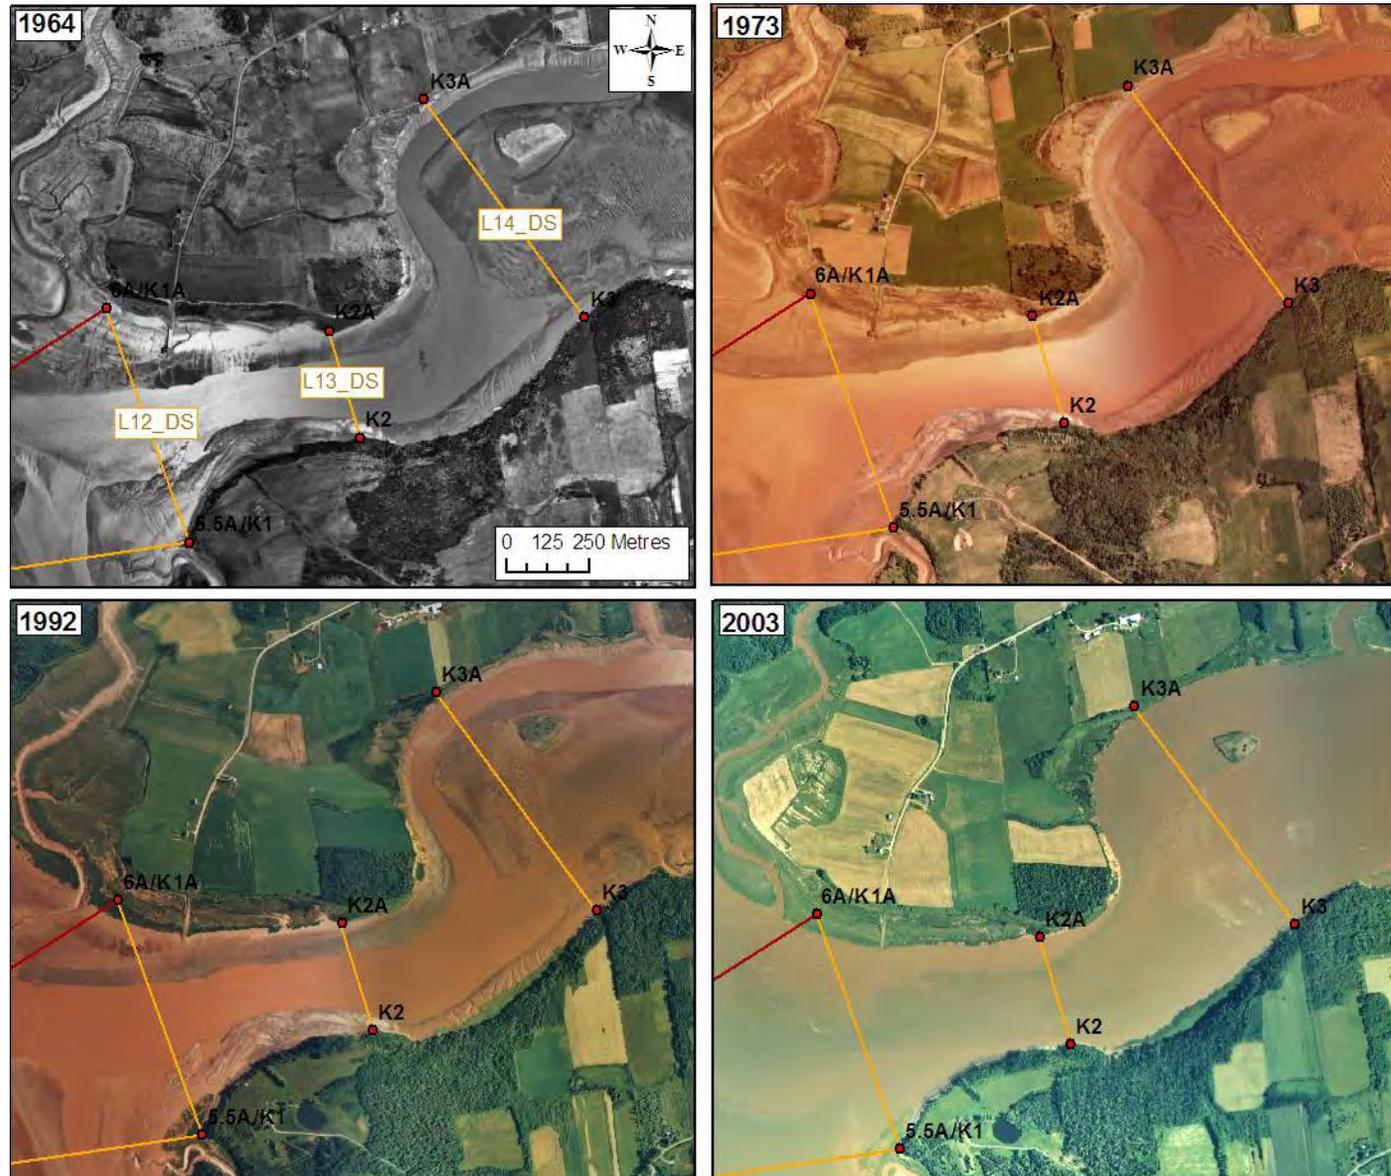
Figure 4.4d: Location of downstream survey lines 12, 13 and 14 on the Kennetcook River.

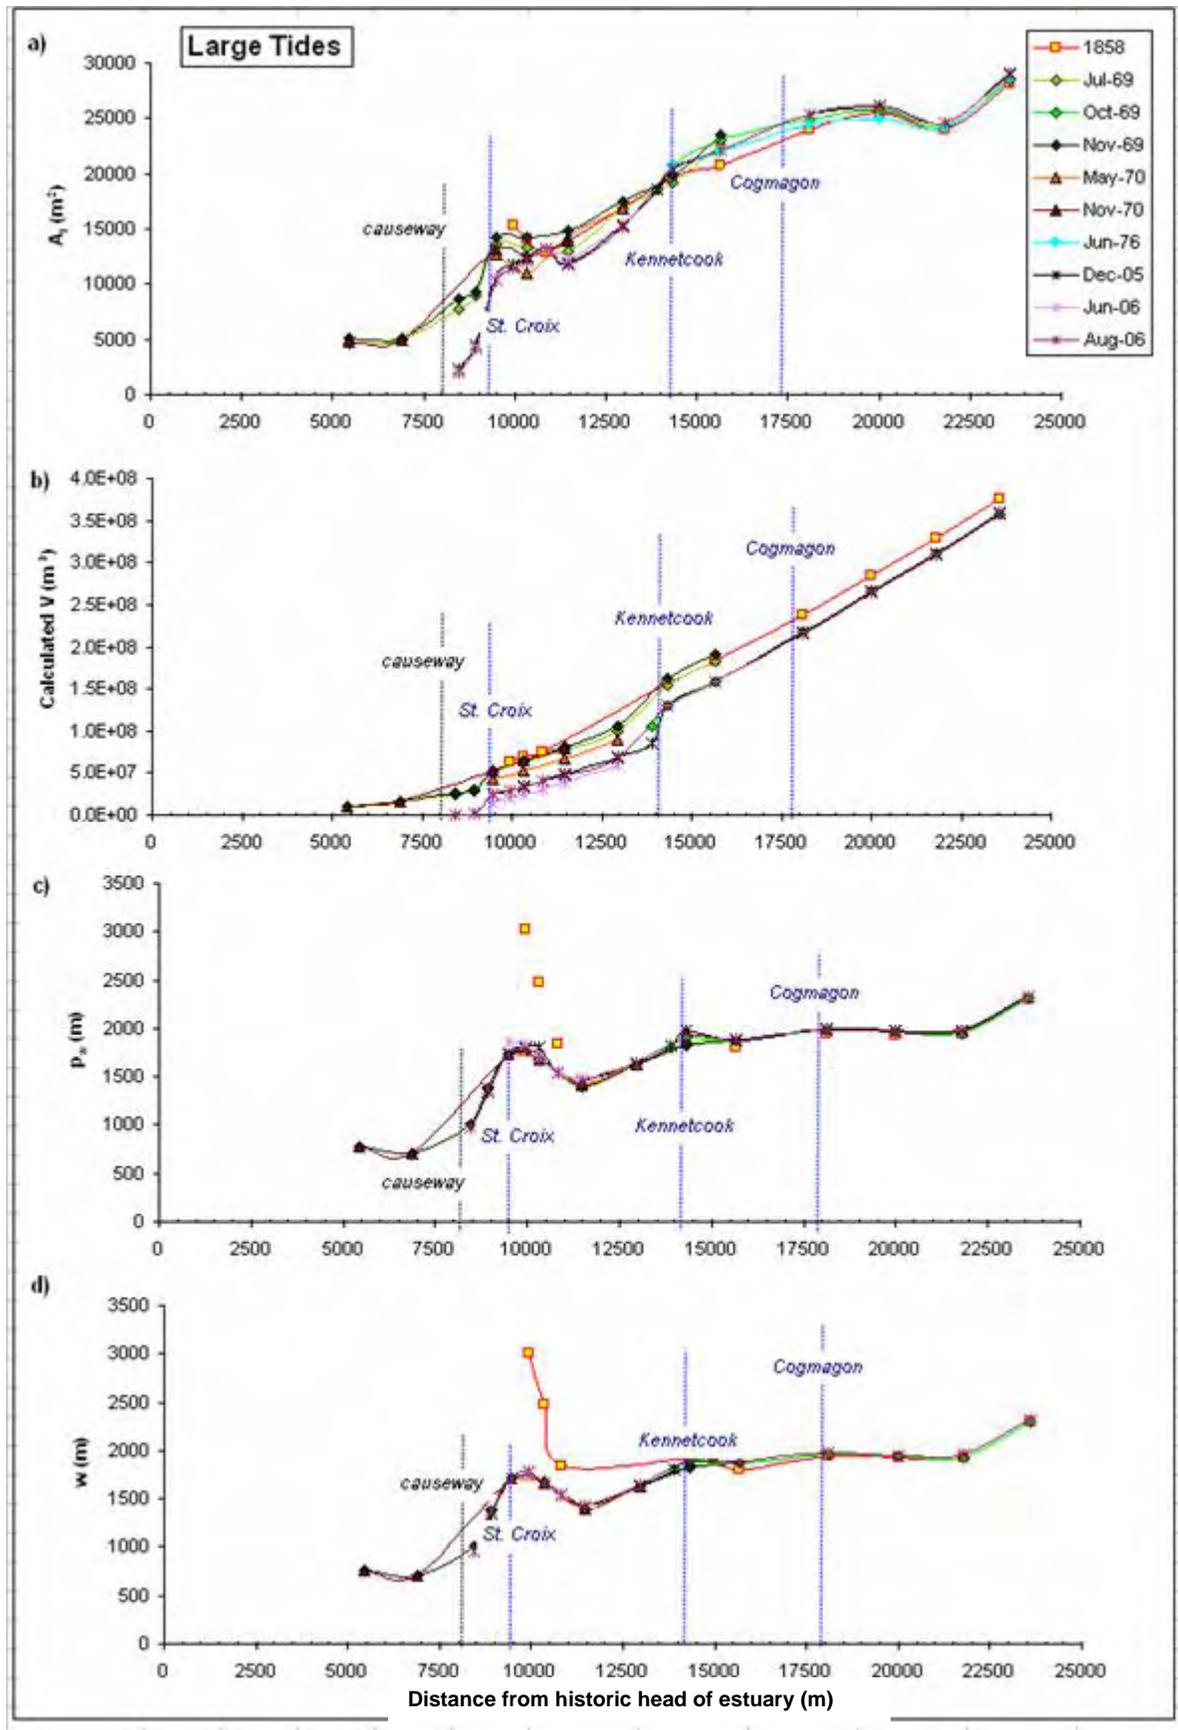
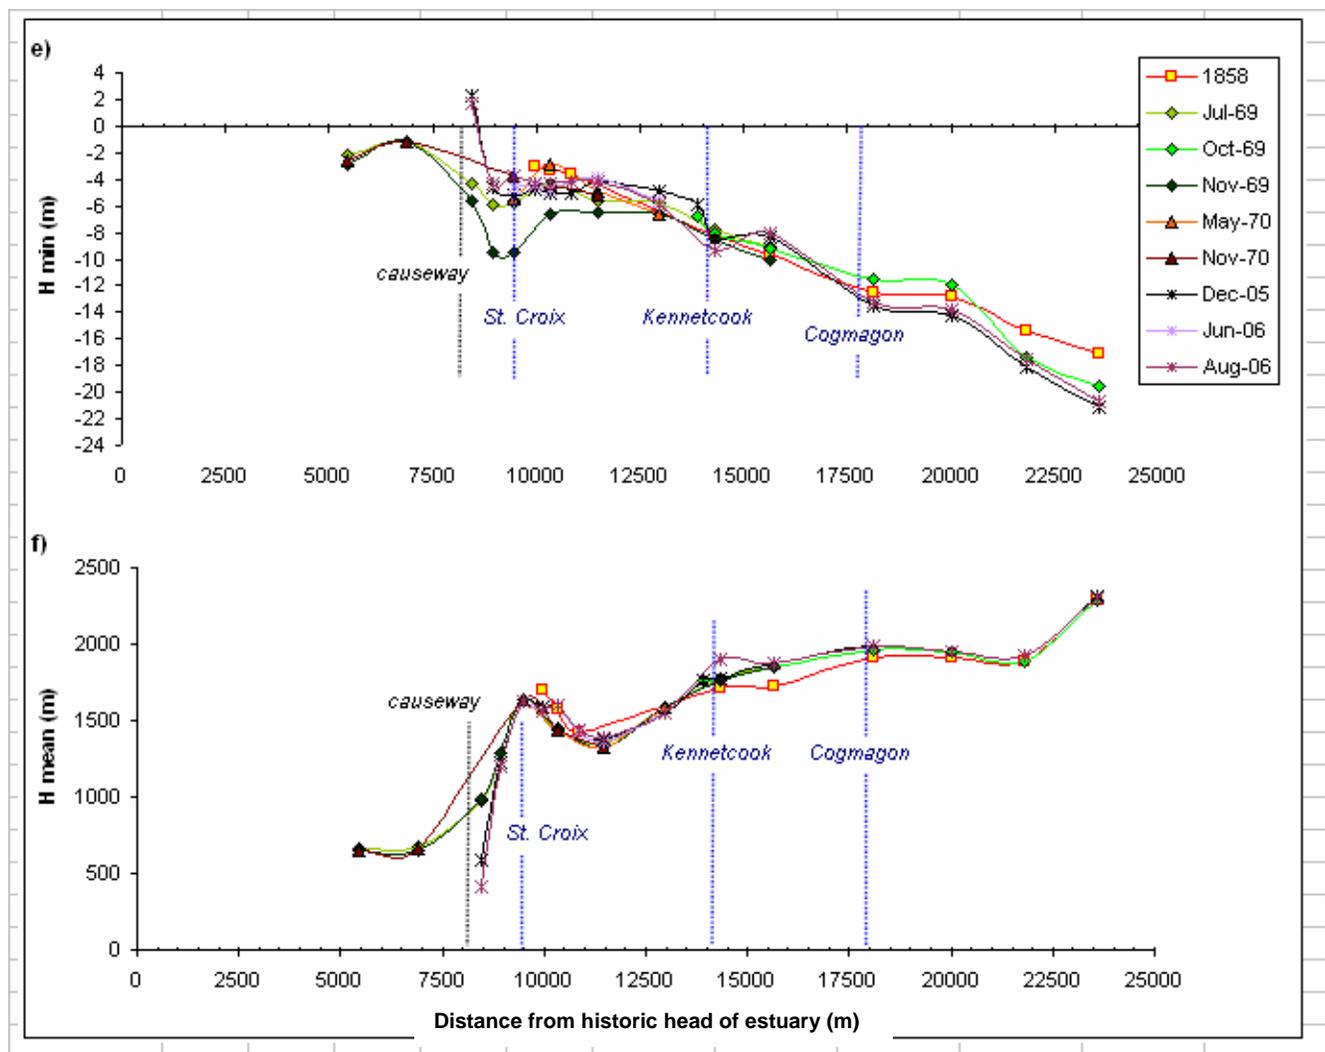
Figure 4.5: Downstream changes in channel form parameters for large tides for a) intertidal cross sectional area; b) tidal prism; c) wetted perimeter; d) width; e) minimum bed elevation (m CGVD28) and f) mean elevation (m CGVD28). Historic head of the Avon River estuary is located approximately 8 km upstream of the Windsor causeway.

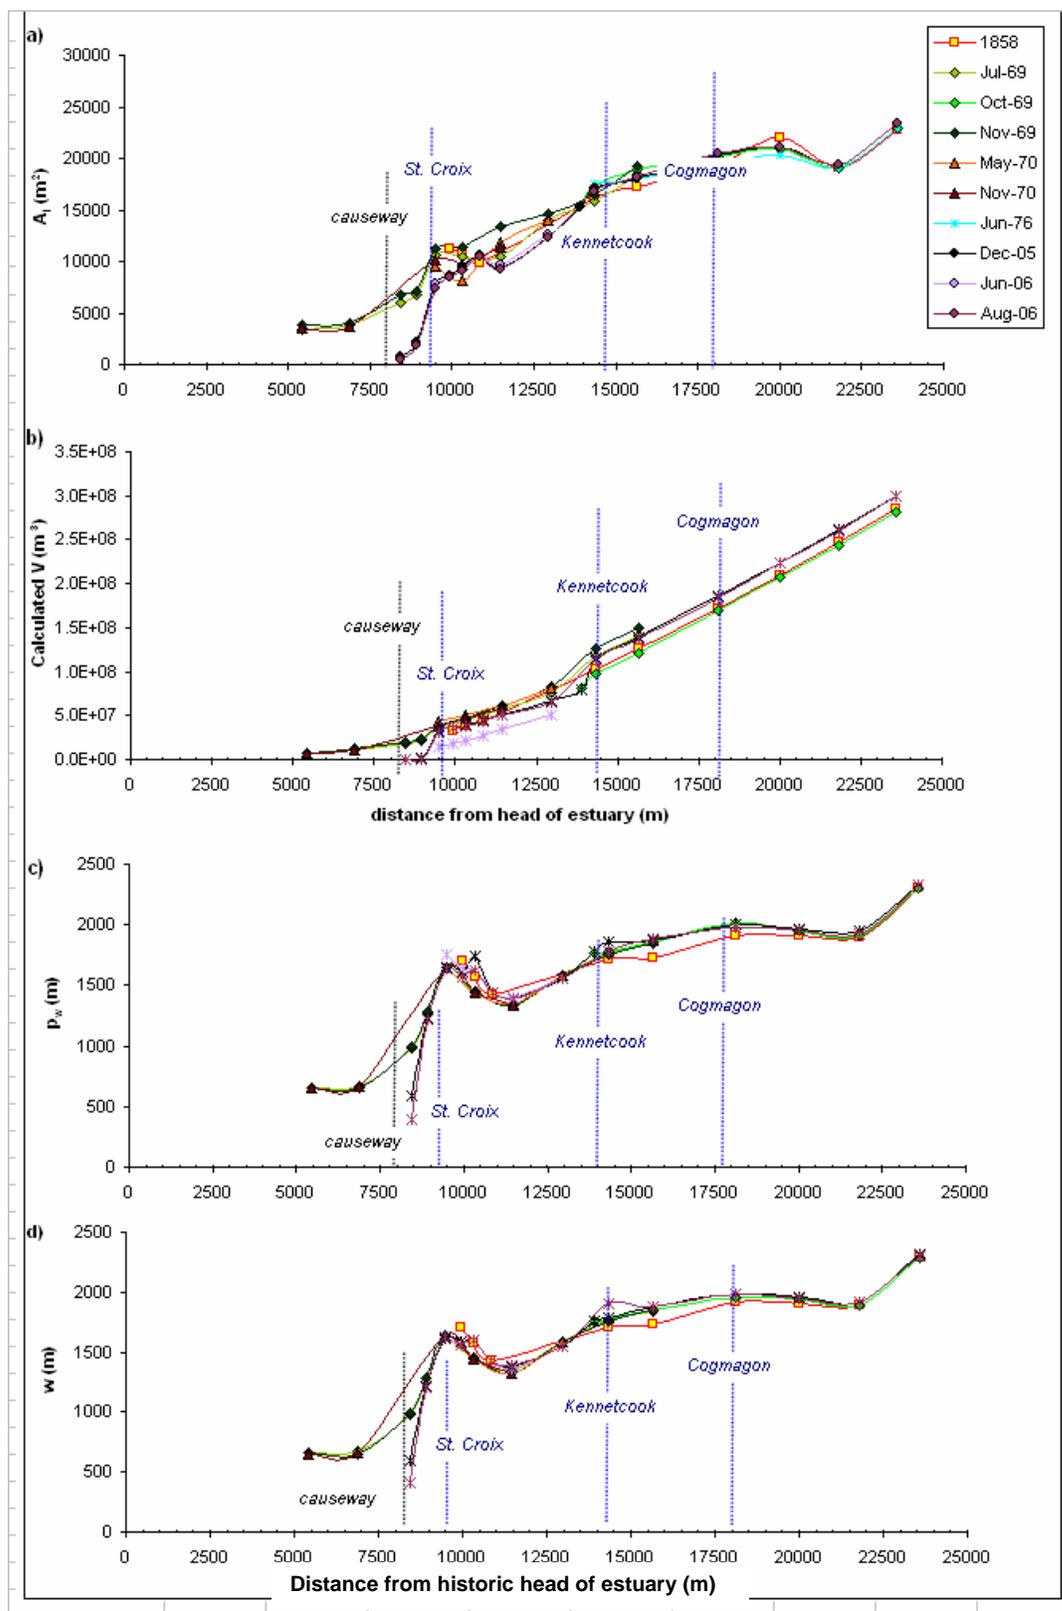
Figure 4.6: Downstream changes in channel form parameters for mean tides for a) intertidal cross sectional area; b) tidal prism ; c) wetted perimeter and d) width

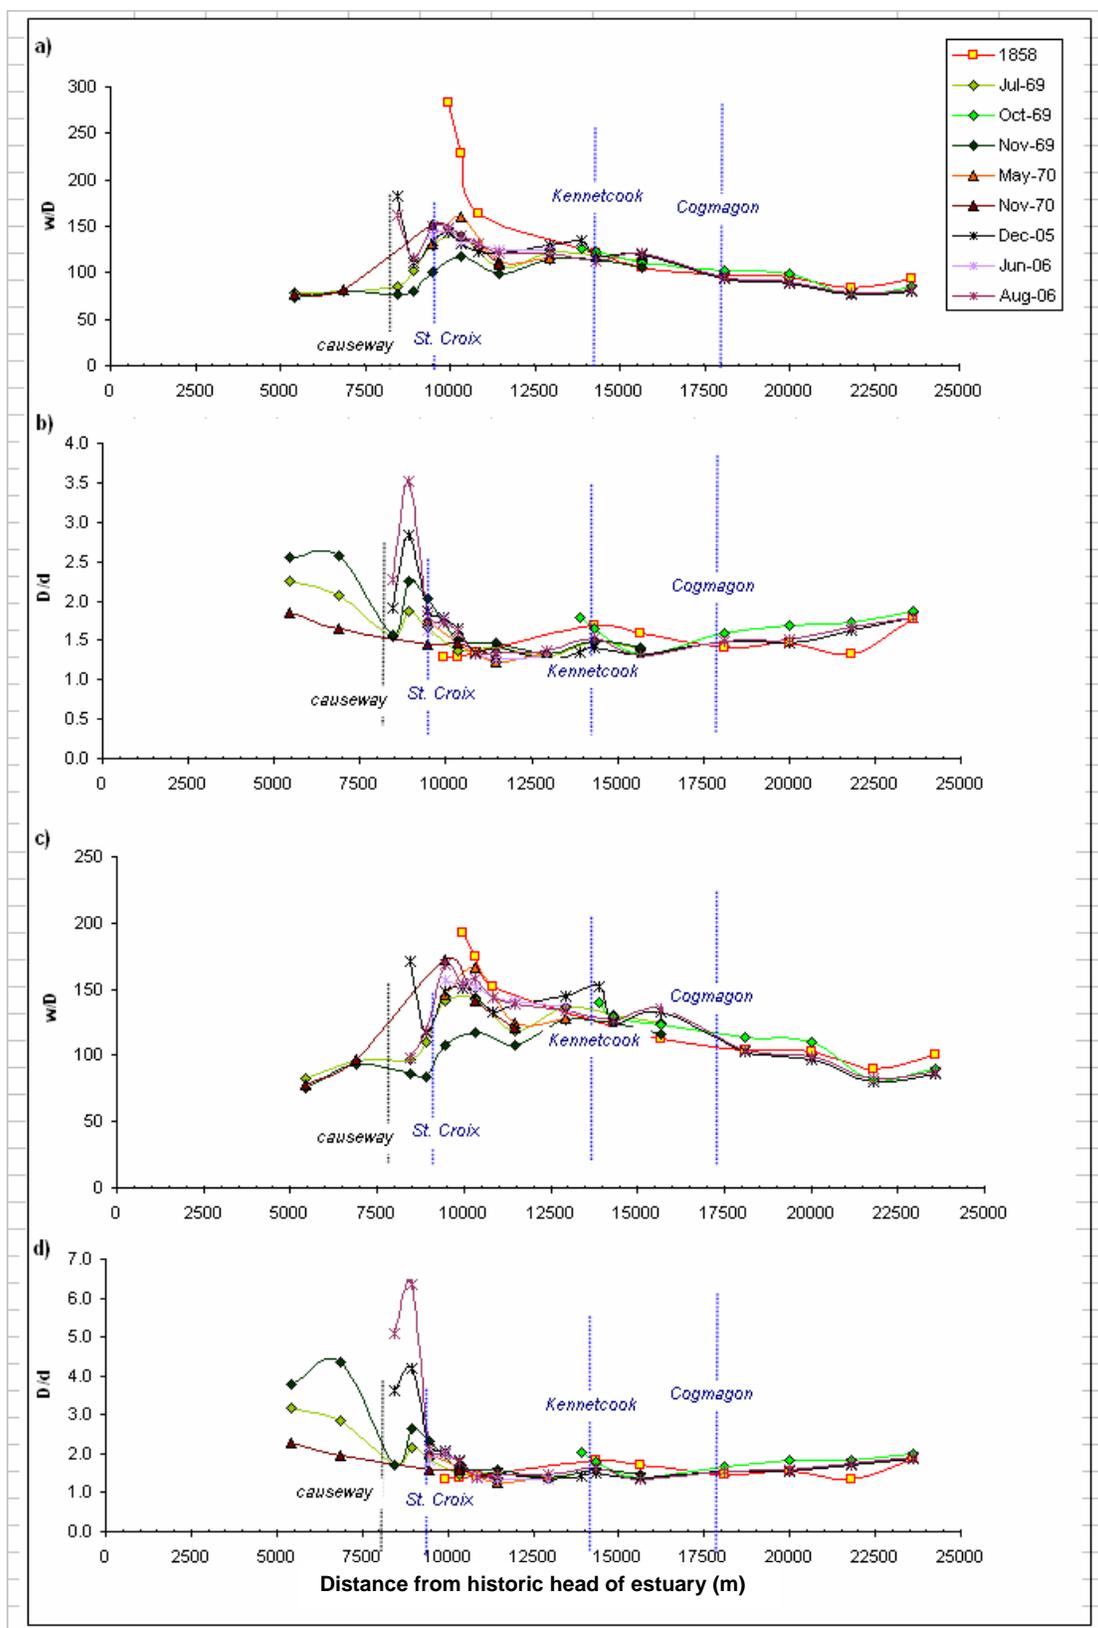
Figure 4.7: Downstream changes in channel form ratios for large tides a) width/min depth; b) min depth / mean depth and mean tides; c) width/min depth; d) mind depth/mean depth.

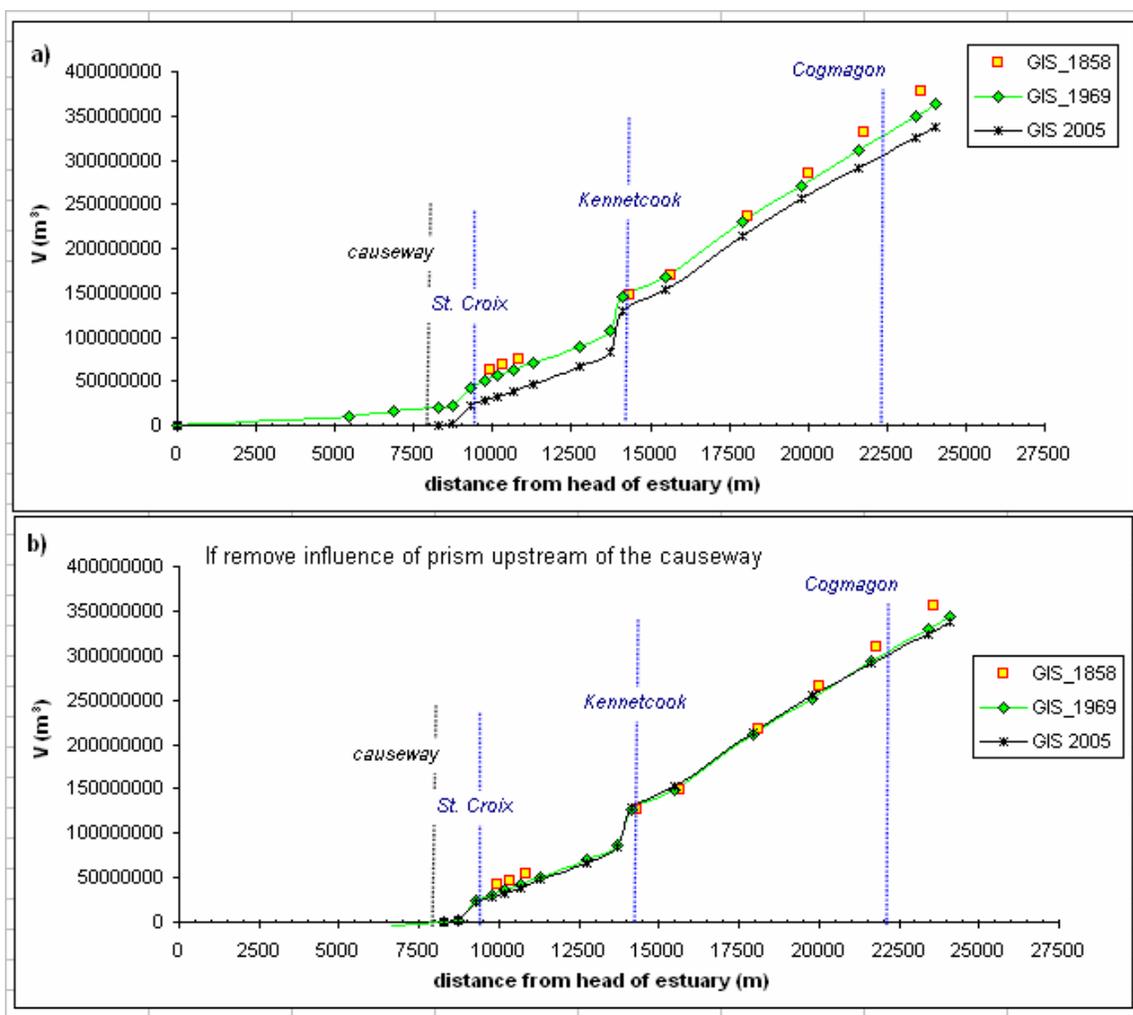
Figure 4.8: change in tidal prism calculated from GIS analysis with increasing distance from head of the Avon River for a) full tidal prism and b) volume of prism 'lost' upstream of the causeway removed.

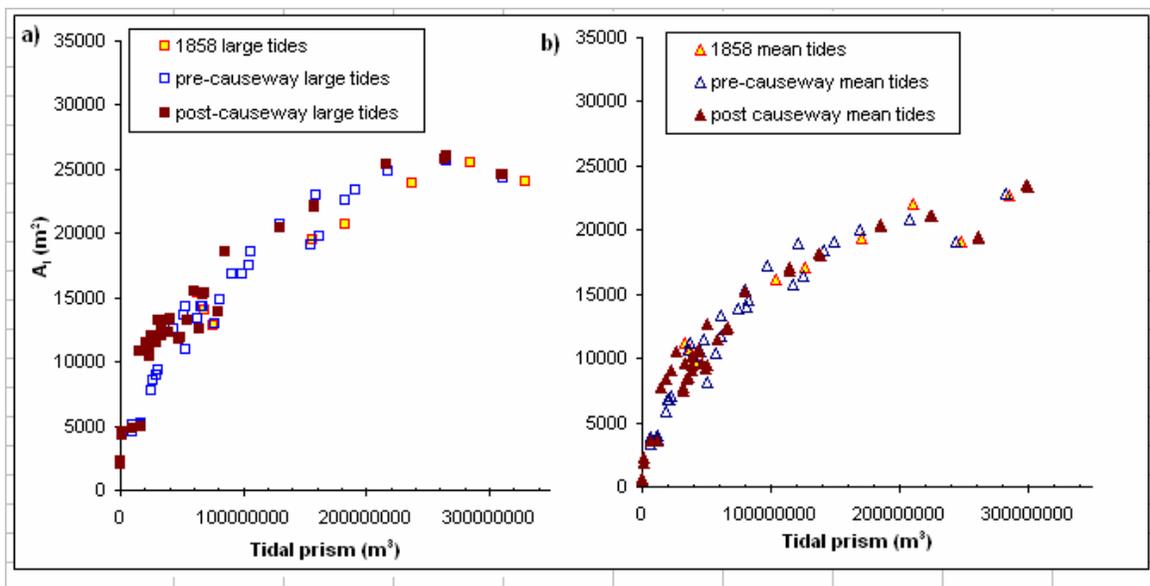
Figure 4.9: Change in intertidal cross sectional area as a function of the tidal prism for a) large (7.57 m) and b) mean (5.77m) tides.

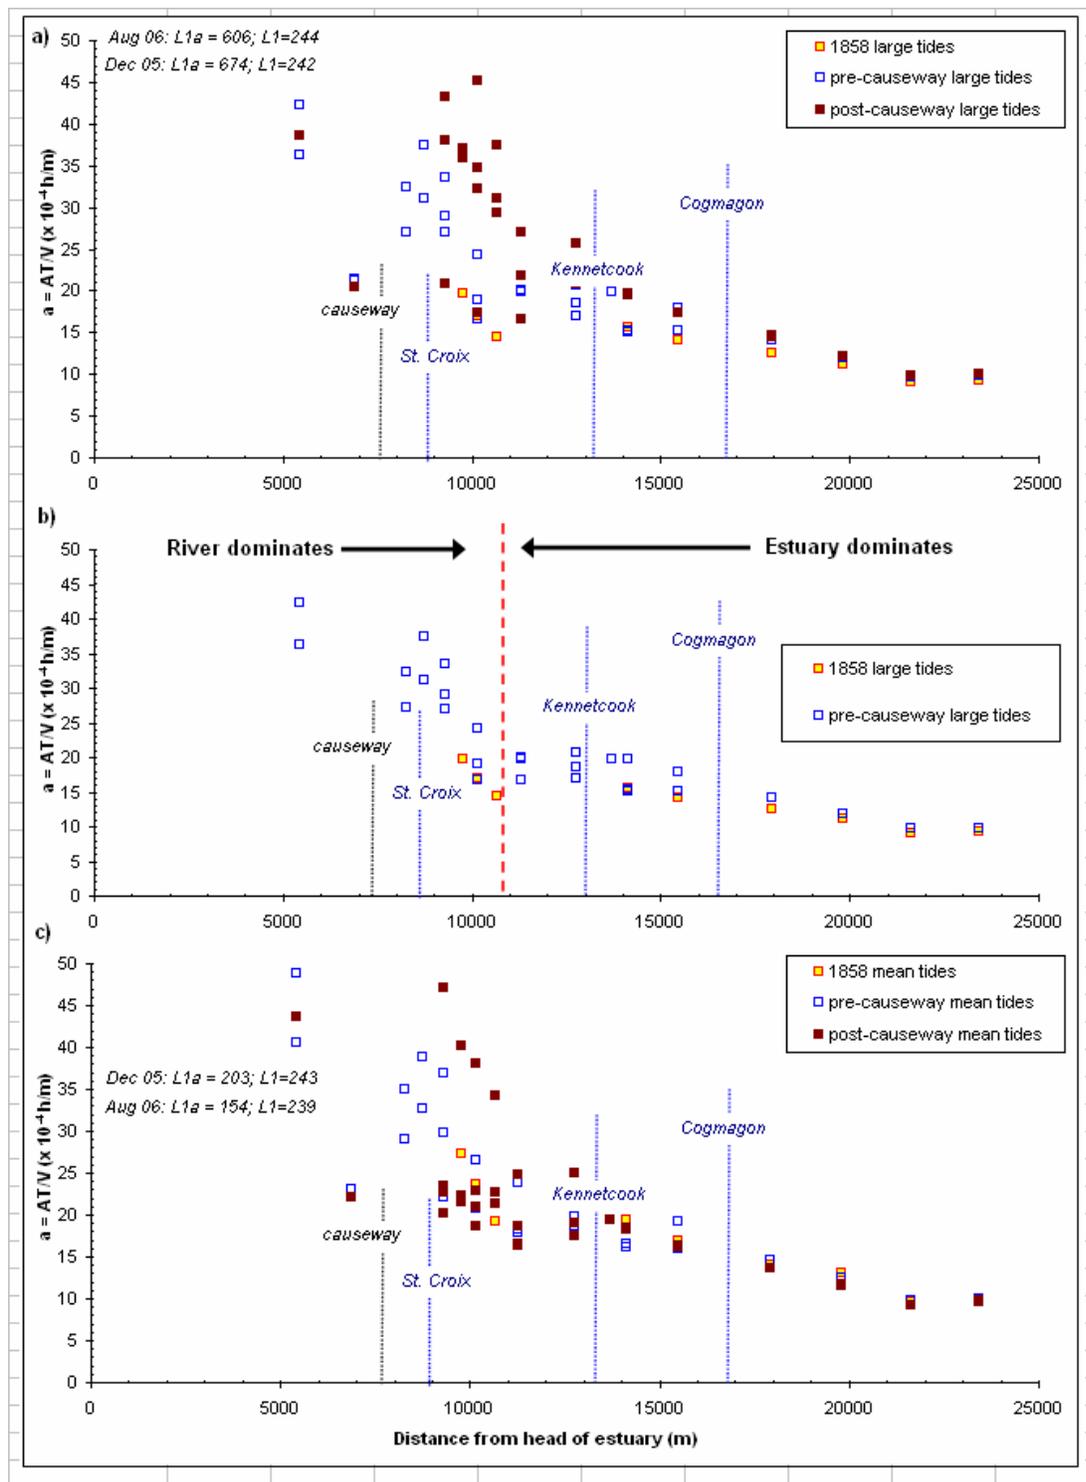
Figure 4.10: Variation in parameter 'a' ( $=AT/V$ ) (Bray et al., 1982) with distance from head of tide for a) large tides pre and post causeway; b) pre-causeway large and mean tides and c) mean tides pre and post causeway.  $A$  = intertidal cross sectional area,  $V$  = tidal prism above cross section and  $T$  = length of time during which there is tidal water in the channel

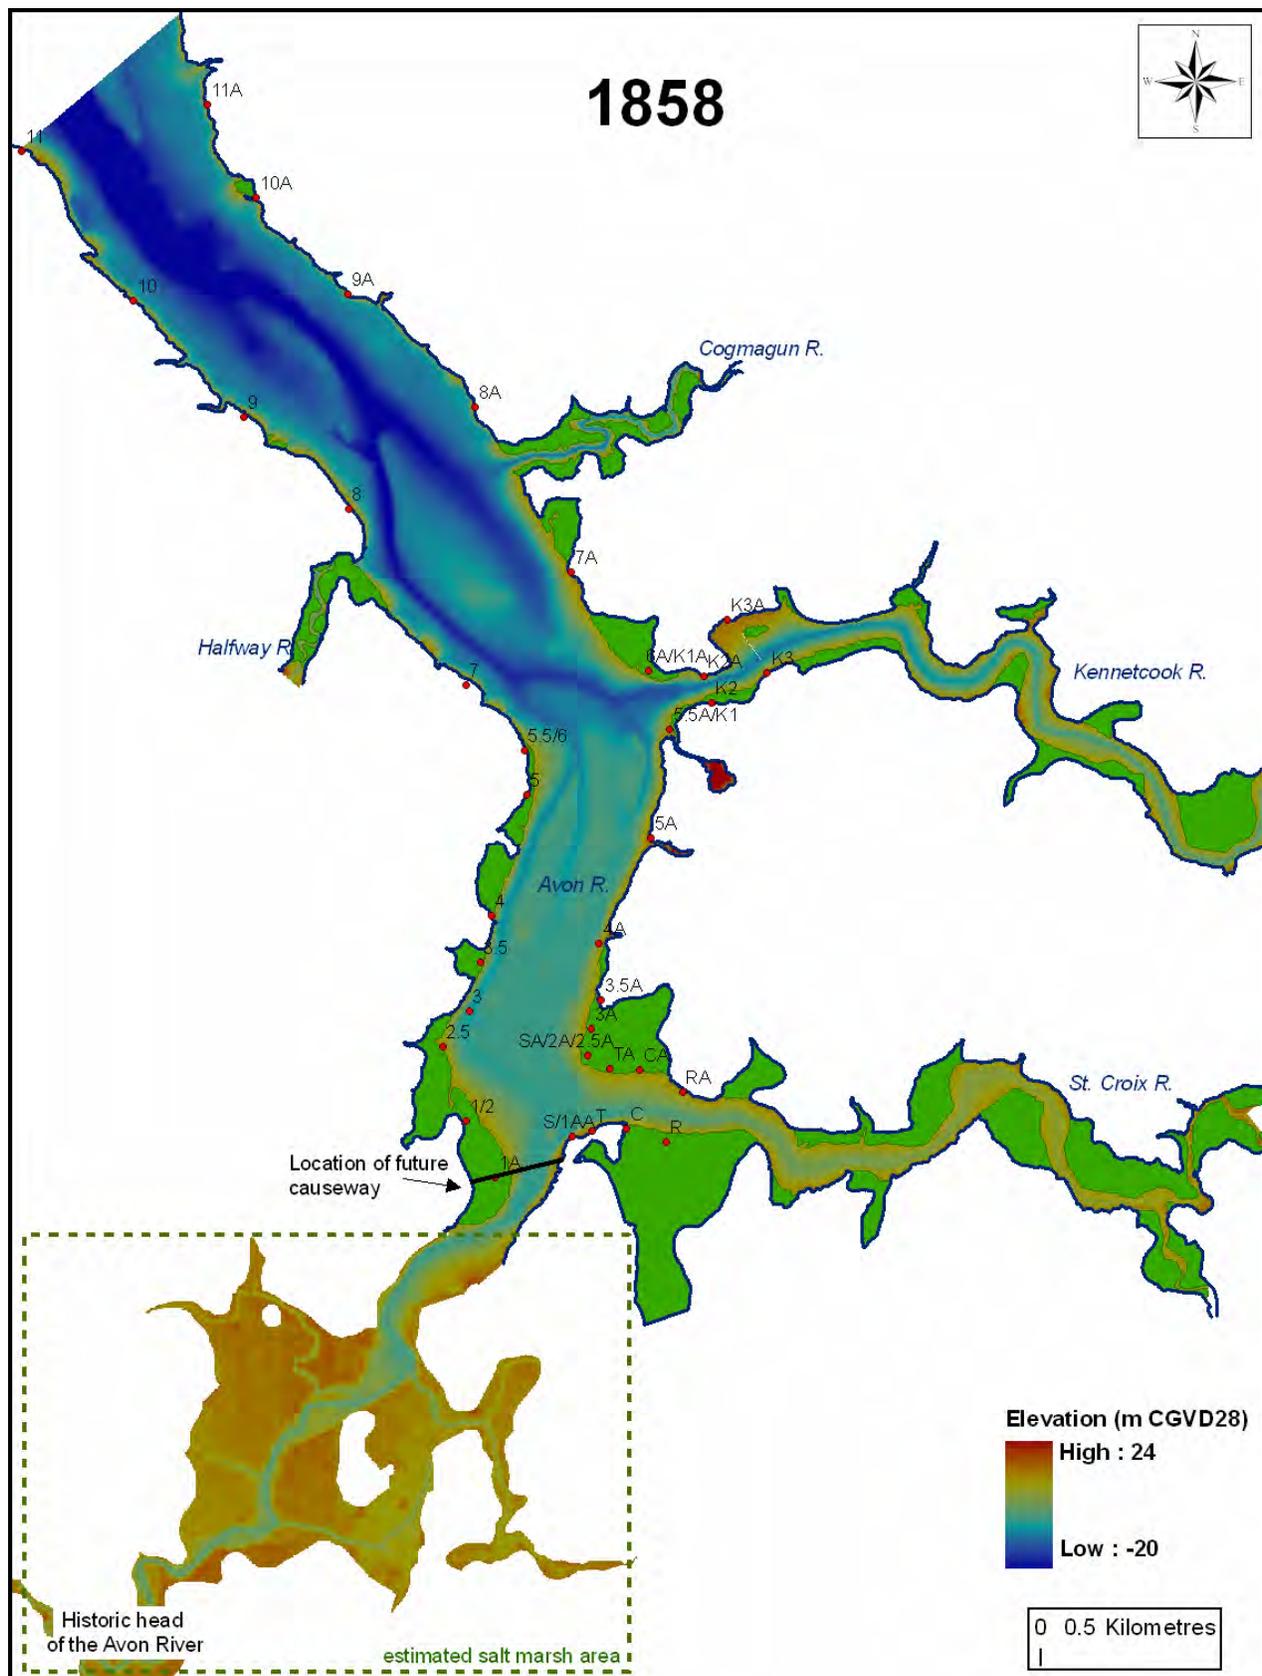
Figure 4.11a): Digital elevation model generated for 1858 for full tidal prism. Note that the areas upstream of the causeway are estimate values since no data were available. Marsh areas are in green and survey posts are provided for reference. Dyked marshes are not shown.

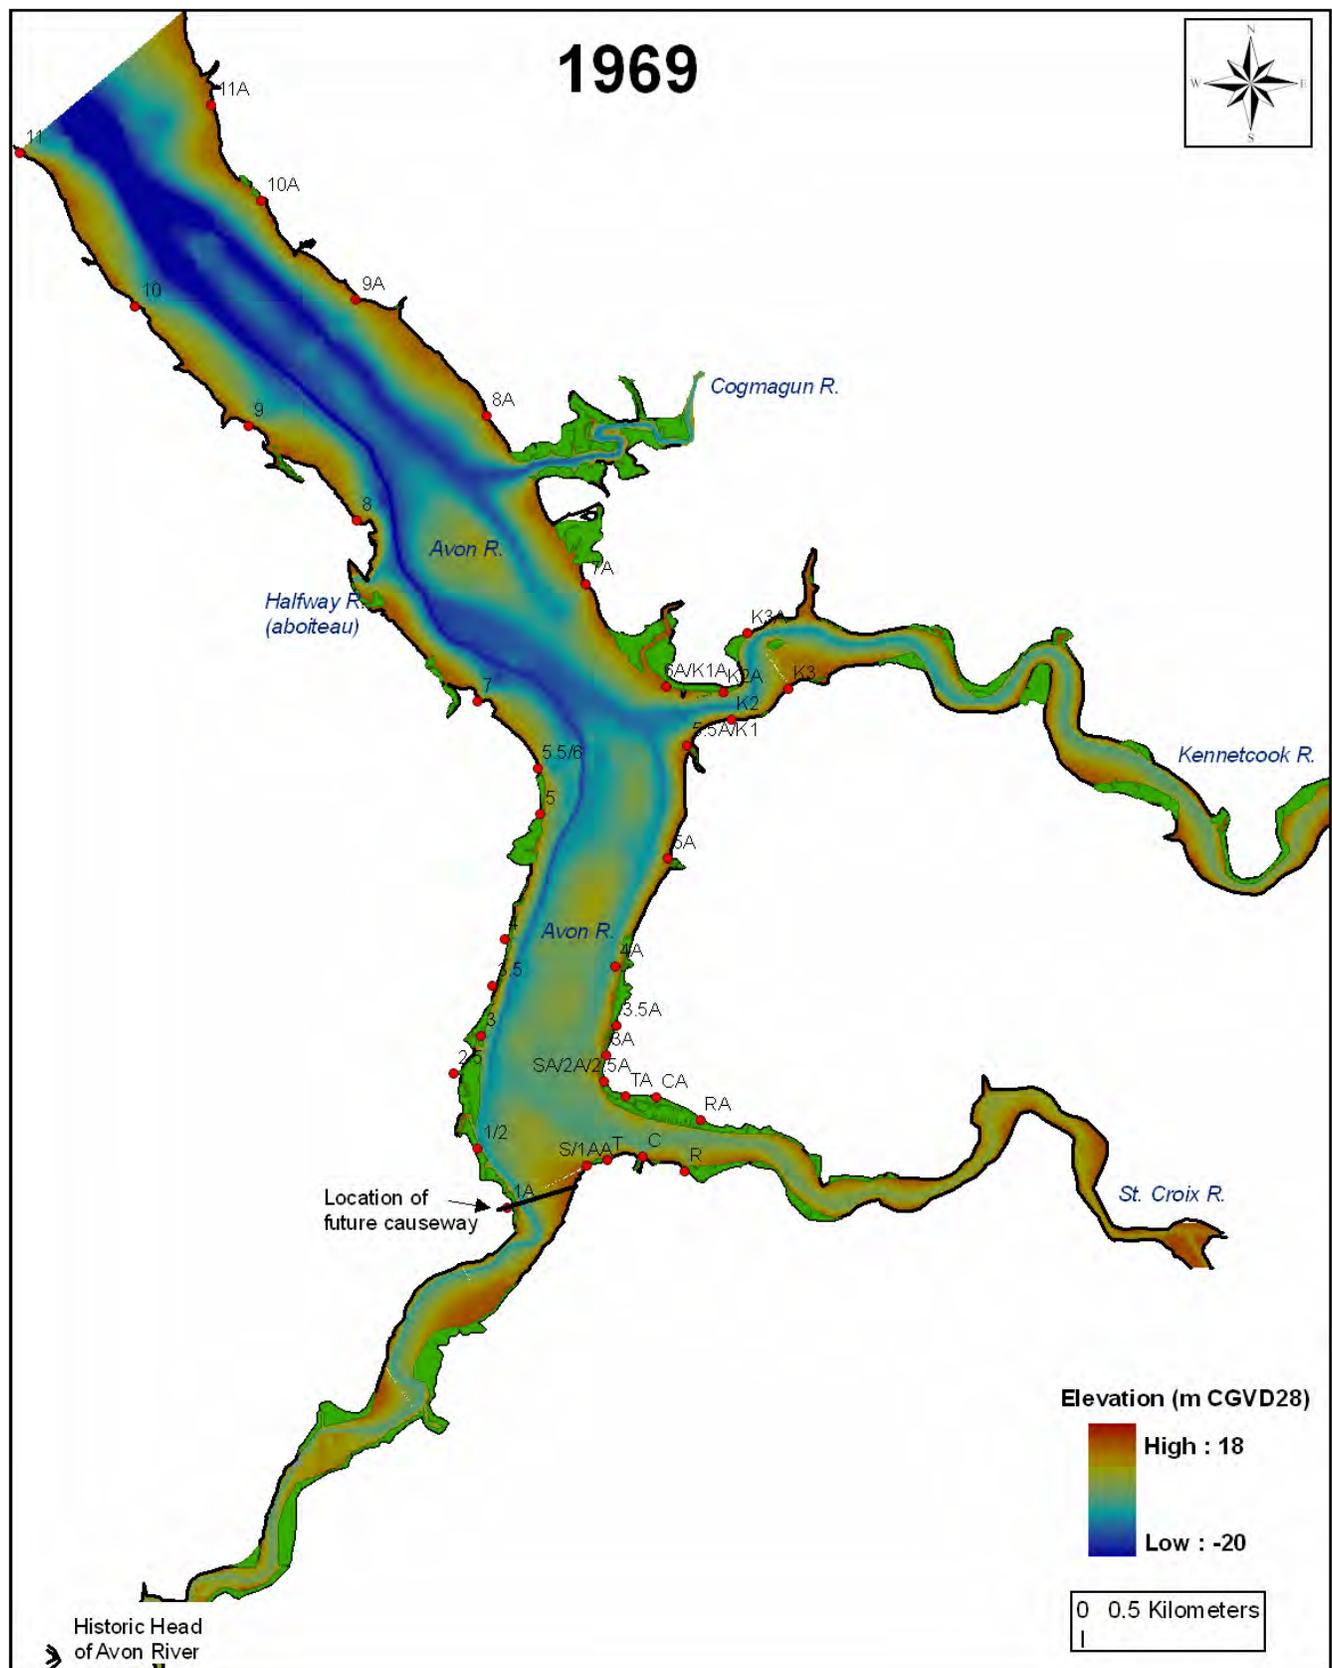
Figure 4.11b): Digital elevation model generated for 1969 for full tidal prism. Marsh areas for 1964 are in green and survey posts are provided for reference. Salt marsh in green. Dyked marshes excluded.

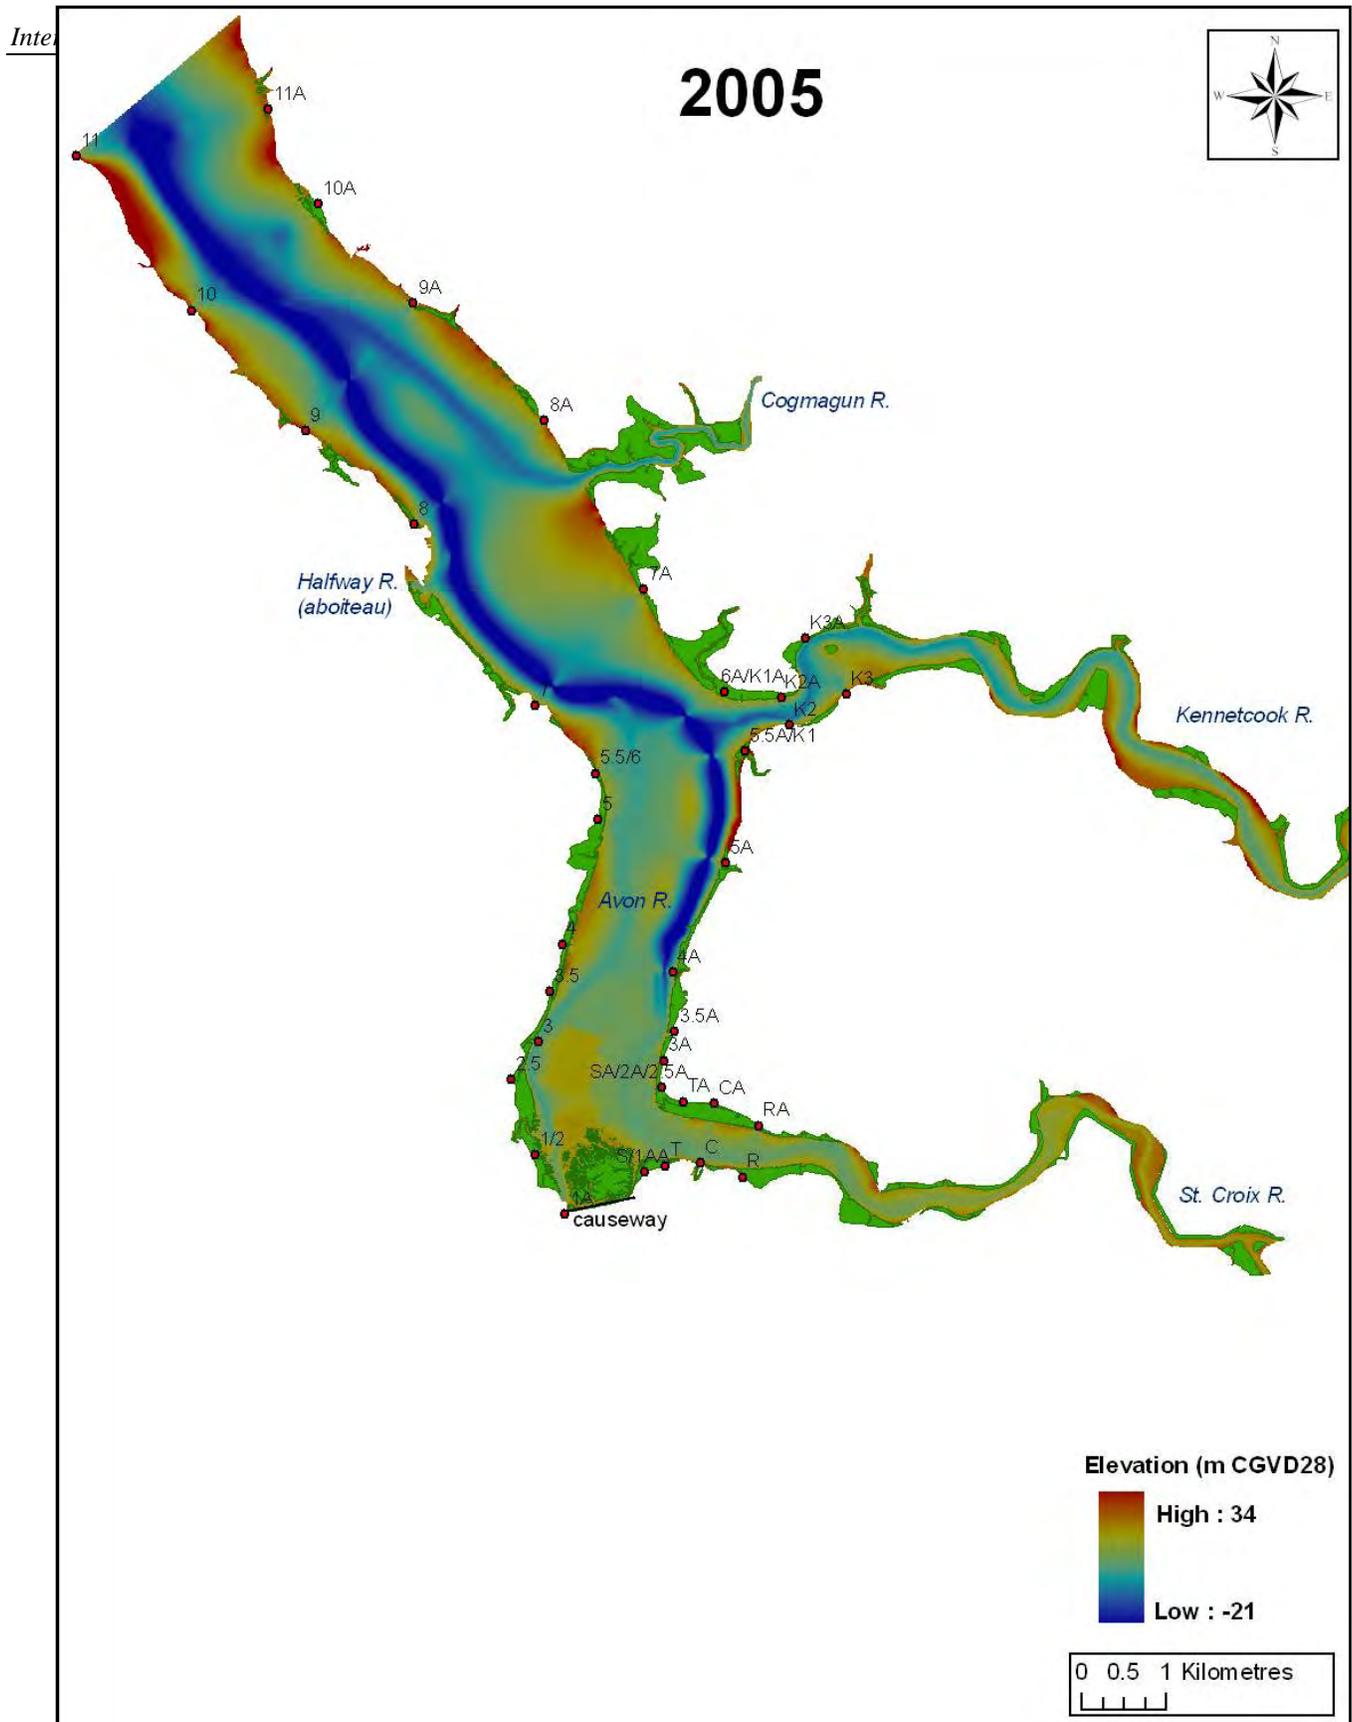
Figure 4.11c): Digital elevation model generated for 2005 for full tidal prism. Marsh areas for 2003 are in green and survey posts are provided for reference.

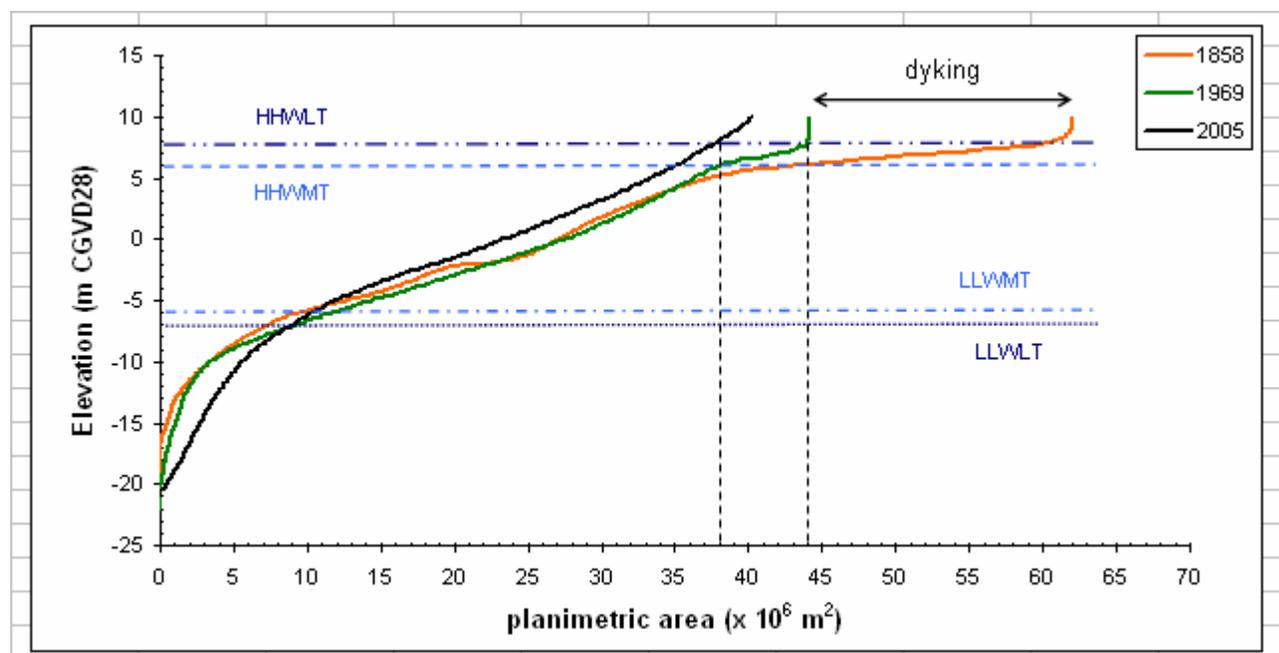
Figure 4.12: Comparison of hypsometric curves with change in planimetric area associated with change in elevation for the 1858, 1969 and 2005.
