## Intertidal Morphodynamics of the Avon River Estuary

Final report submitted to the  
Nova Scotia Department of Transportation and Public Works (NSTPW)

Prepared by  
Dr. Danika van Proosdij, Department of Geography, Saint Mary's University  
& Greg Baker, MP\_SpARC, Saint Mary's University  
923 Robie, St. Halifax, N.S., B3H 3C3

September 30, 2007

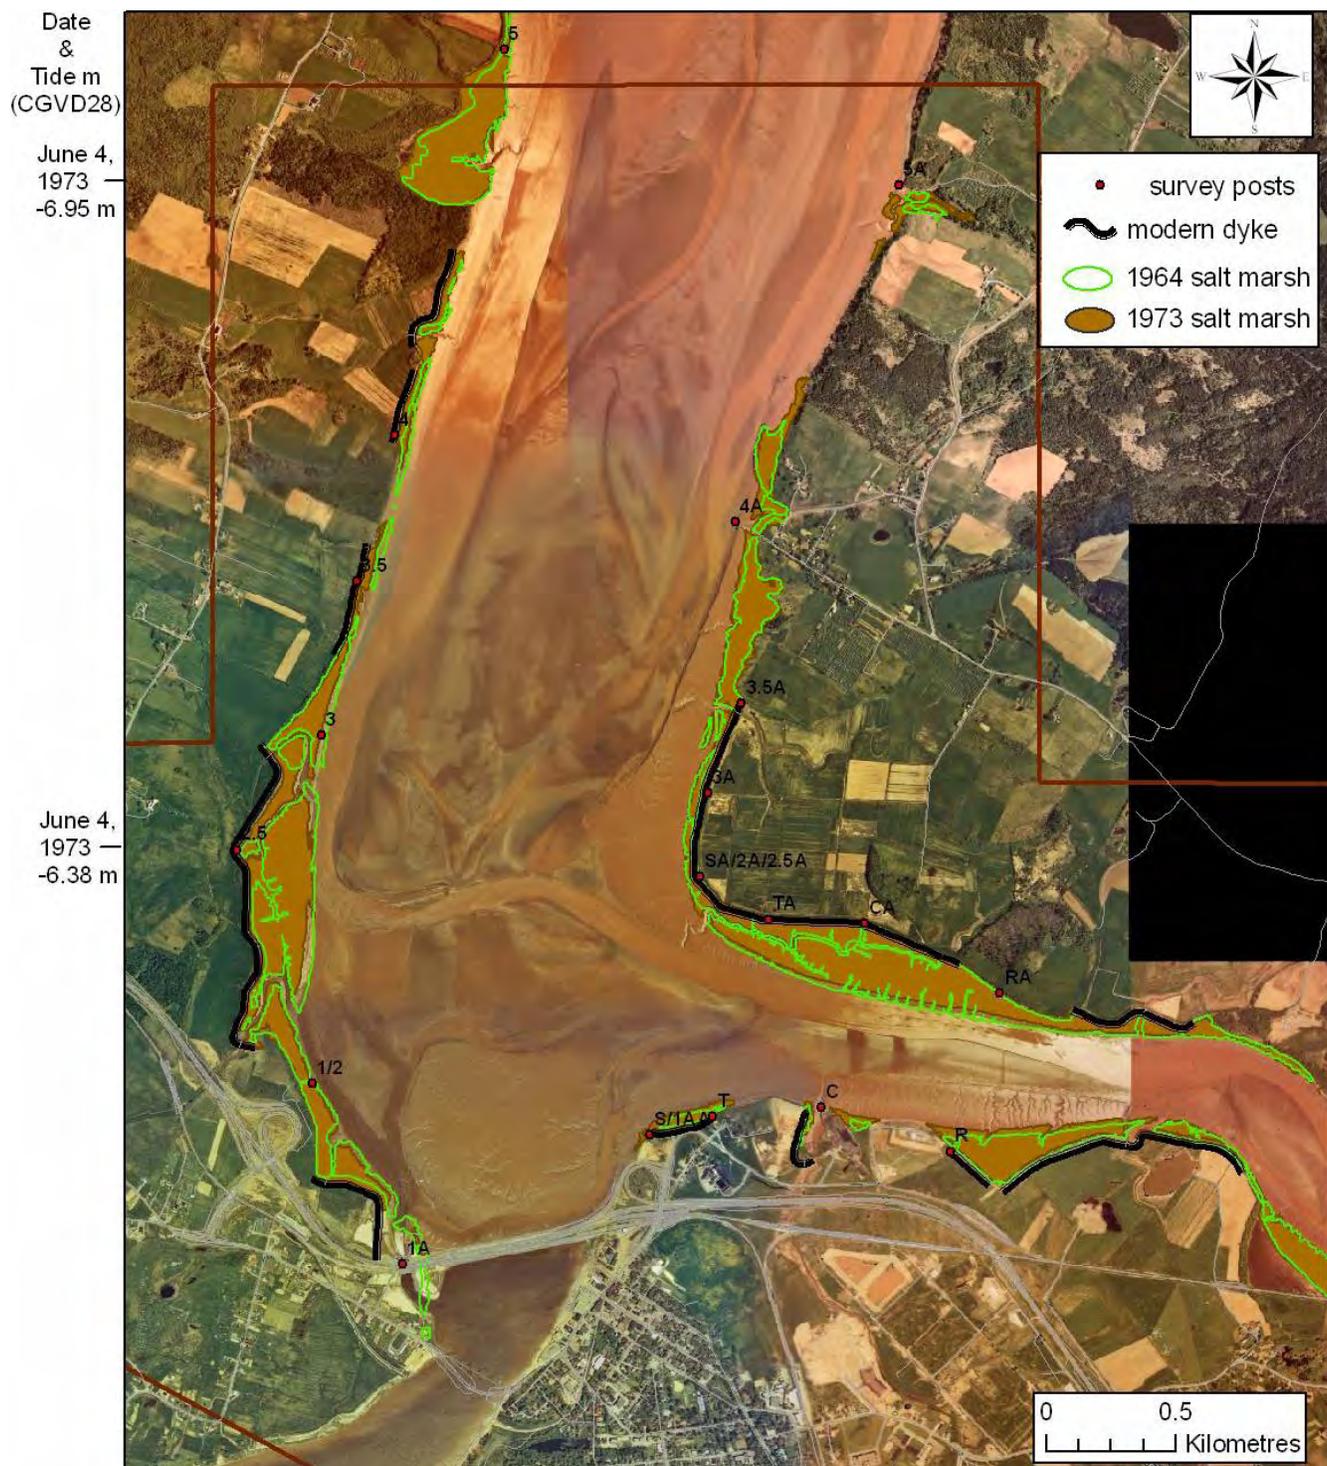
Figure 4.16: Digitized marsh polygons from 1964 to 1973 overlay on a 1973 aerial photograph. Note relative stability of marsh vegetation with some erosion initiated near post 3 and expansion of mudflat adjacent to the causeway. Dyke lines and roads represent present day for reference.

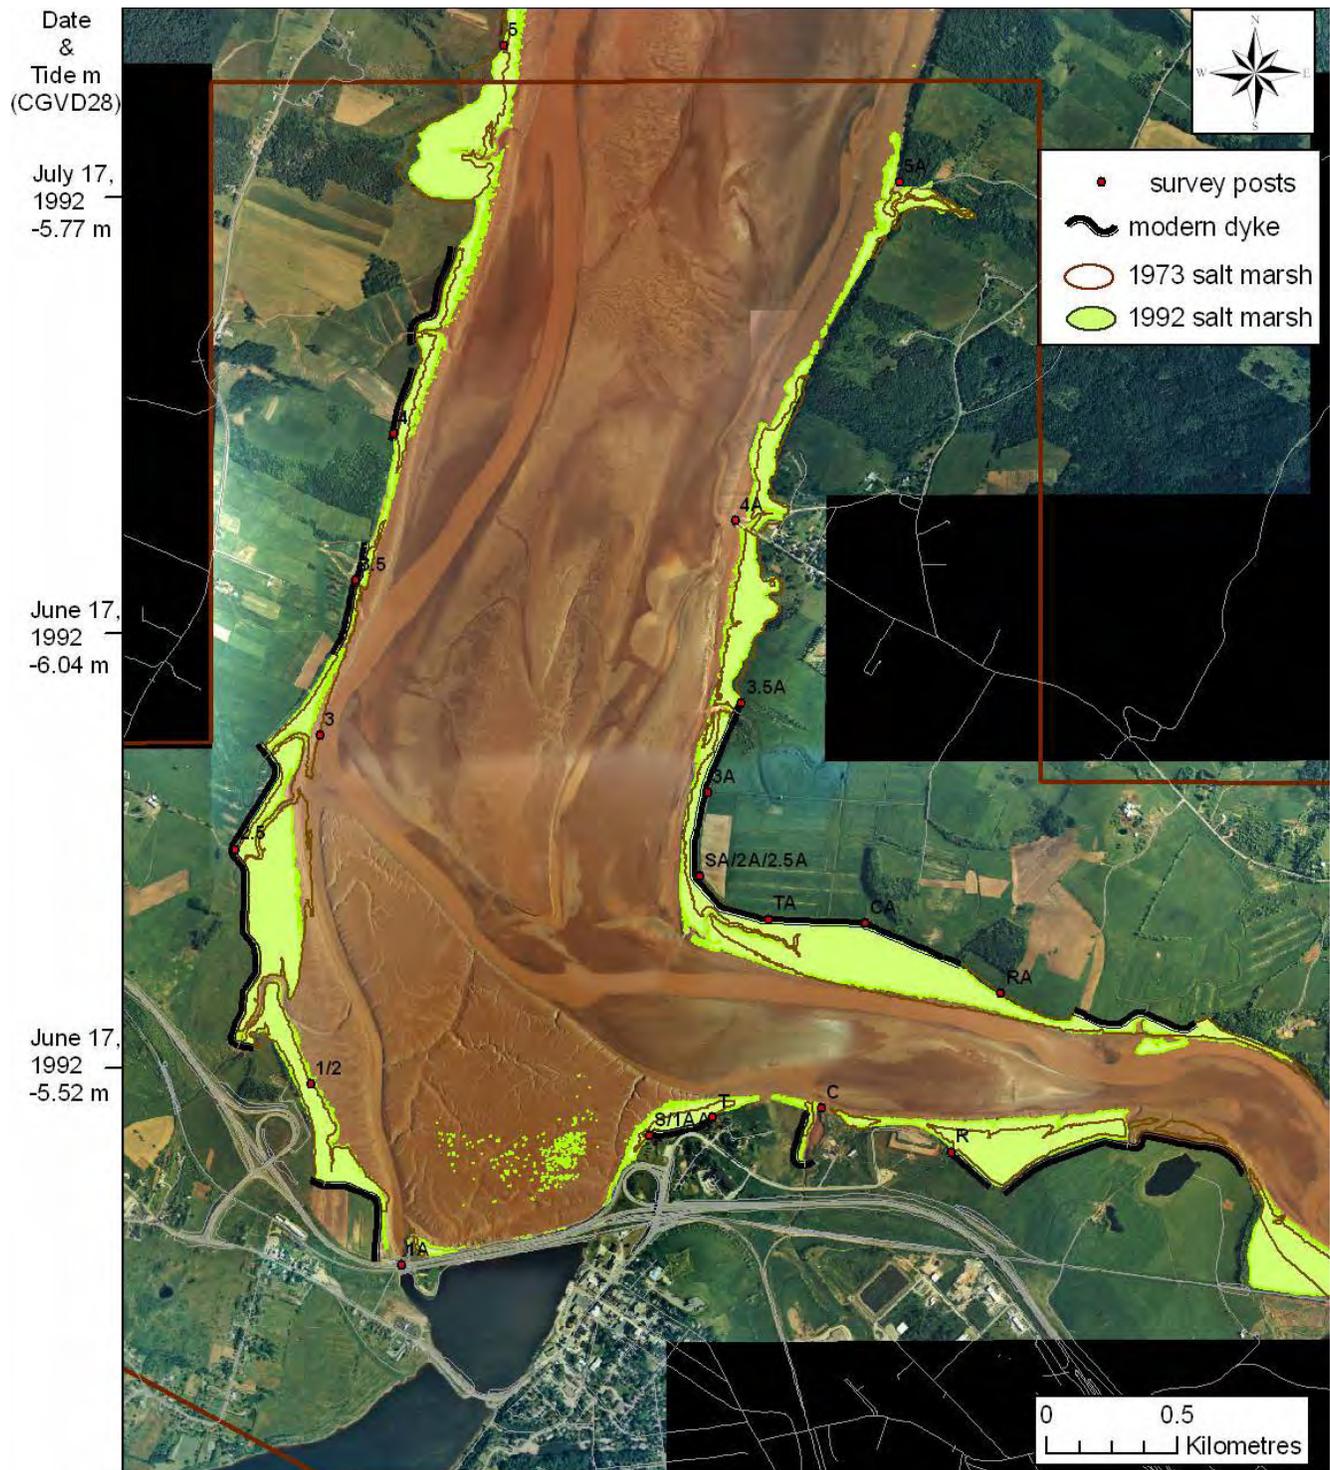
*Figure 4.17: Digitized marsh polygons from 1973 to 1992 overlain on a 1992 aerial photograph. Note accelerated erosion along west bank near post 3 and 2.5, accelerated mudflat development and new channel thalweg position. Dyke lines and roads represent present day for reference.*

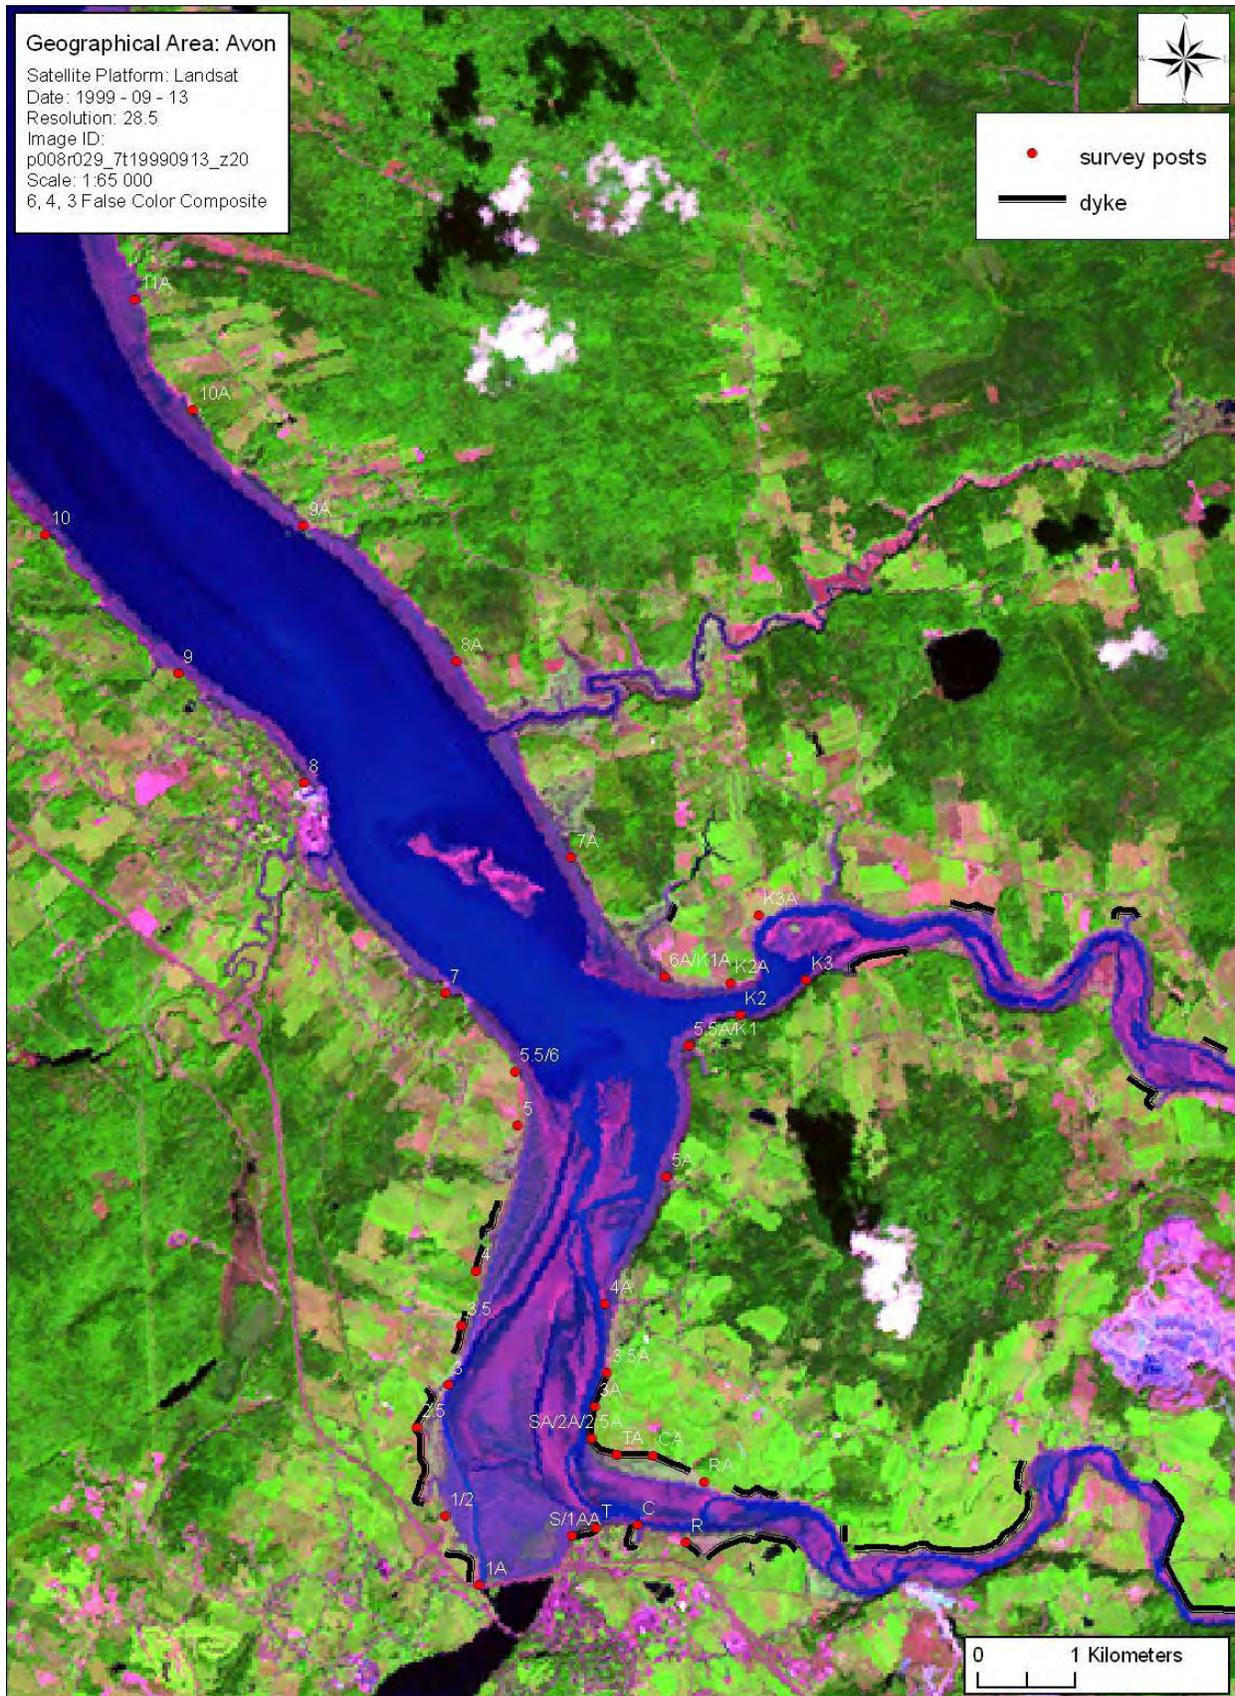
Figure 4.18: 1999 Landsat 7 bands 6,4,3 false color composite illustrating position of main channels and intertidal bedforms. Resolution of satellite is 28.5 m.

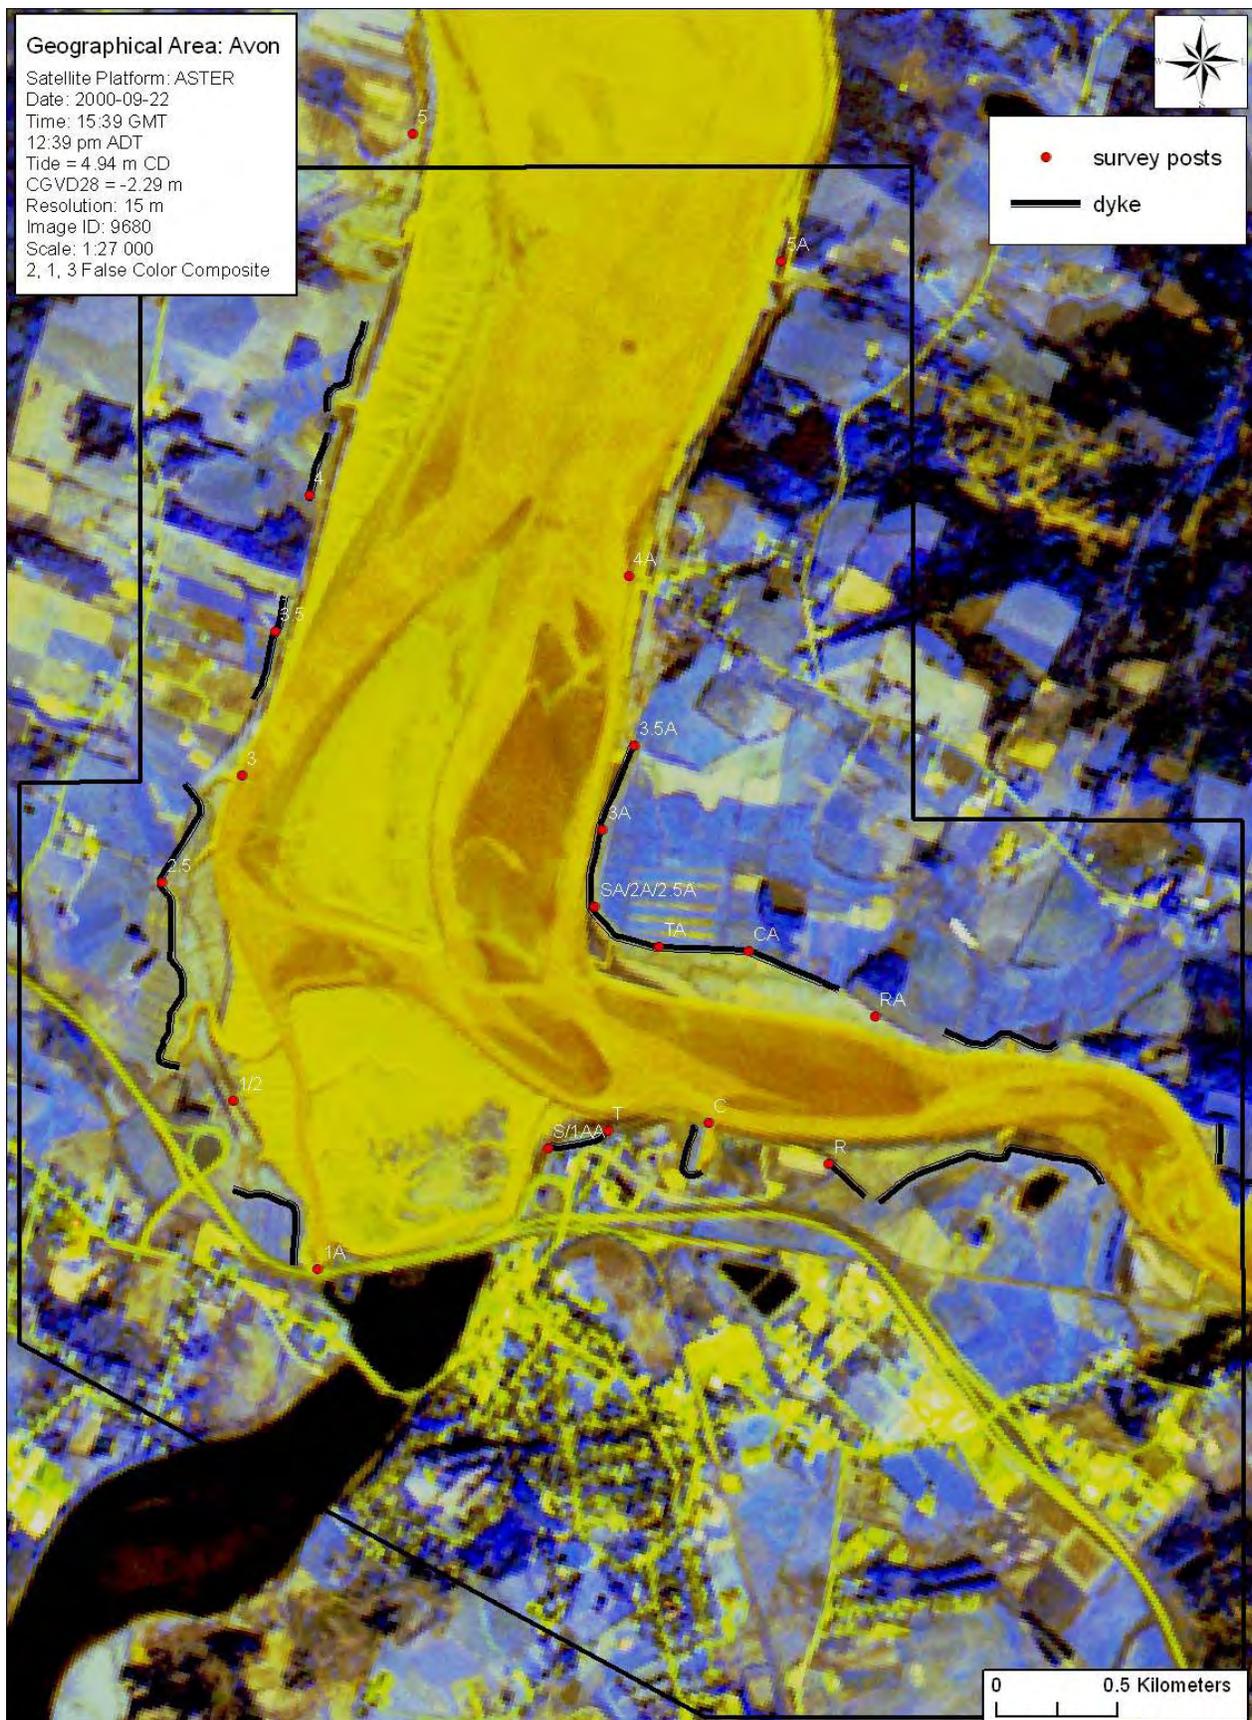
Figure 4.19: ASTER Satellite illustrating position of main channels and intertidal bedforms on Sept 22, 2000. Resolution of satellite is 15 m. Note vegetation on mudflat downstream of causeway.

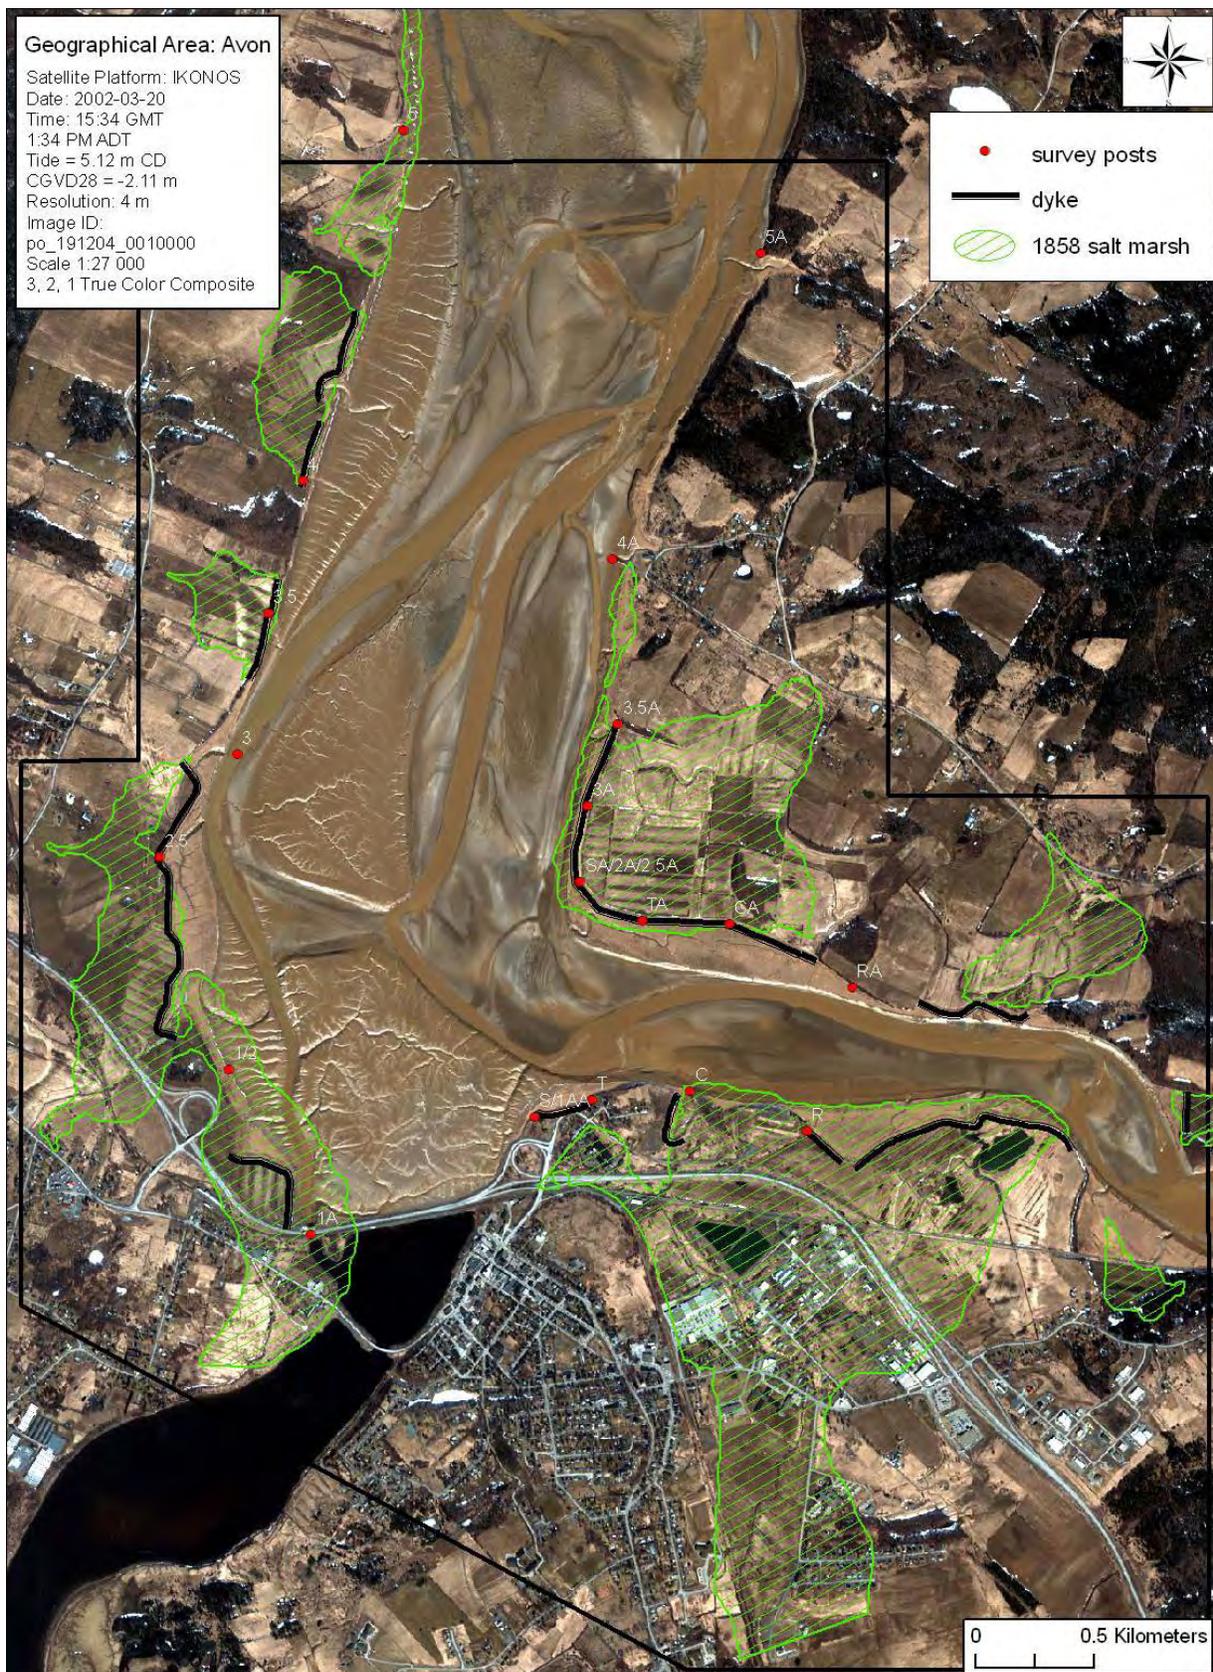
*Figure 4.20: Multispectral IKONOS satellite image illustrating position of main channels and intertidal bedforms on March 20, 2002. Resolution of satellite is 4 m. Location of 1858 marsh provided for reference. No vegetation is visible on Windsor mudflat/salt marsh since it is too early in the growing season and most of the previous year's growth would be dead and/or sheared off therefore would not contain chorophyll which could be detected by the satellite.*

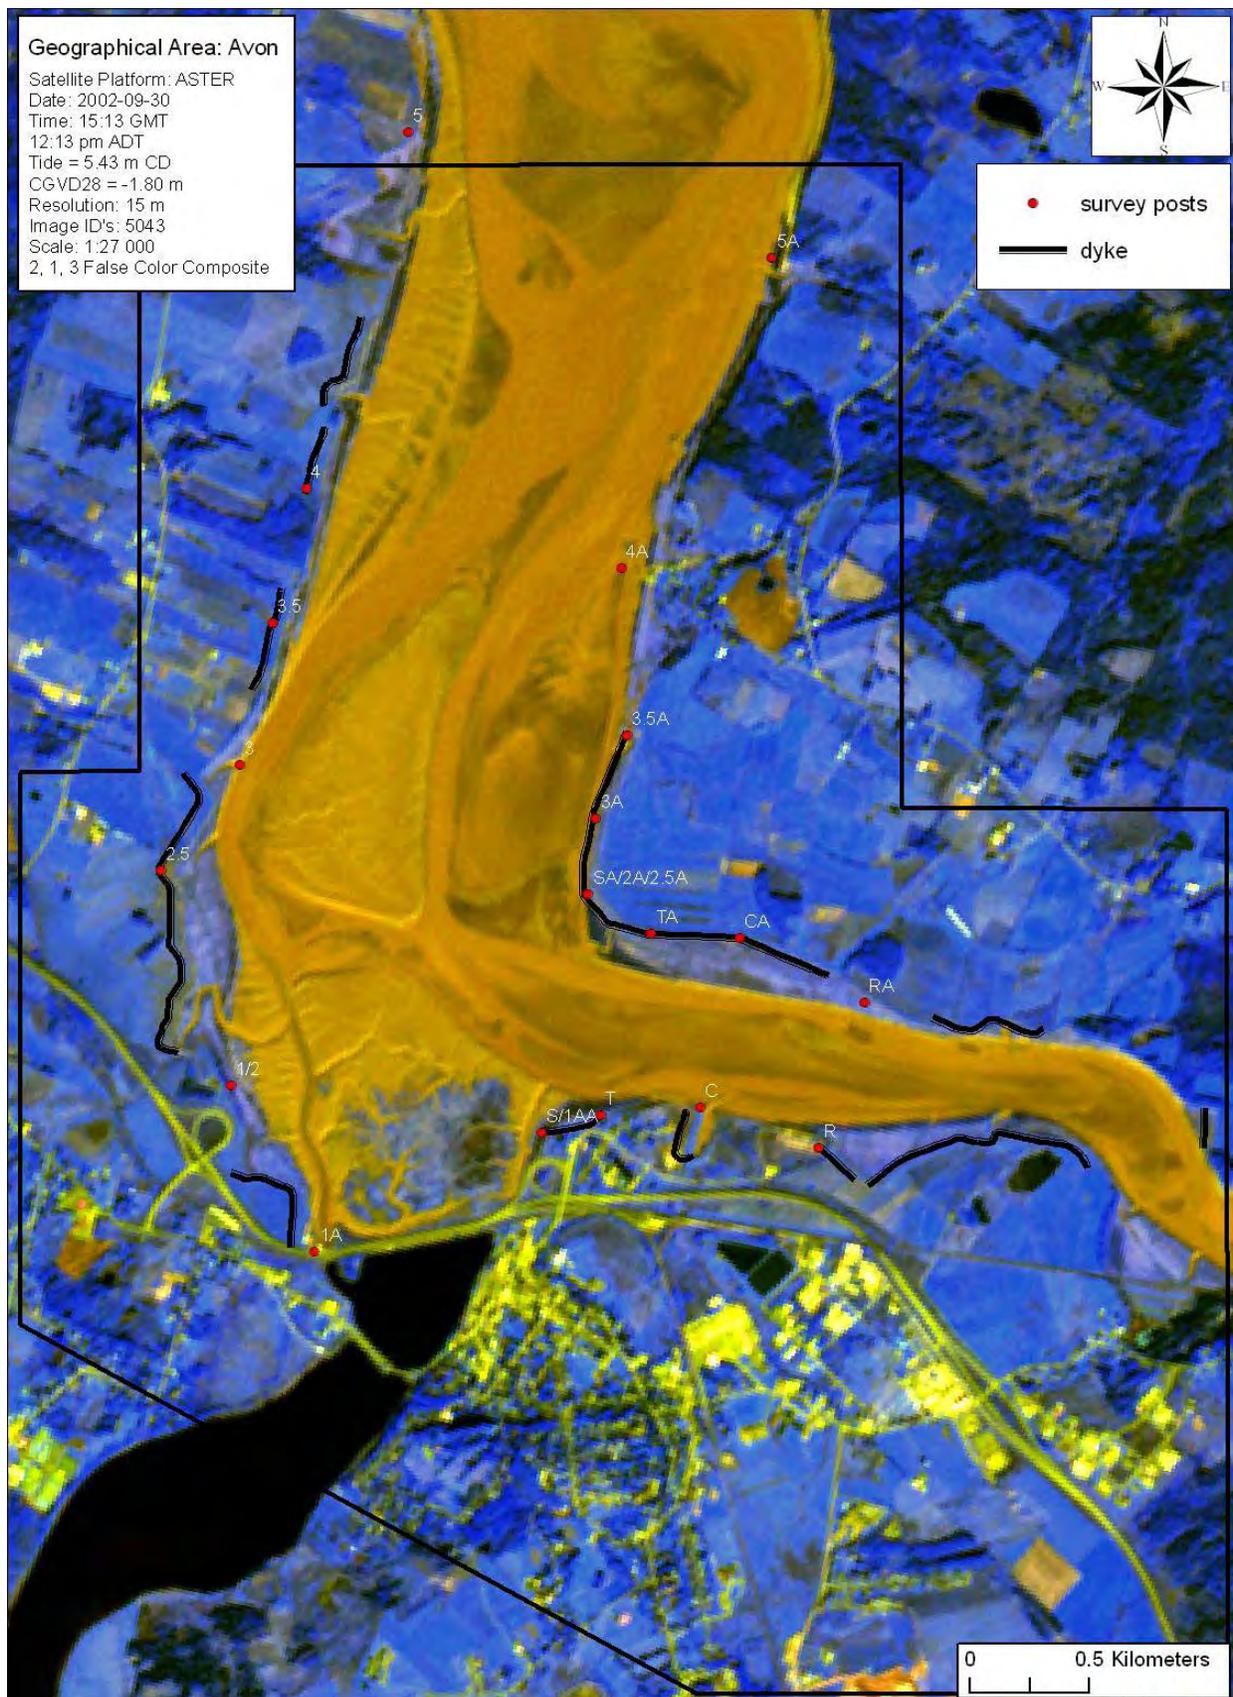
*Figure 4.21: ASTER satellite image illustrating position of main channels and intertidal bedforms on Sept 30, 2002. Resolution of satellite is 15 m. Note expansive vegetation downstream of causeway.*

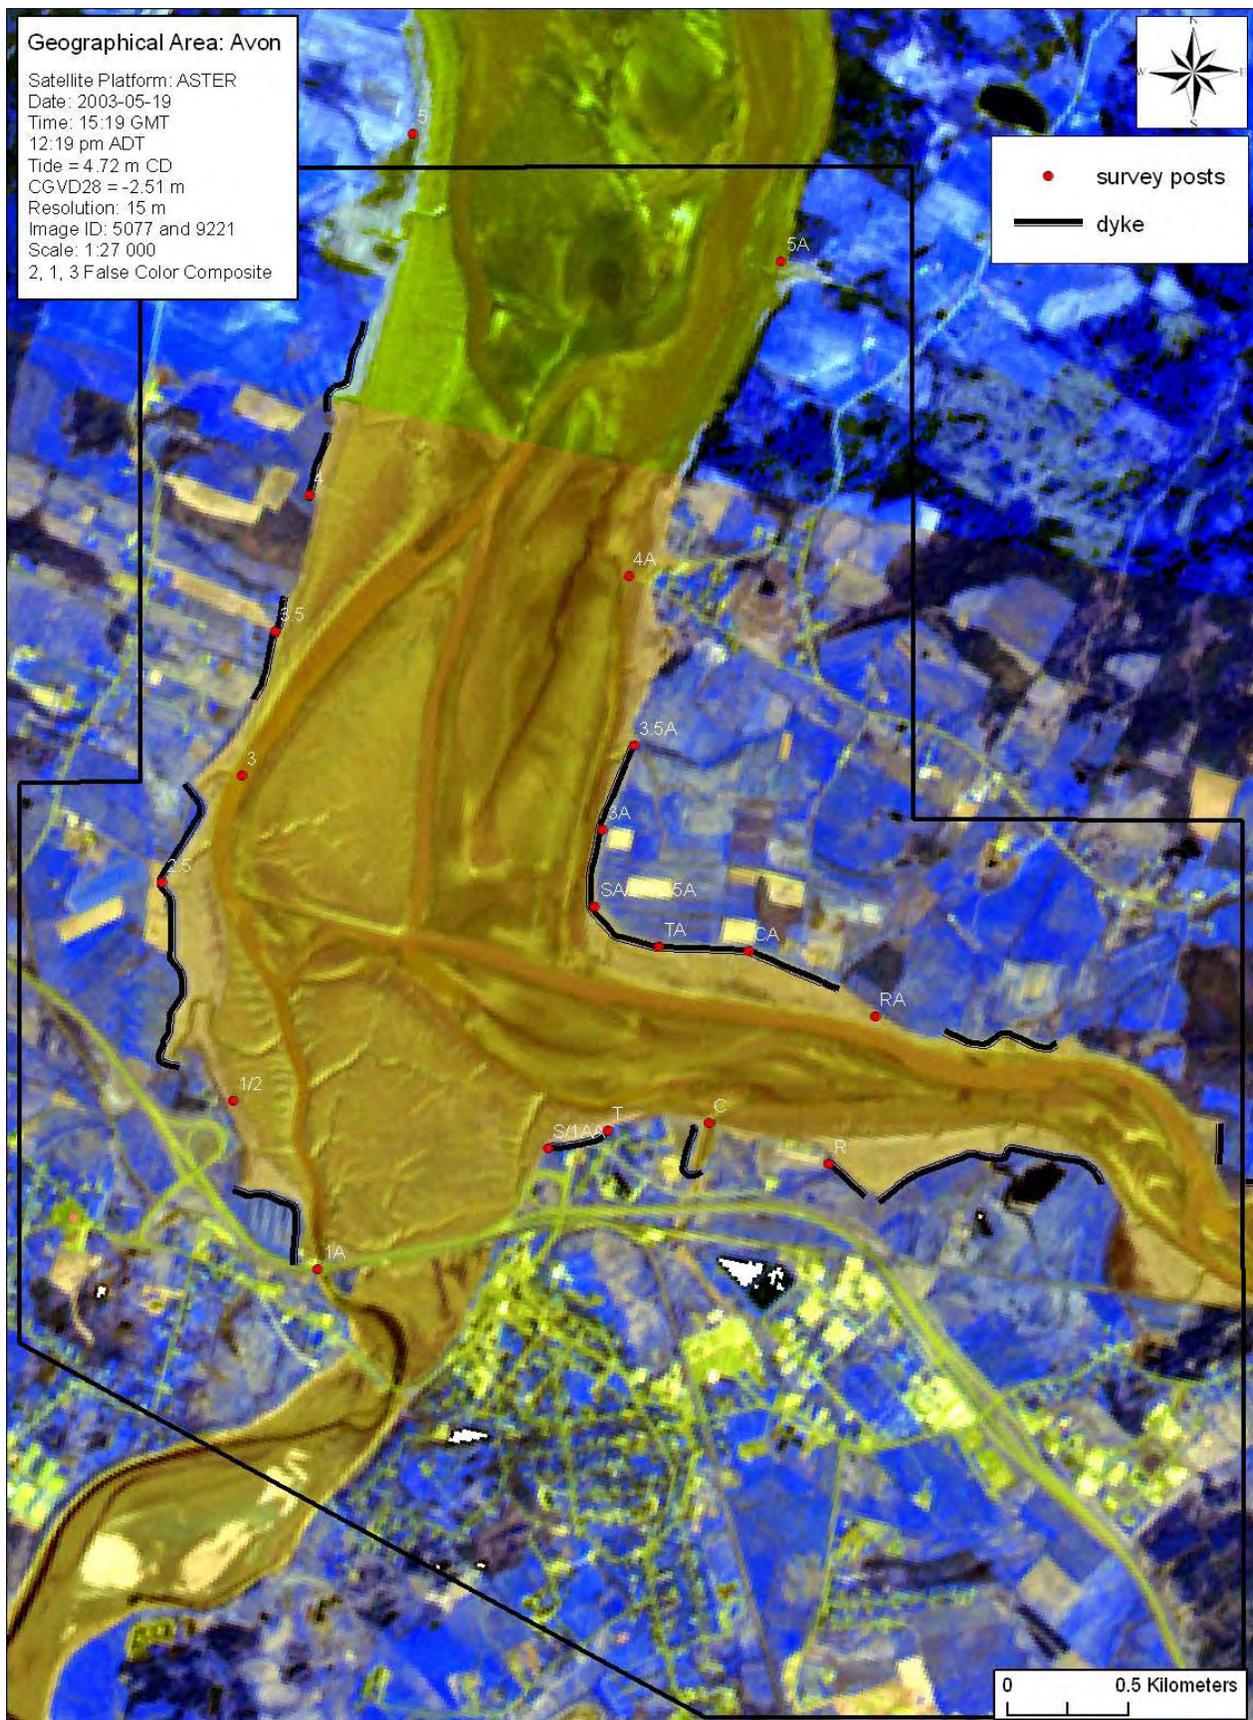
Figure 4.22: ASTER satellite image illustrating position of main channels and intertidal bedforms on May 19, 2003. Resolution of satellite is 15 m.

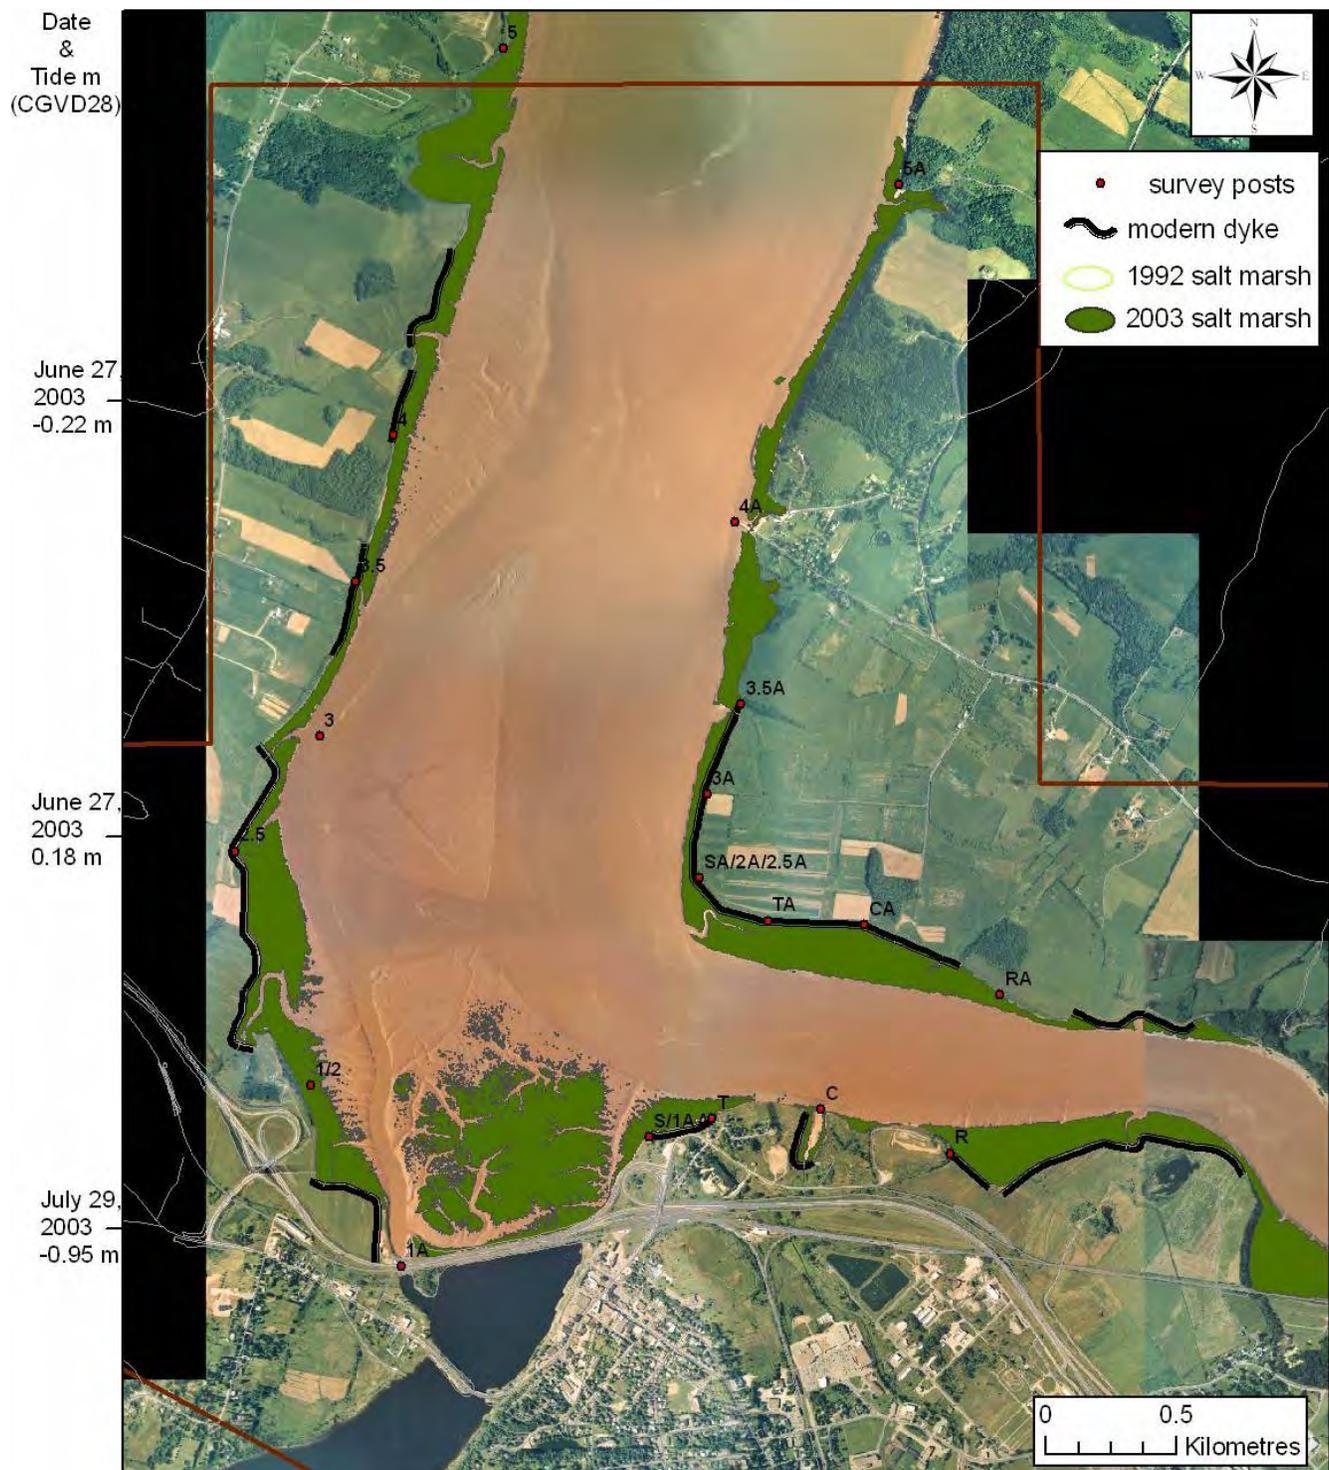
Figure 4.23: Digitized salt marsh polygons for 1992 and 2003 overlain on a 2003 aerial photograph. Note extensive erosion, near the west side of line 3 and colonization of mudflat adjacent to the causeway. Dyke lines and roads represent modern day.

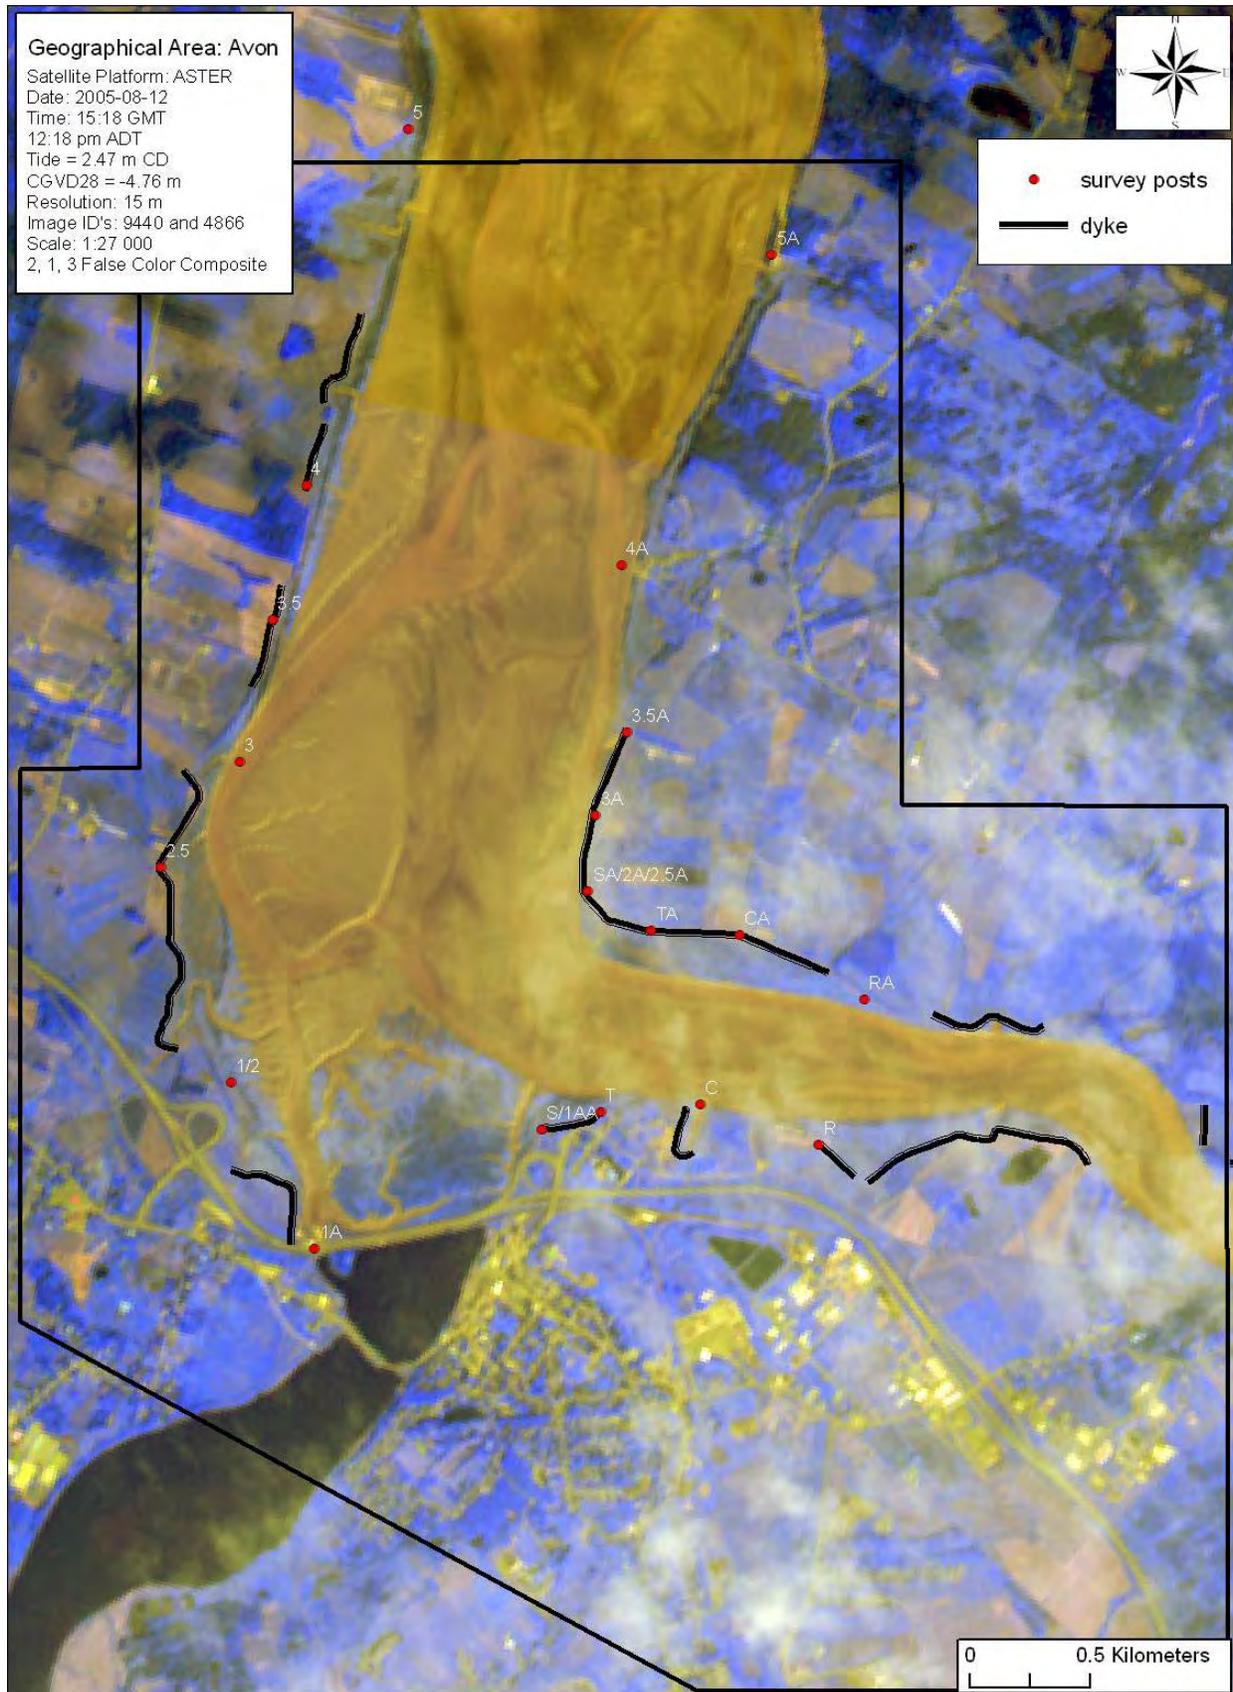
Figure 4.24: ASTER satellite image illustrating position of main channels and intertidal bedforms on July 12, 2005. Resolution of satellite is 15 m. Note expansion of marsh on western bank of tidal gate channel near Post 1/2 and erosion on eastern side at posts 2.5A, 3A and 3.5 A.

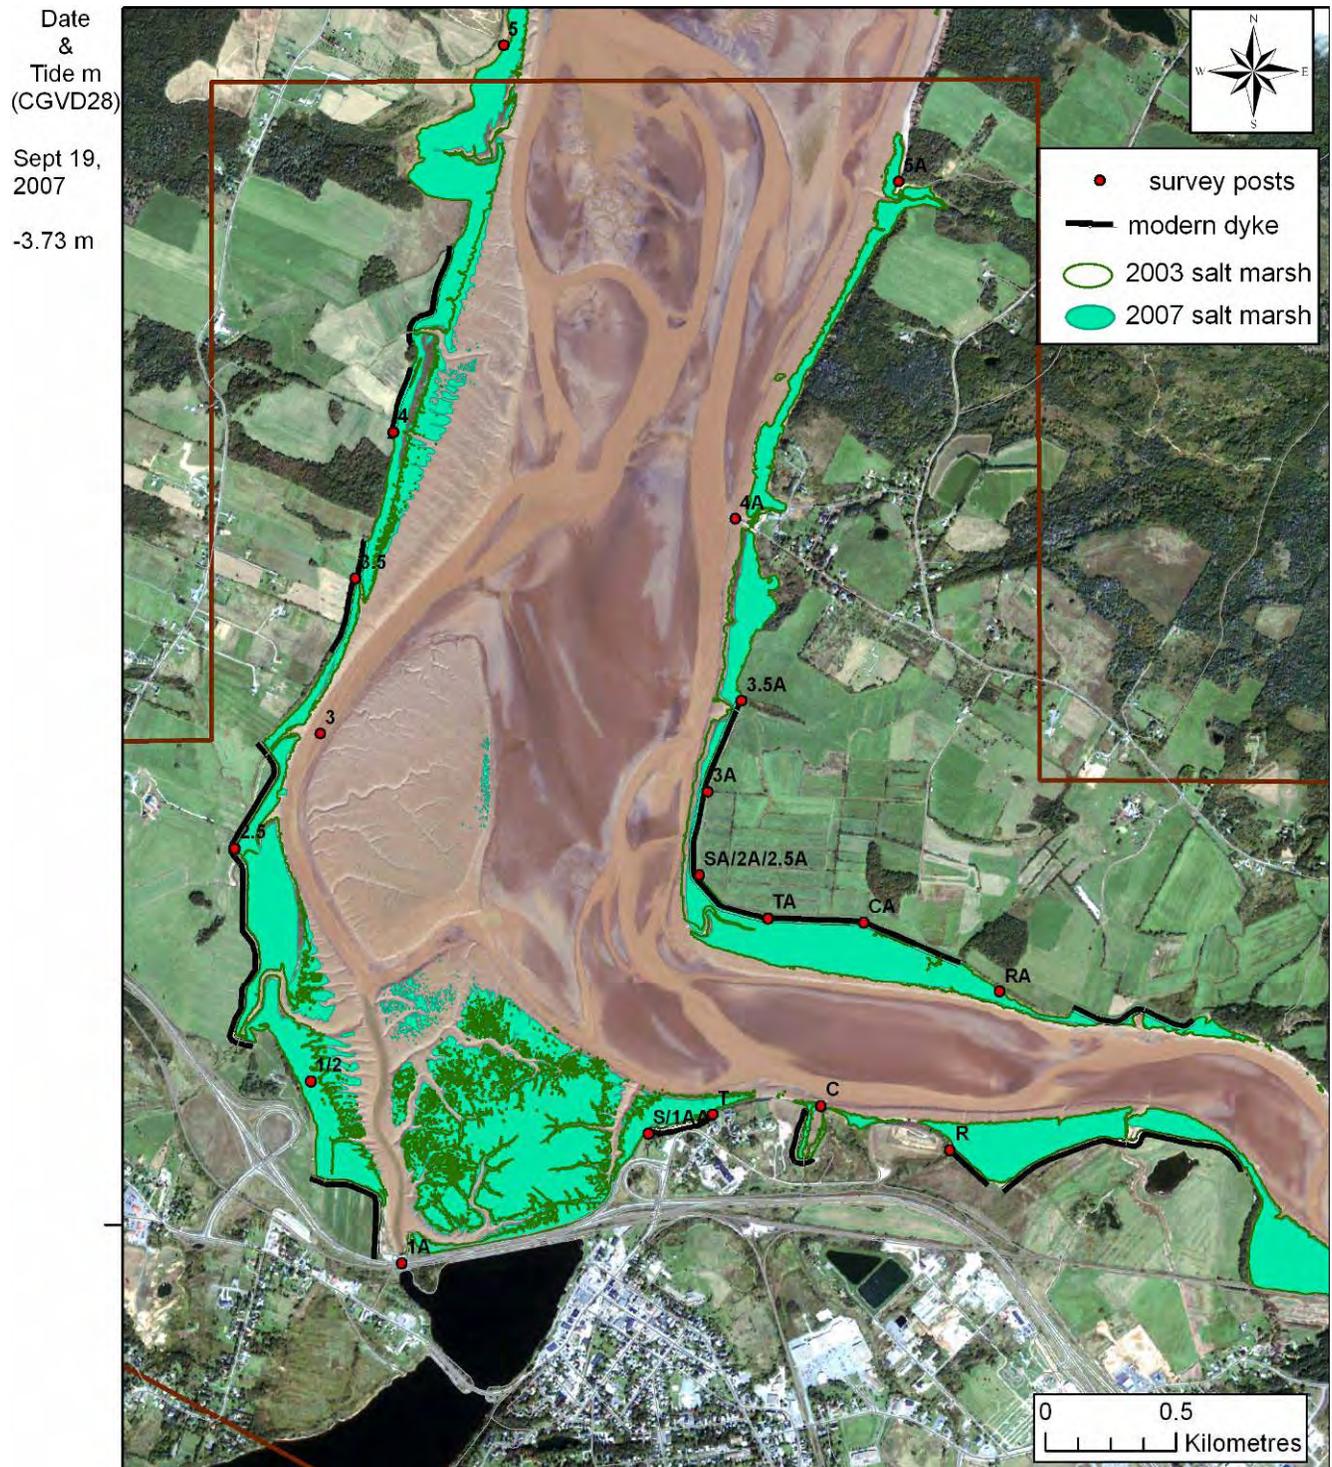
Figure 4.25: IKONOS satellite image illustrating position of main channels and intertidal bedforms on Sept 19, 2007. Resolution of multispectral image is 4 m. Note expansion of marsh downstream of causeway to cover entire potential mudflat area for deposition.

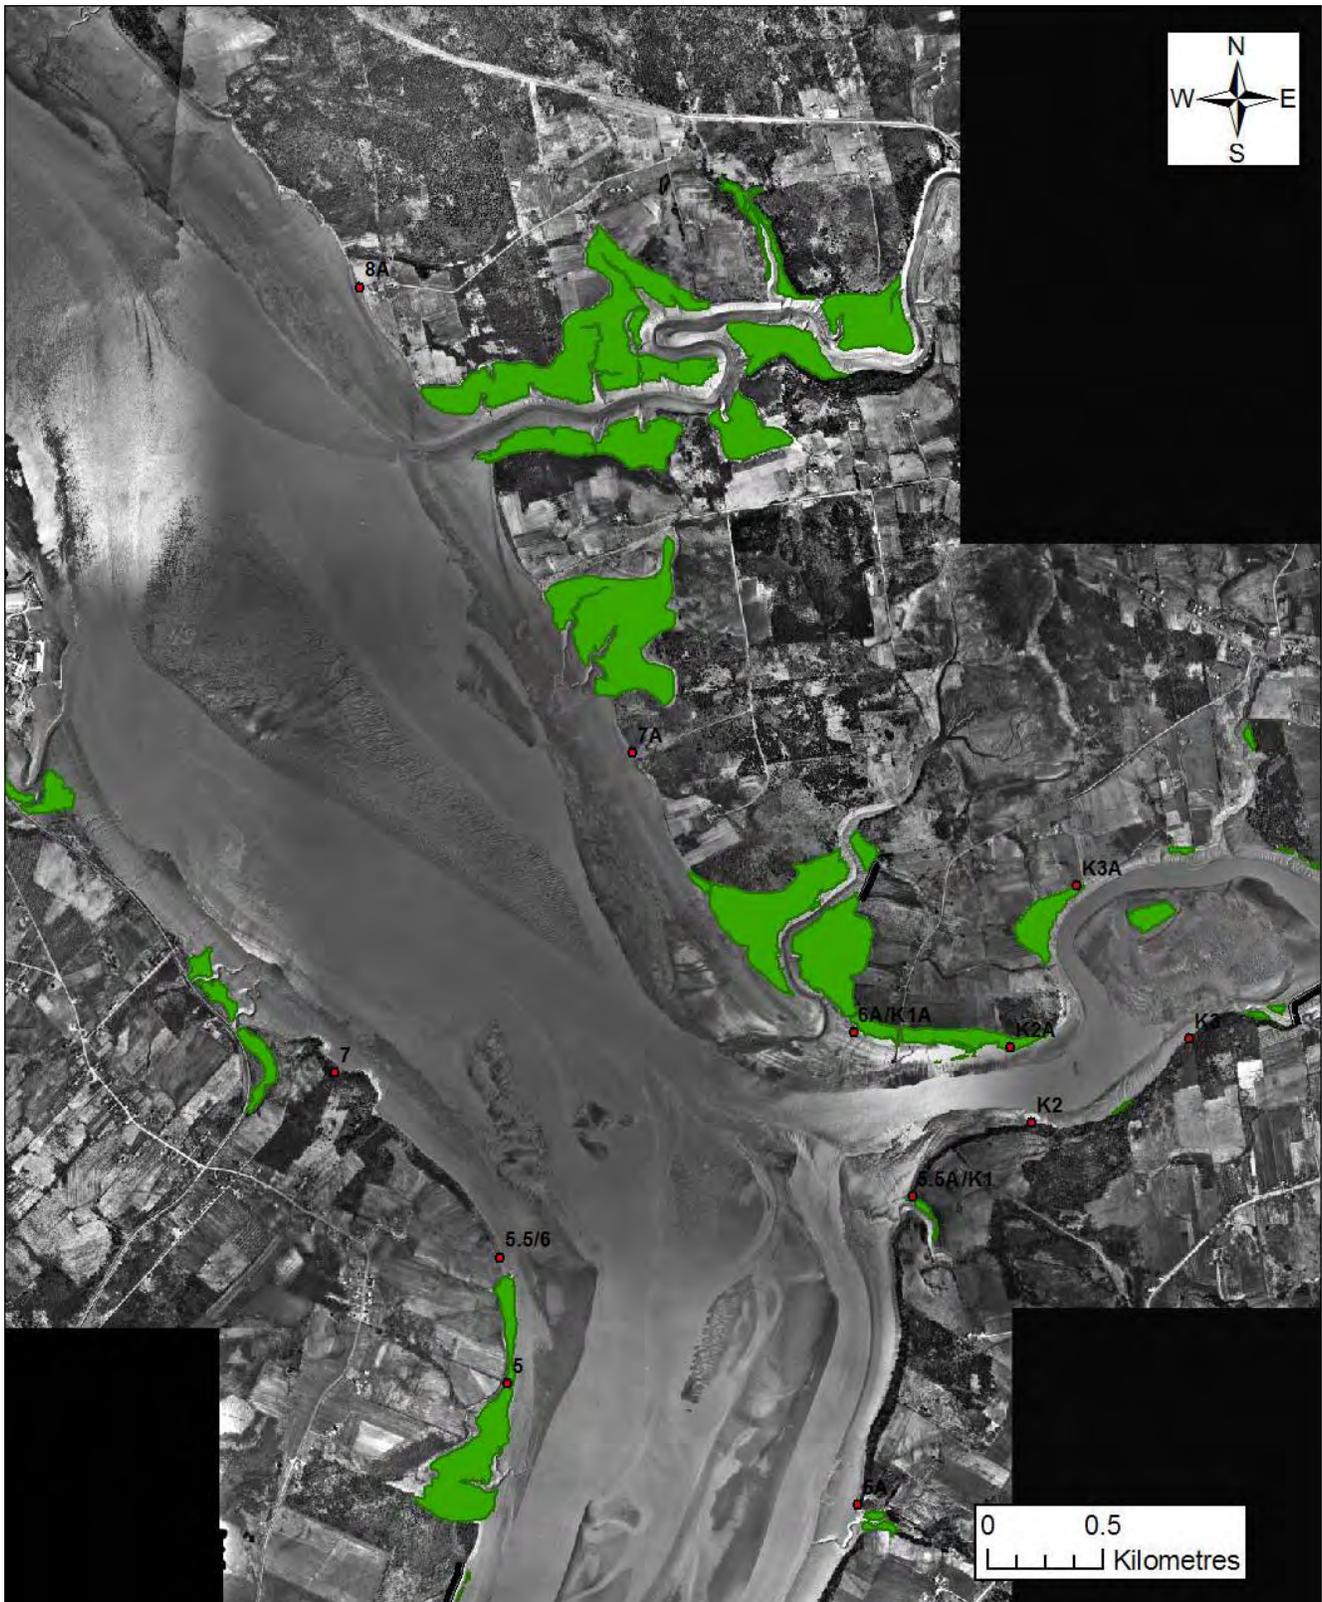
*Figure 4.26: Digitized marsh polygons in 1964 at low tide overlain on a 1964 aerial photograph just south of Hantsport.*
