## Intertidal Morphodynamics of the Avon River Estuary

Final report submitted to the  
Nova Scotia Department of Transportation and Public Works (NSTPW)

Prepared by  
Dr. Danika van Proosdij, Department of Geography, Saint Mary's University  
& Greg Baker, MP\_SpARC, Saint Mary's University  
923 Robie, St. Halifax, N.S., B3H 3C3

September 30, 2007

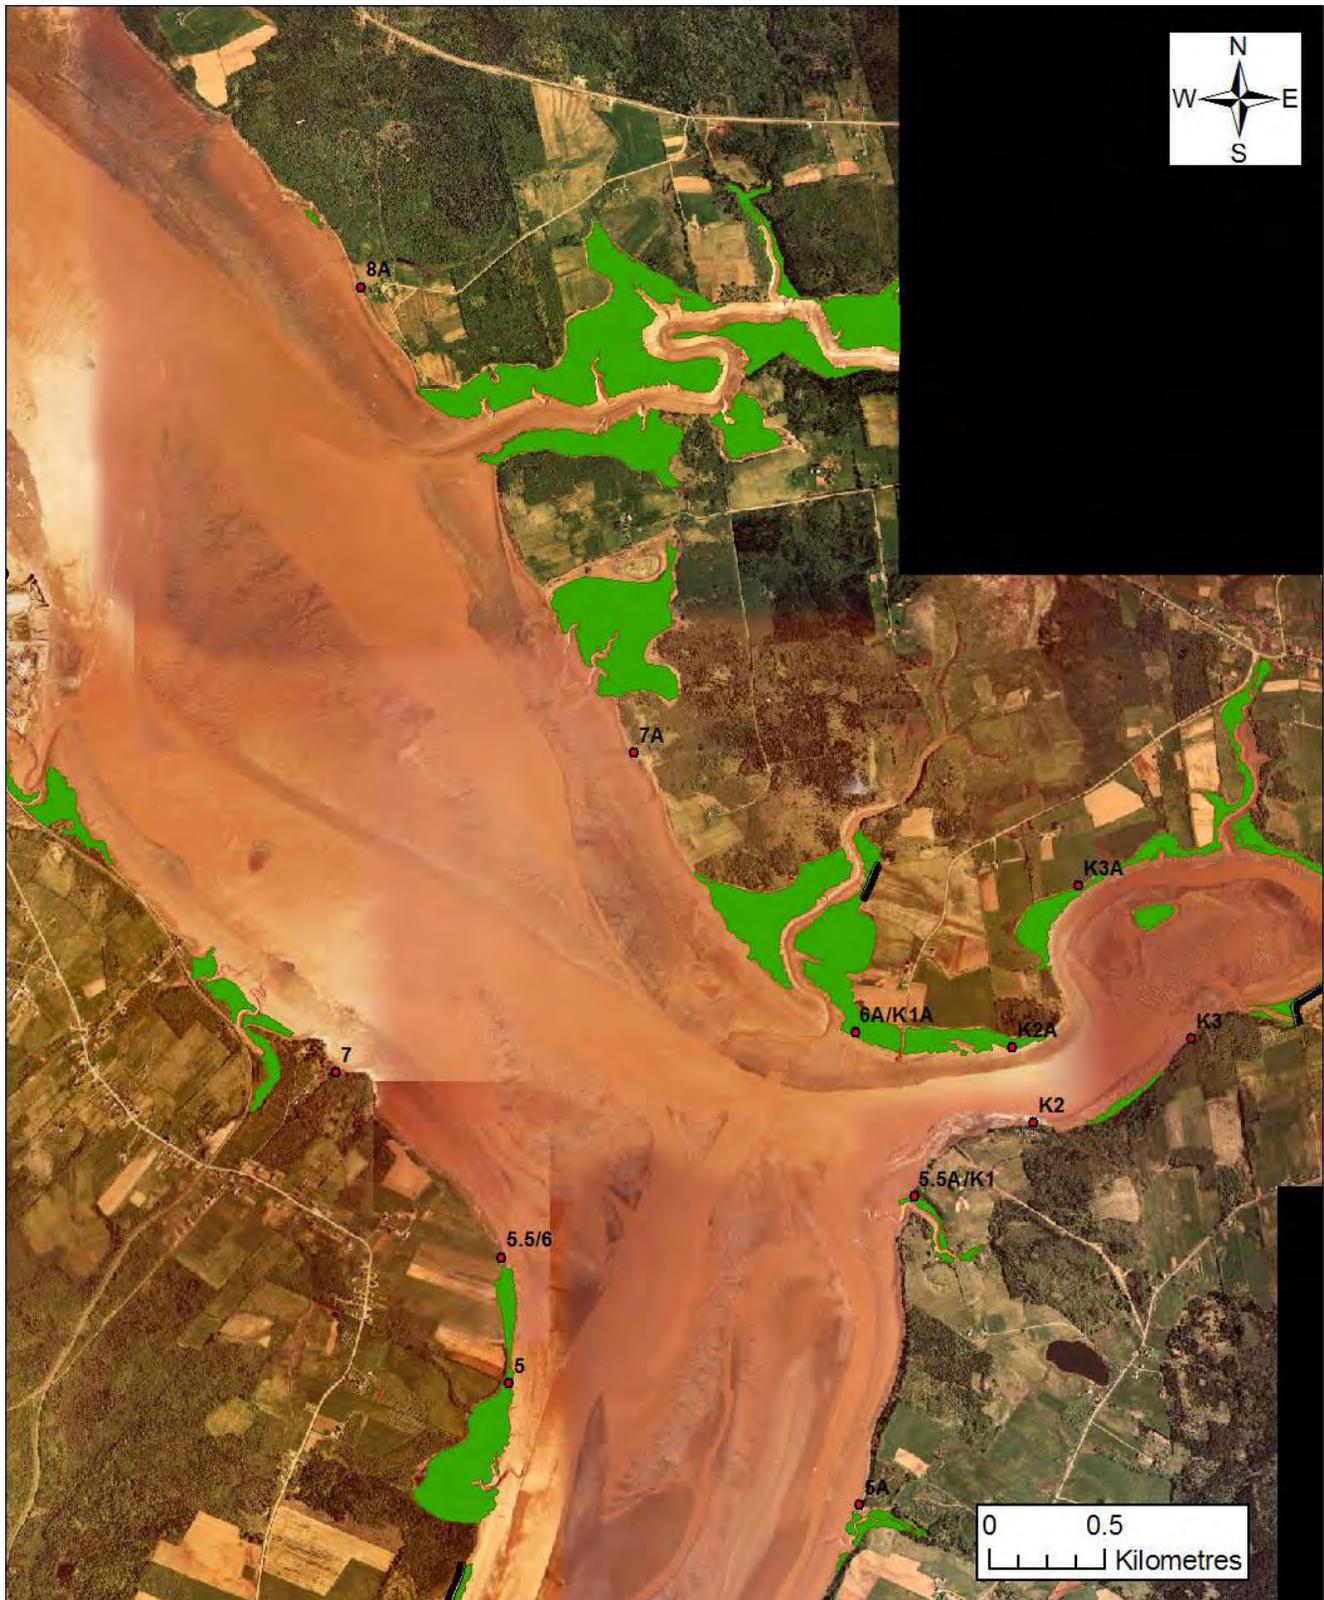
Figure 4.27: Digitized marsh polygons in 1973 at low tide overlain on a 1973 aerial photograph just south of Hantsport.

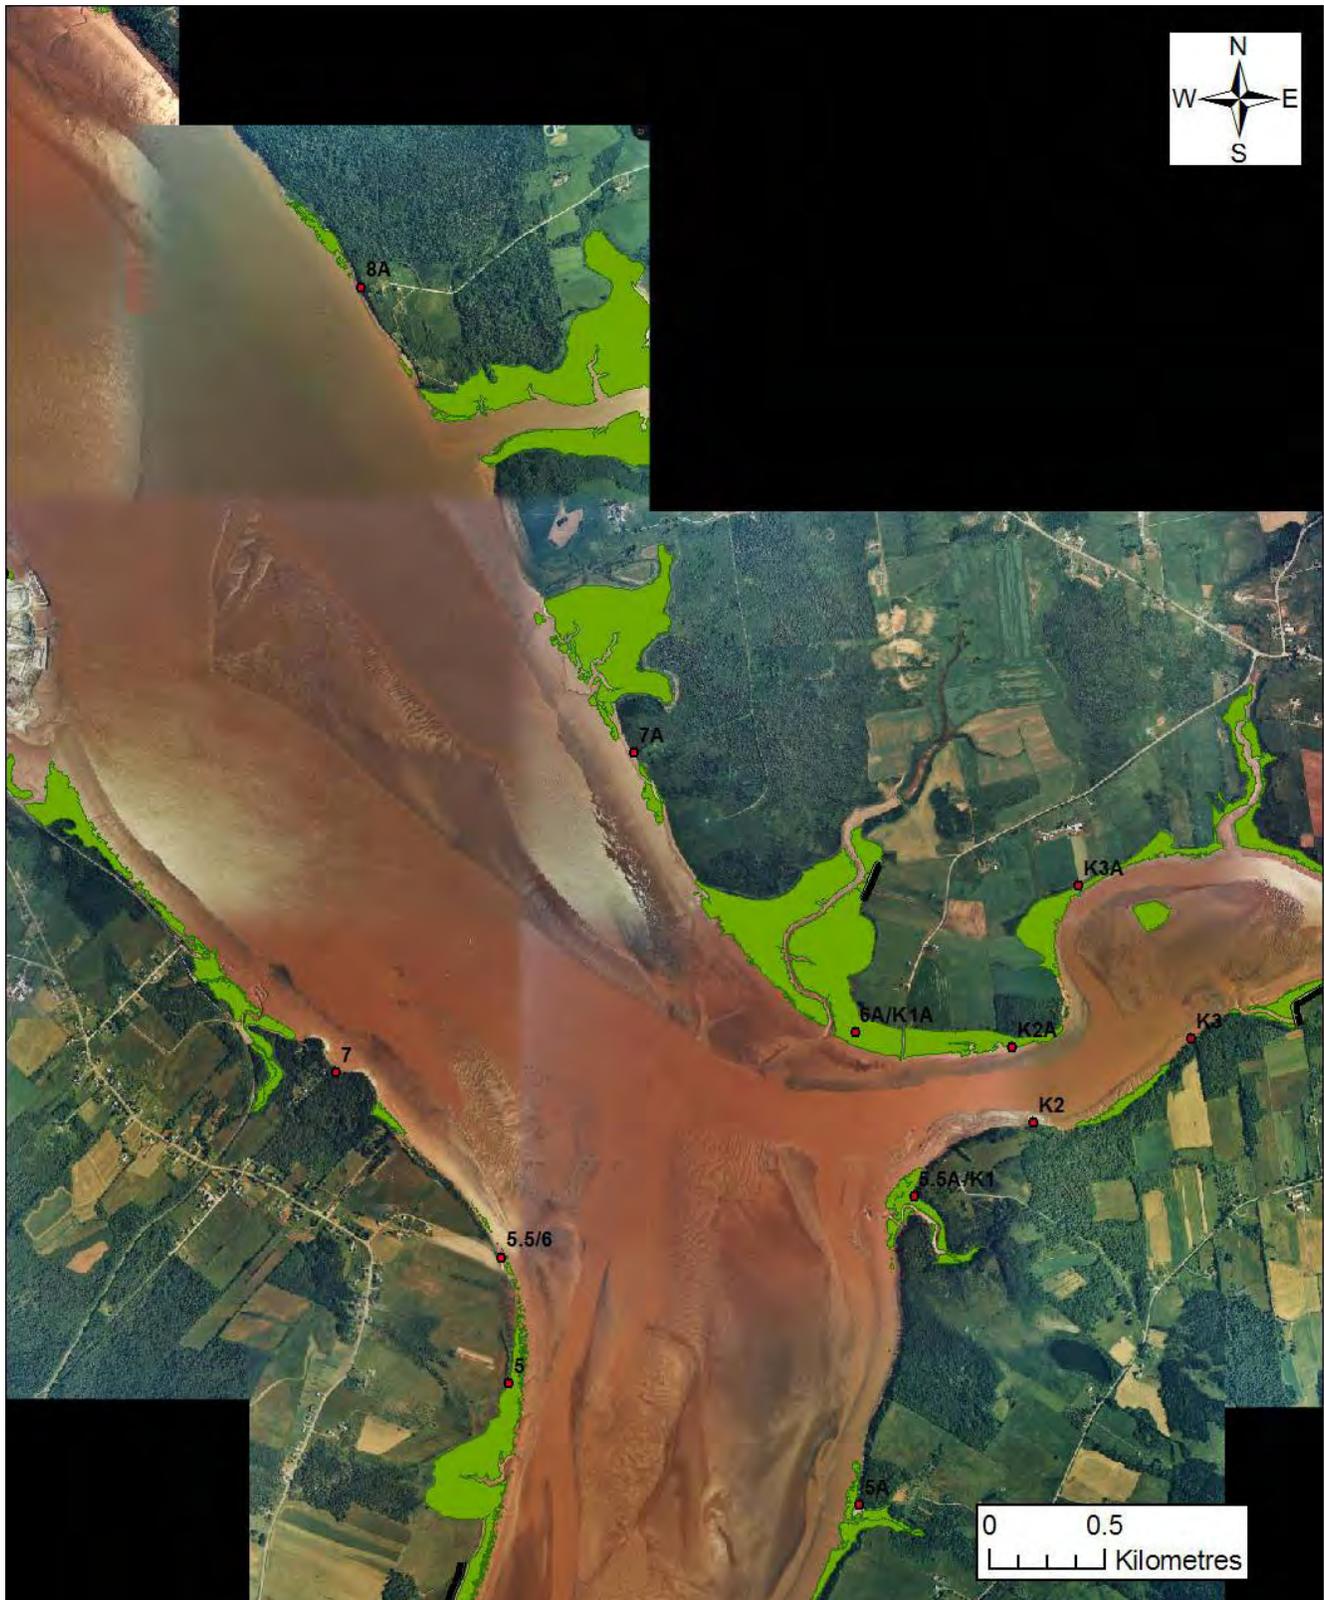
Figure 4.28: Digitized marsh polygons in 1992 at low tide overlain on a 1992 aerial photograph just south of Hantsport.

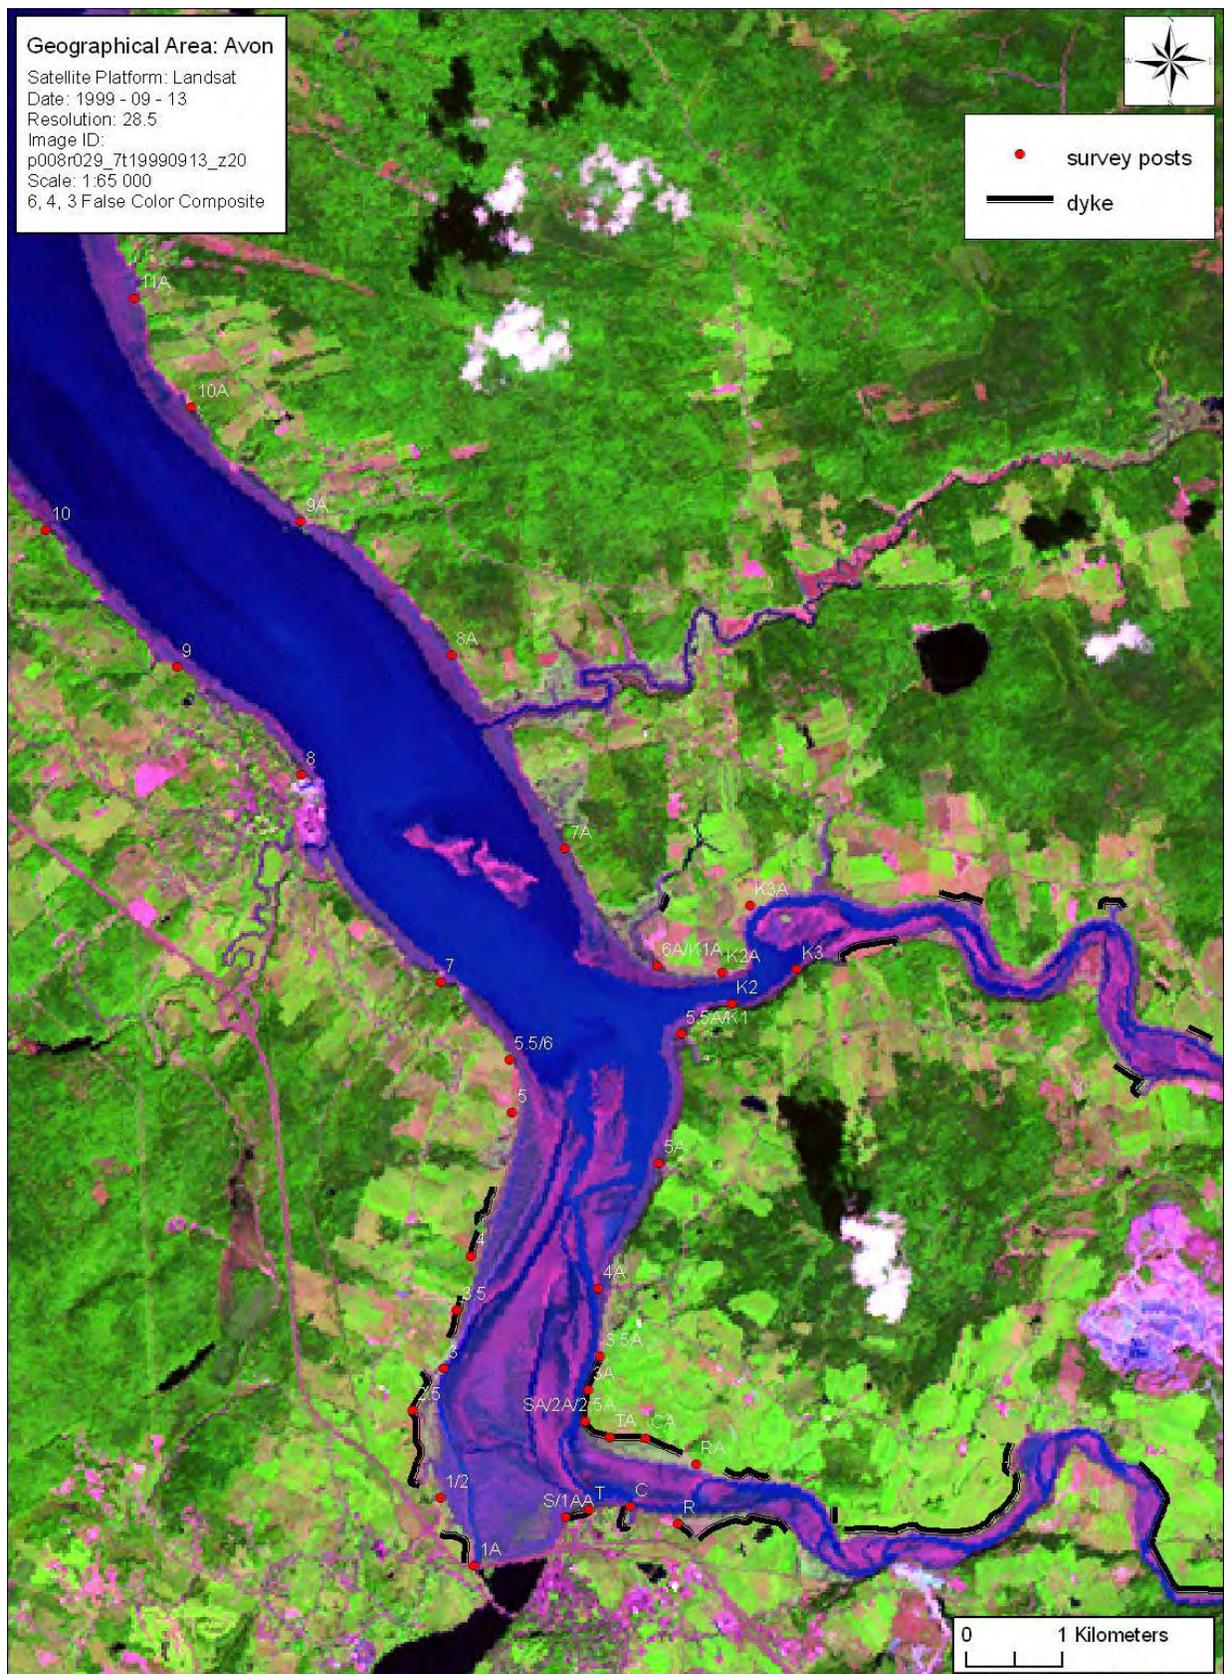
*Figure 4.29: Landsat 7 bands 6,4,3 false color composite illustrating position of main channels and intertidal bedforms at low spring tide. Note position of sand wave near Hantsport.*

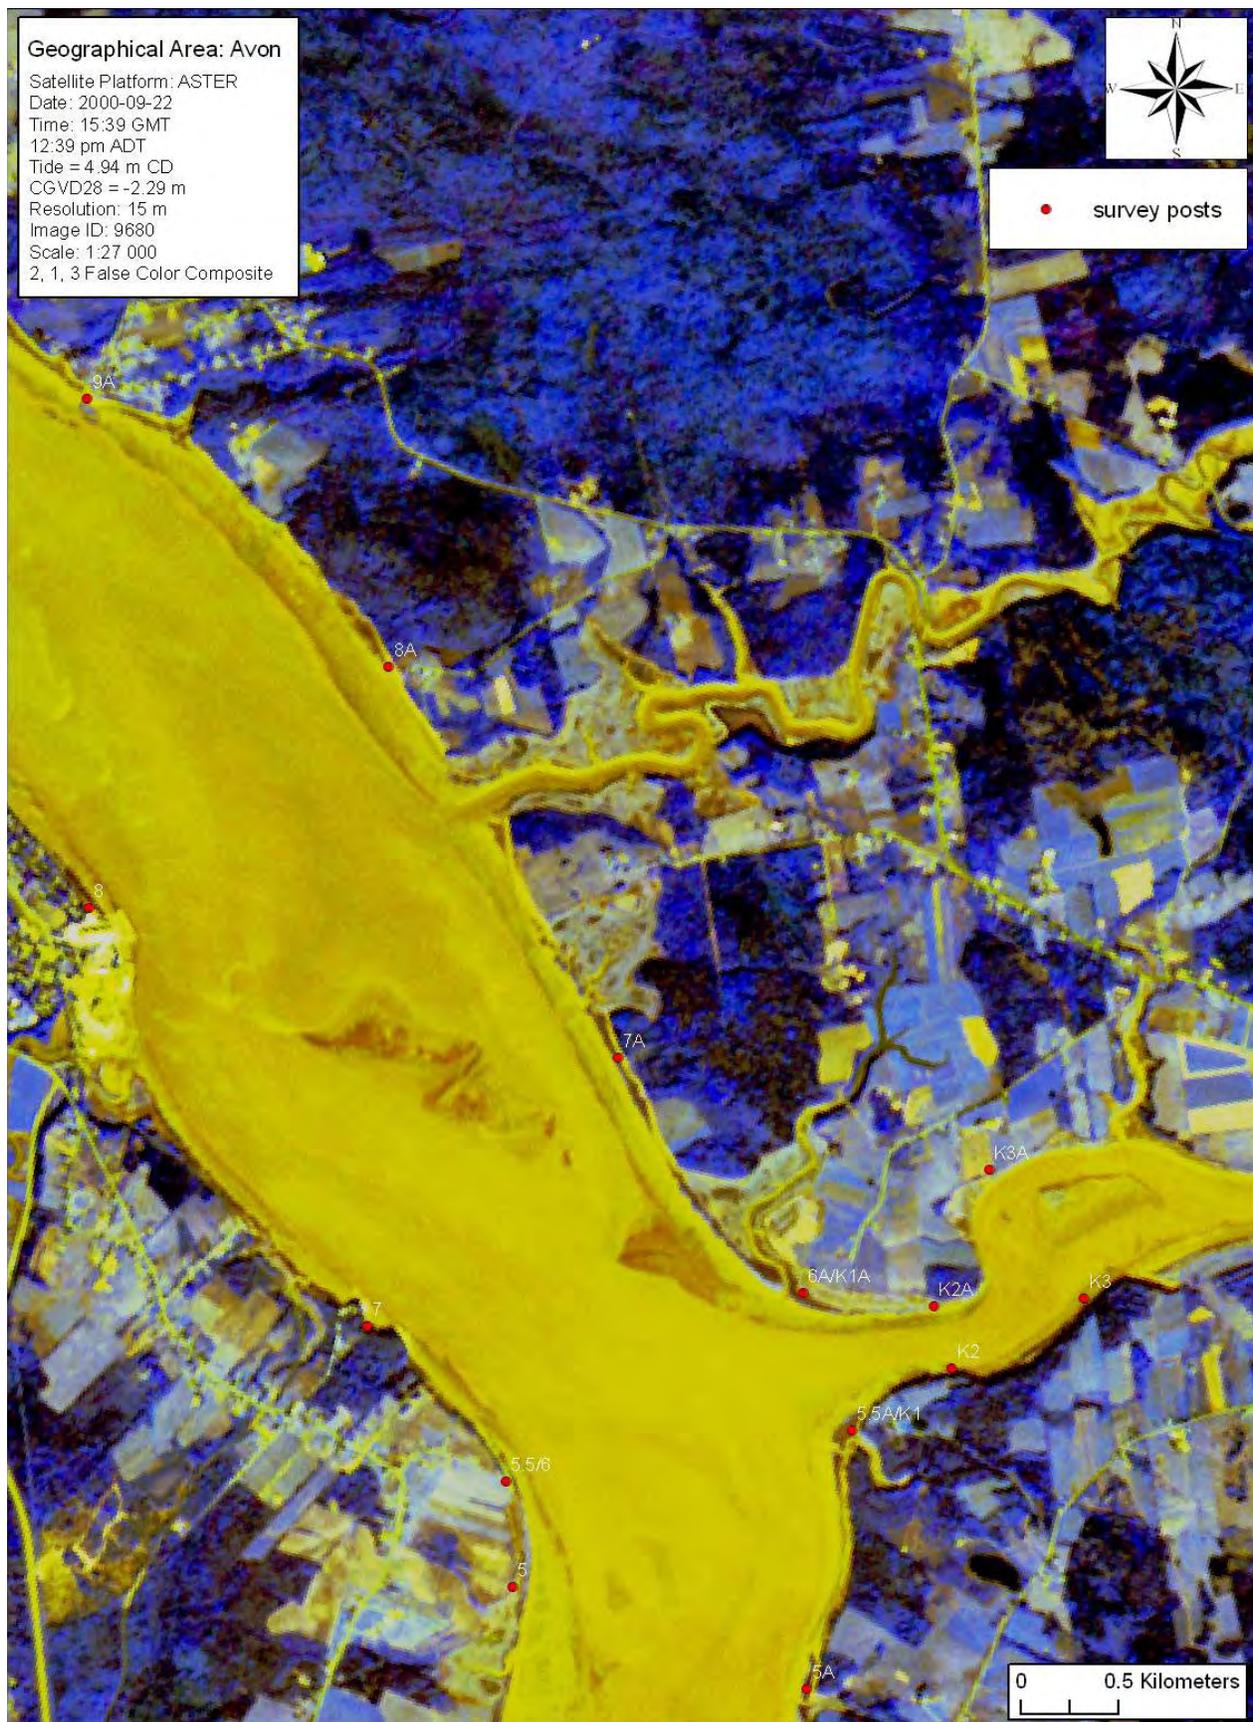
Figure 4.30: ASTER satellite image on Sept 22,2000 near Hantsport.

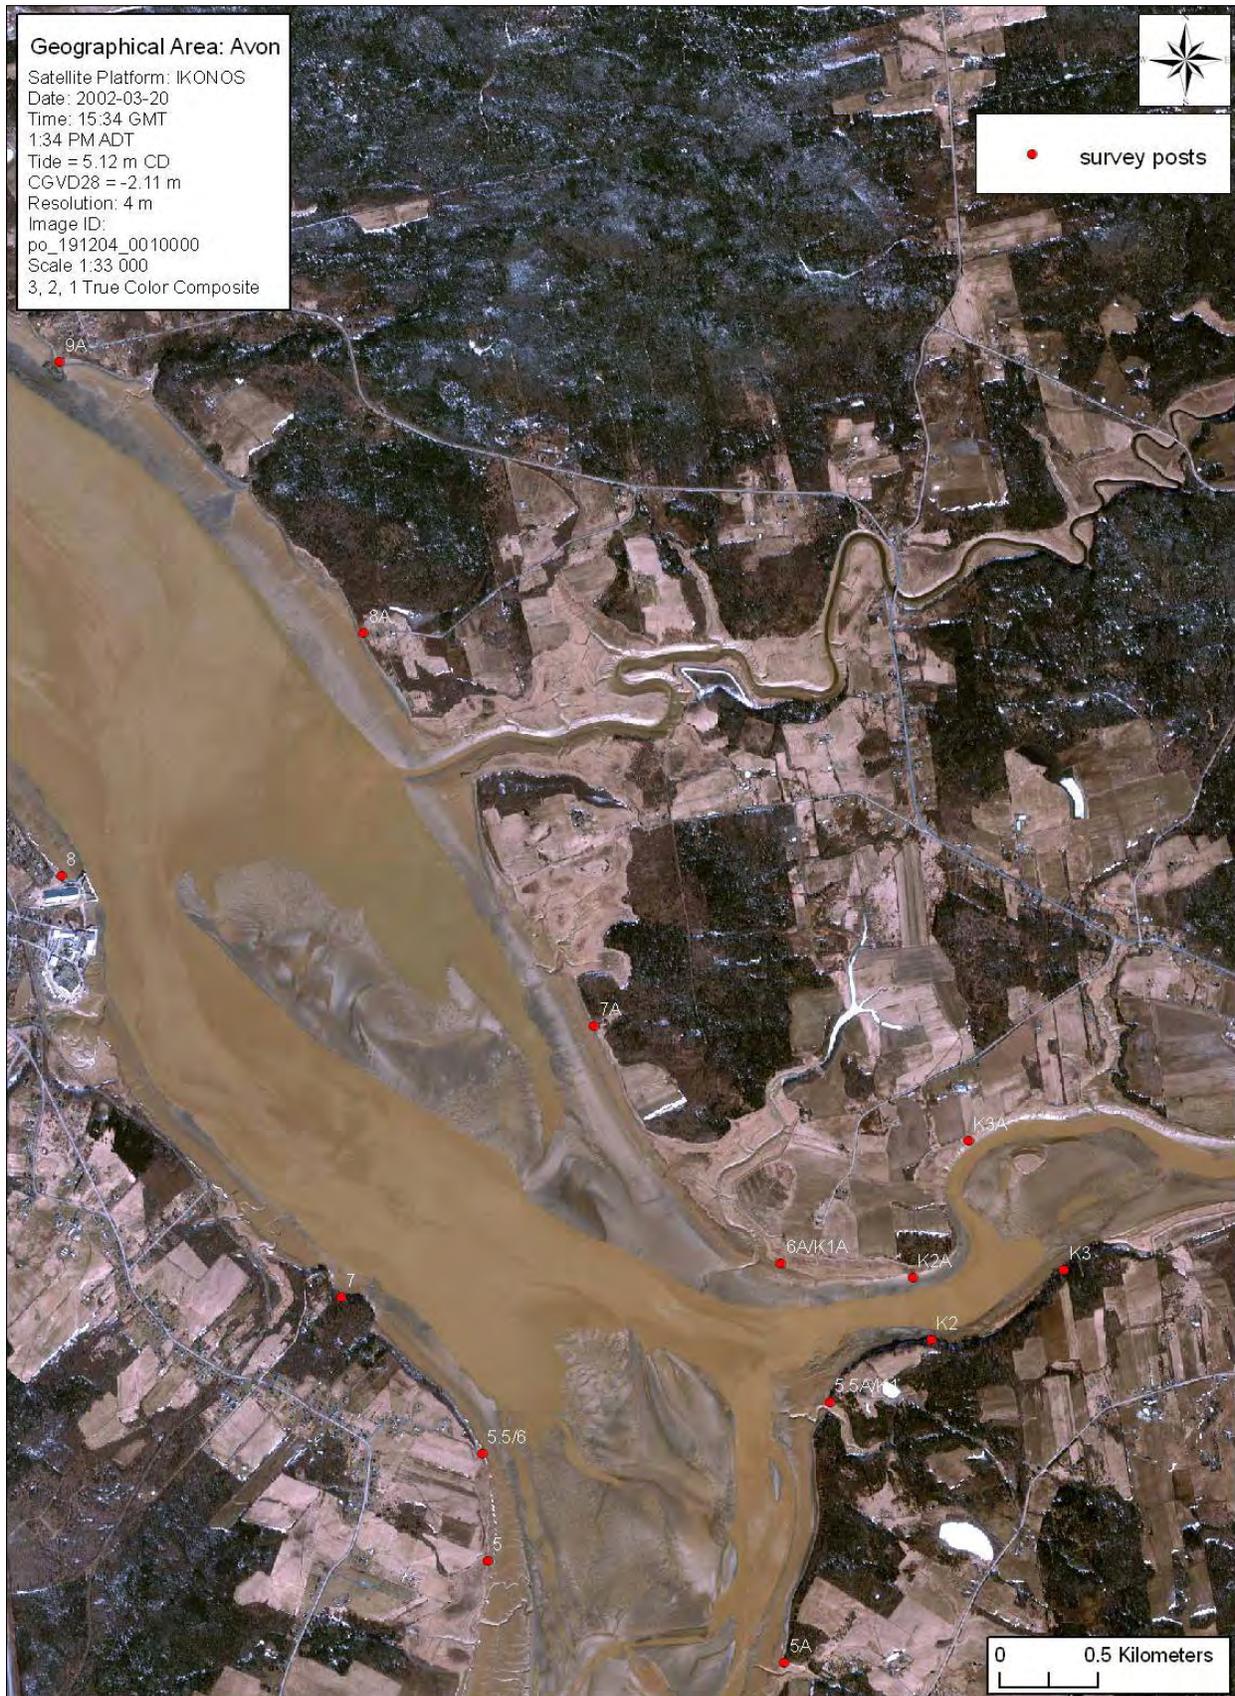
Figure 4.31: Multispectral IKONOS image illustrating sand bodies near Hantsport and Kennetcook River on March 20, 2002..

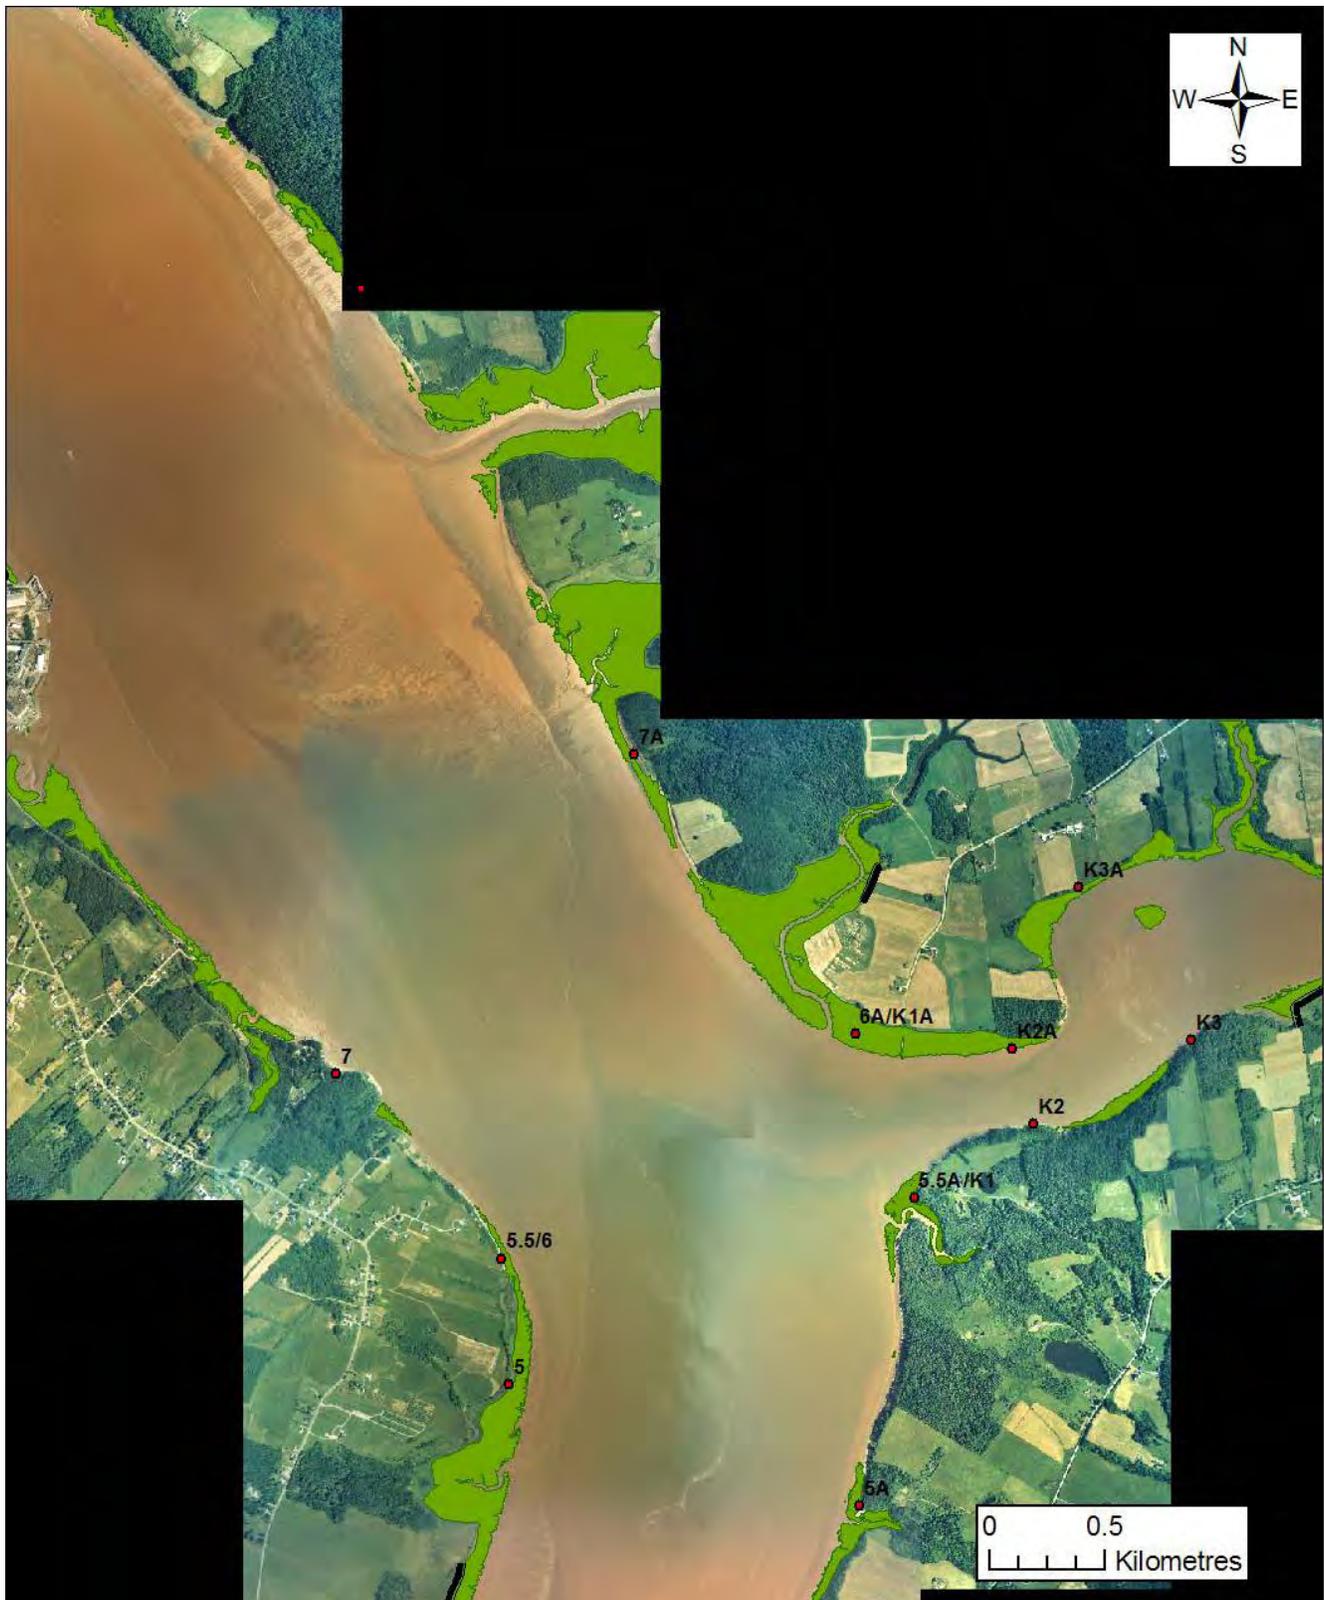
Figure 4.34: Digitized marsh polyons in 2003 near Hantsport and Kennetcook River. Tide is just below level of low marsh.

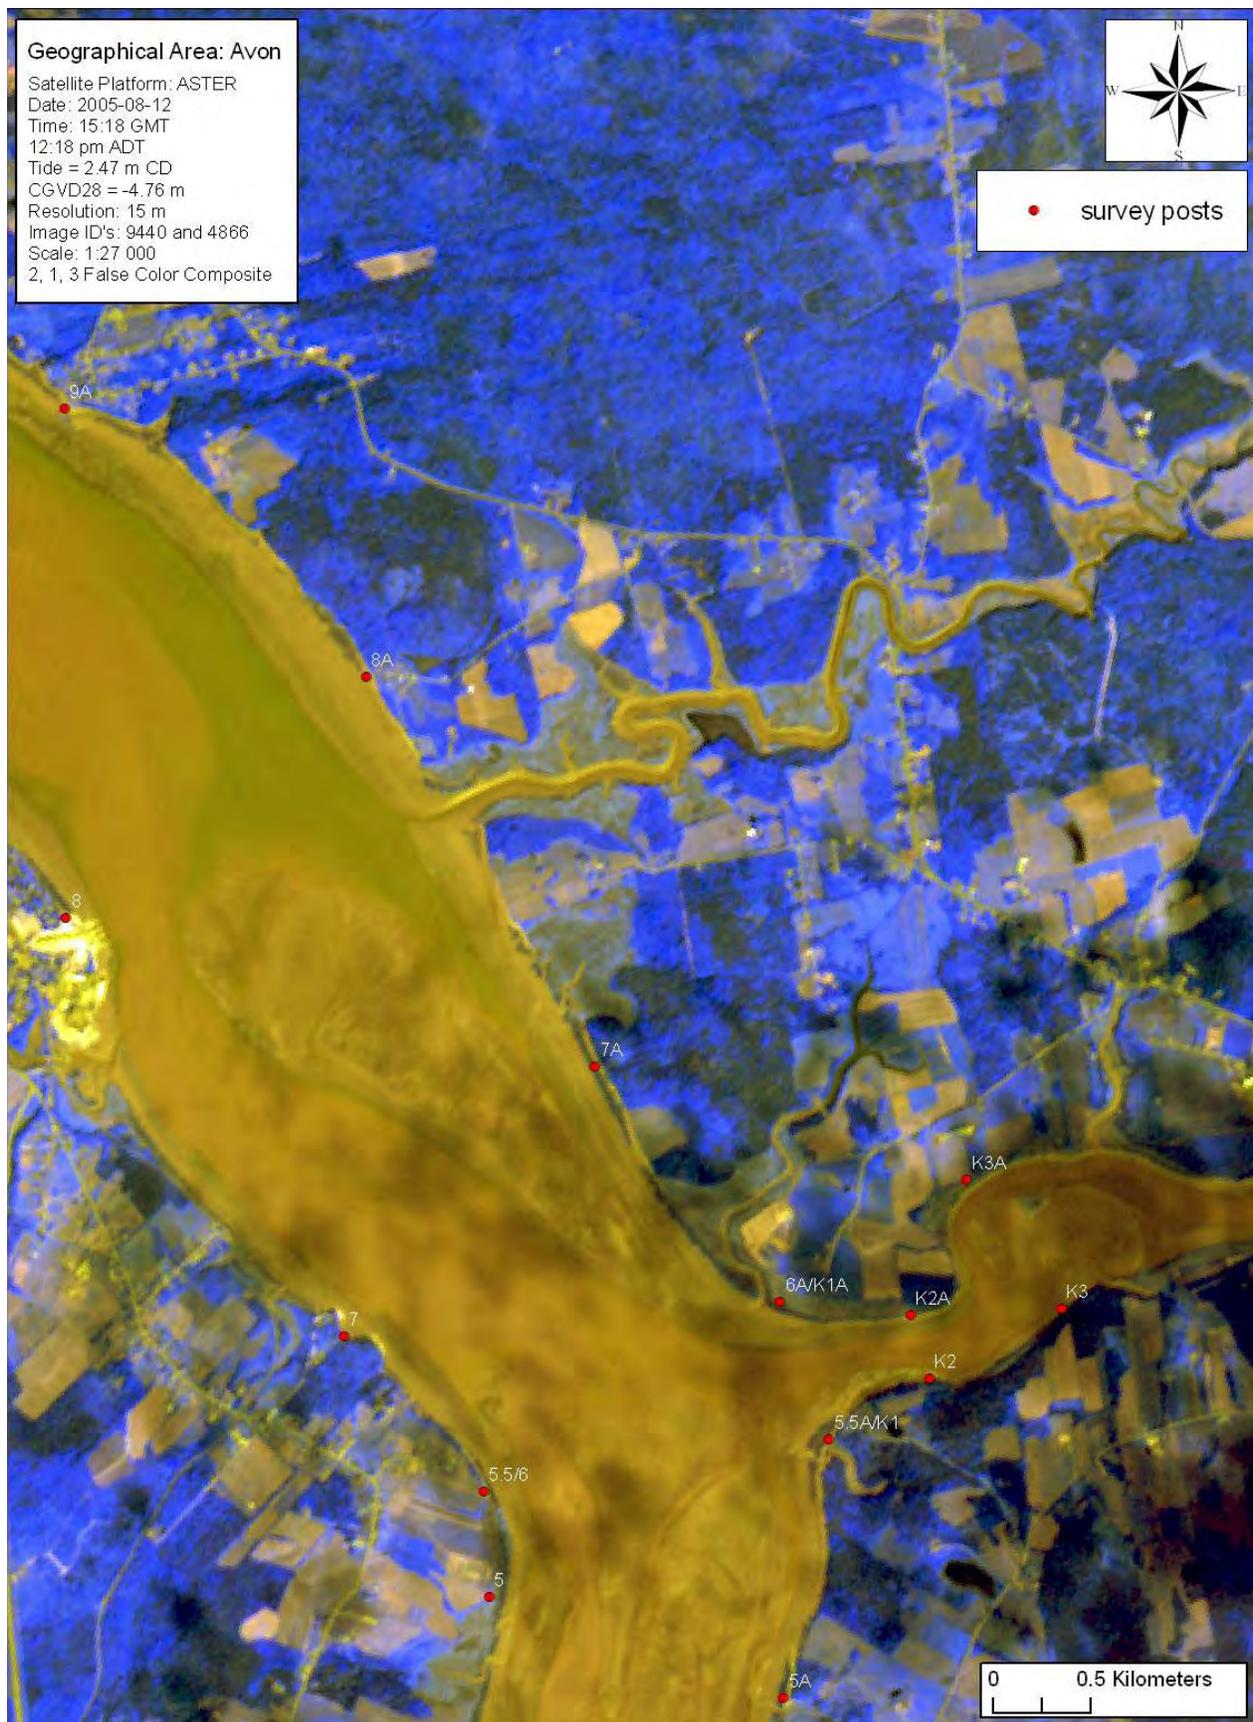
Figure 4.35: ASTER satellite image on July 12, 2005 illustrating large permanence of sand body near Hantsport.

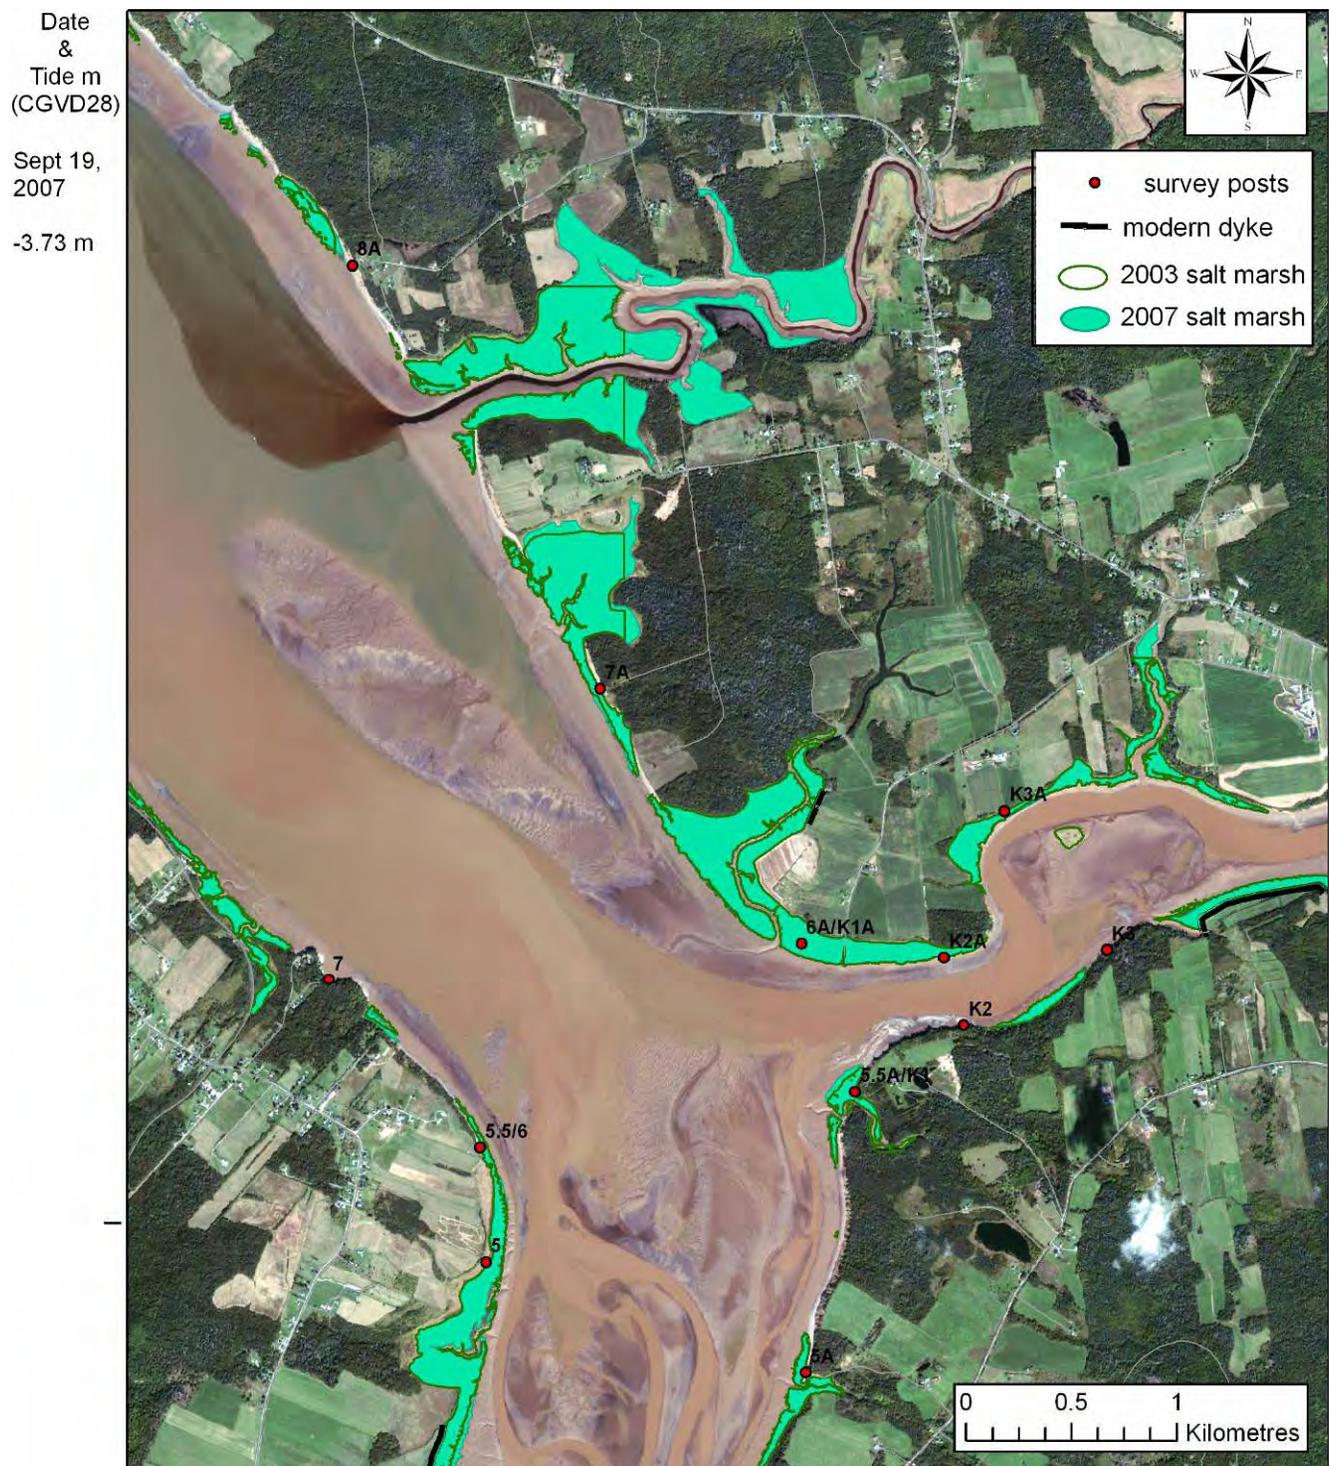
Figure 4.36: Multispectral IKONOS satellite image on Sept 19, 2007 illustrating large permanence of sand body near Hantsport. In addition, a potential plume of tanins is visible draining from the Cogmagun river. Field visits on Sept 21 indicate that tanins draining from marsh soils are the likely cause of this plume.

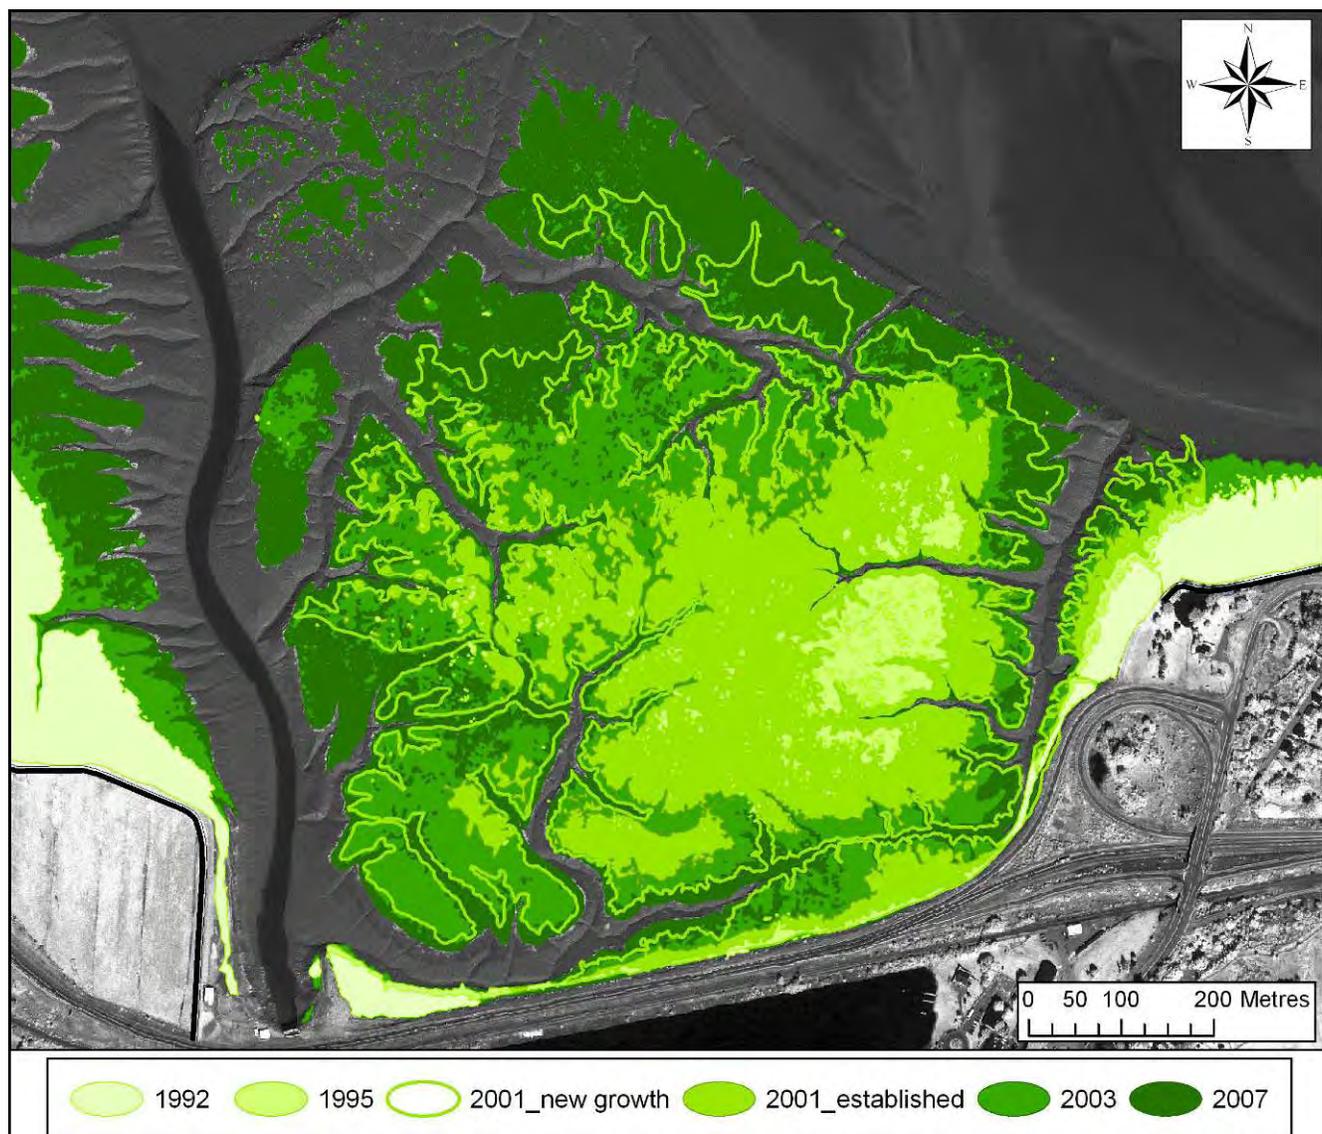
Figure 4.37: Comparison of Townsend, 2001 marsh GPS survey conducted in the fall of 2001 distinguishing between established *spartina alterniflora* (e.g. mature) and juvenile *s. alt.* Note expansion and coalescence within juvenile boundaries from 2001. In addition note relative stability of position of the tidal creek channels. Superimposed over IKONOS panchromatic satellite image collected on September 19, 2007.

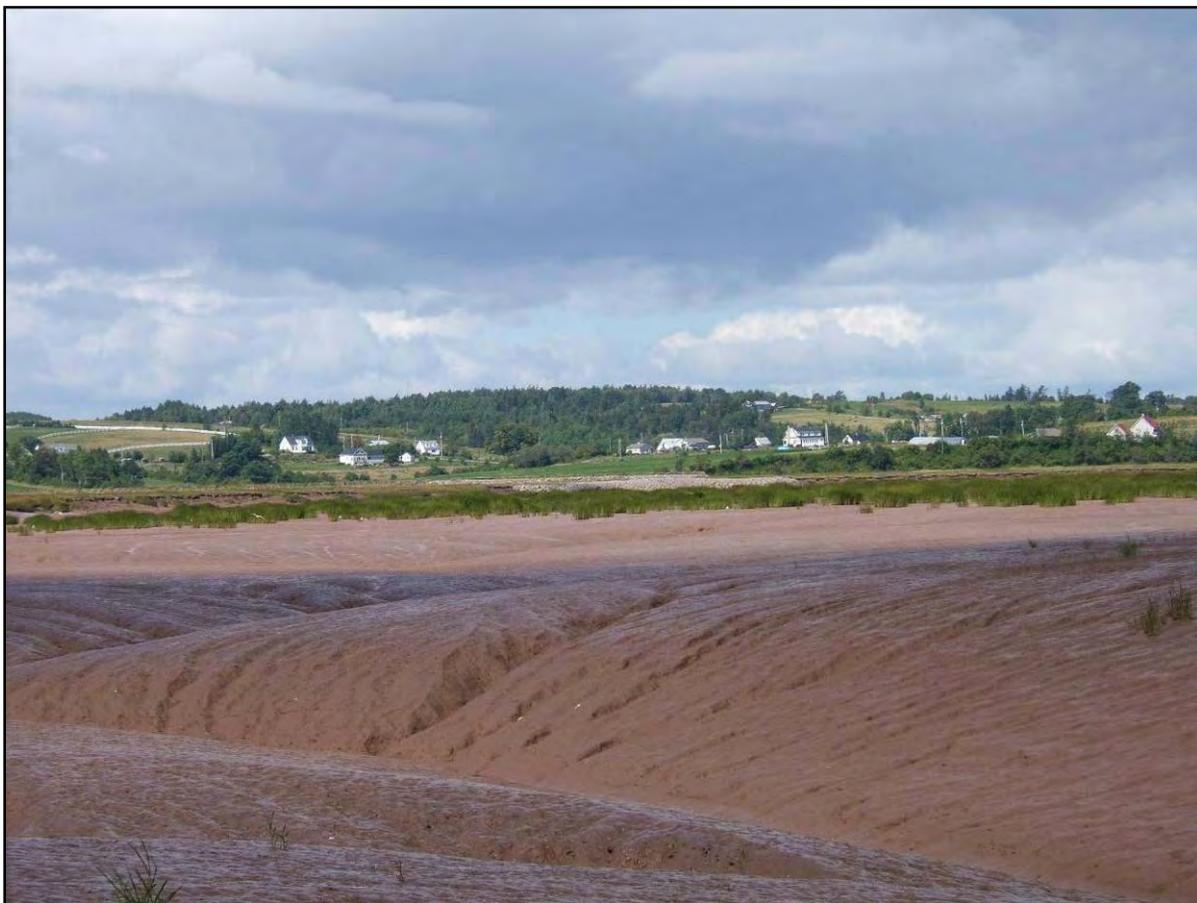
Figure 4.38: New colonies of *Spartina alterniflora* on mudflat to the north west of the original Windsor marsh. Photo by D. van Proosdij August 2006.

The most noticeable change between 1992 and 2003, particularly when compared with the earlier years (Fig 4.21, 4.22), is the extensive growth of marsh vegetation by the Windsor Causway (refer to van Proosdij and Townsend, 2006 for a detailed account and mechanisms of colonization by *Spartina alterniflora*) (Fig 4.37). Additional marsh growth is visible along the south shore of the St. Croix, and erosion continues along the western edge, threatening the dyke along that section (pers comm. K. Carroll, 2005) as the thalweg continues to shift towards the west. The edge of the dyke and foreshore have been armoured in the area. The mudflat area near post 1/ 2 now shows evidence of marsh colonization (Fig 4.22). In addition, the mudflat at the north western section of the Windsor marsh (Fig 4.37) that was not colonized in 2003 now has a healthy *Spartina alterniflora* population (Figure 4.38). By September 2007, the majority of the original mudflat surface had been colonized by *S. alterniflora* and the tidal channel parallel to the causeway has been almost completely infilled, particularly along the eastern edge.

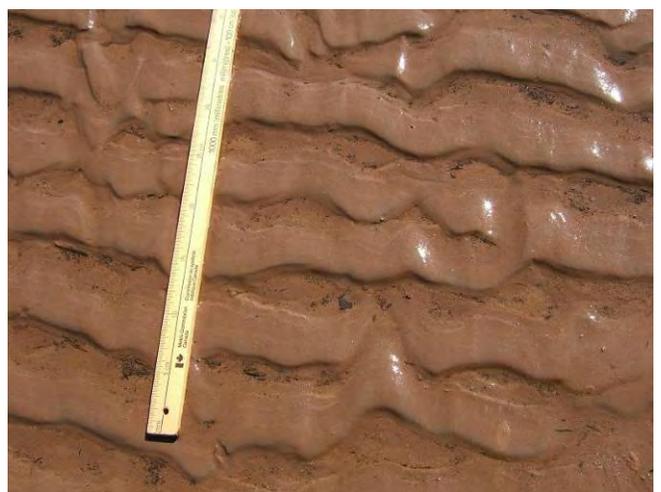
Figure 4.41: Ripples on sand flats on Sept 21, 2007

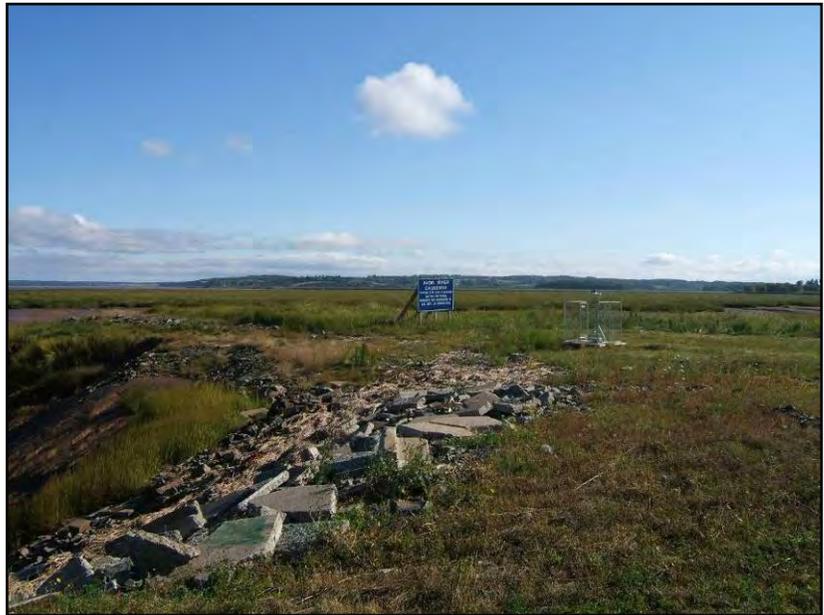
Figure 5.2: Windsor mudflat and Saint Mary's University weatherhawk Meteorological station viewed from the Tide Gate in August 2006.
