Highway 104 Operational and Safety Review

NS Department of Transportation and Infrastructure Renewal

Hwy 104 Operational and Safety Review

Final Report

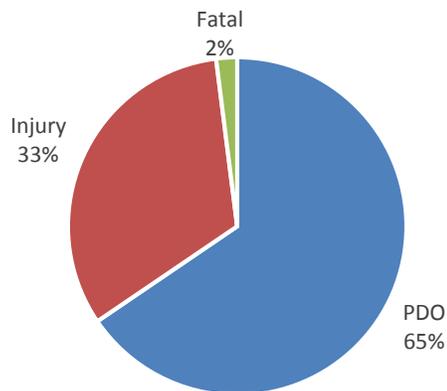
Figure 3-1: Distribution of Study Area Collisions by Severity (2007 – 2012)

Approximately 200 collisions have occurred in the study area during the six-year period between 2007 and 2012. As shown in Figure 3-1, 65 percent were property-damage-only collisions (PDO), 33 percent were injury collisions, and 2 percent were fatal collisions.

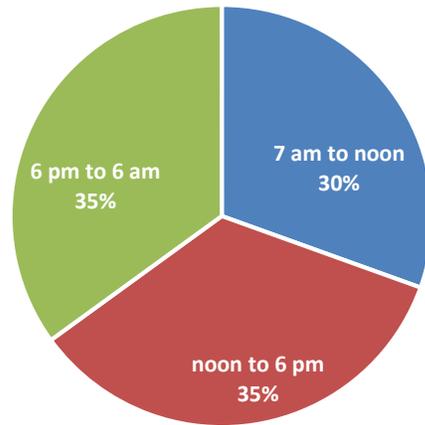
Figure 3-3: Distribution of Study Area Collisions by Time of Day (2007-2012)

Figure 3-3 shows the distribution of collisions by time of day. They were fairly evenly distributed between morning, afternoon, and night time. Approximately 25 percent occurred when it was dark.

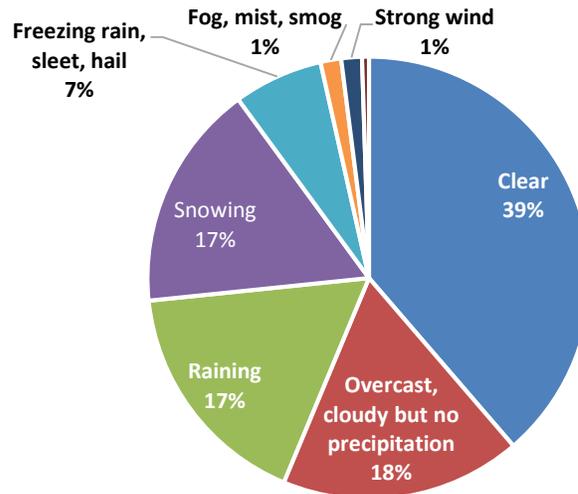
Figure 3-4: Weather Conditions at the Time of Study Area Collisions (2007-2012)

Weather conditions at the time of the collisions are shown in Figure 3-4. The weather was clear, or overcast with no precipitation, for 57 percent of the collisions. It was snowing, or freezing rain, sleet or hail for 24 percent, and raining for 17 percent.

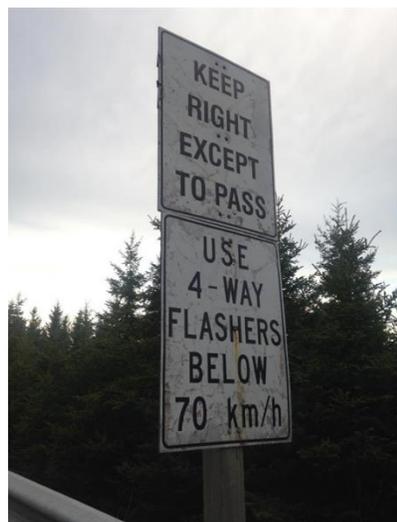
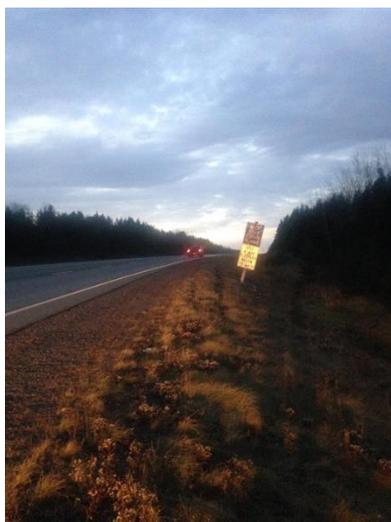
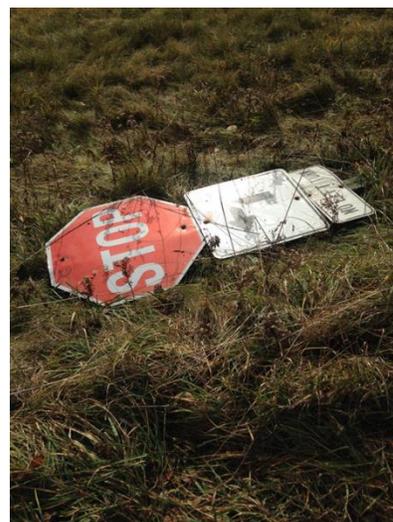
Issue 1 - Examples of Reduced Sign Conspicuity

Issue	Likelihood	Severity	Risk Rating
<p>1. Reduced Sign Conspicuity - It appears that most signs were originally fabricated using ASTM Type 1 sheeting (a.k.a “Engineering Grade”), which provides a lower level of retro-reflectivity compared to the “High Intensity” or “Diamond Grade” sheeting now commonly used by most jurisdictions on similar classes of road. Several signs are also showing a significant amount of deterioration, likely due to their advanced age, which in turn has diminished the effectiveness of their retro-reflective properties. Letter heights were also a concern on some isolated signs.</p>	Infrequent	Negligible to High	C
<p>2. Lack of Advanced Signage – There were some horizontal curves, public intersections, and climbing lanes which lacked advanced signage.</p>	Infrequent	Medium	C
<p>3. Reduced Roadway Delineation – Delineation of the travelled lanes and edge of road is less than desirable in some locations, making it difficult for drivers to perceive the actual alignment of the road. While guard rail reflectors and shoulder delineators are present at some locations, their application is not consistent along the entire corridor. The centerline and edge line pavement markings also were found to offer relatively low levels of conspicuity.</p>	Infrequent	Medium	C

- 18.
19. Establish an inventory and assess the retroreflective properties of all existing signage along the corridor. Develop a prioritized plan to replace existing signage with ASTM Type IV "High Intensity" sheeting or higher. Warning signs should be considered top priority, followed by guide signs and regulatory signs. NSTIR may also wish to consider increasing the size of warning signs to at least 900 mm x 900 mm to make them more visible. (Note: current sign sizes do meet minimum recommended guidelines).

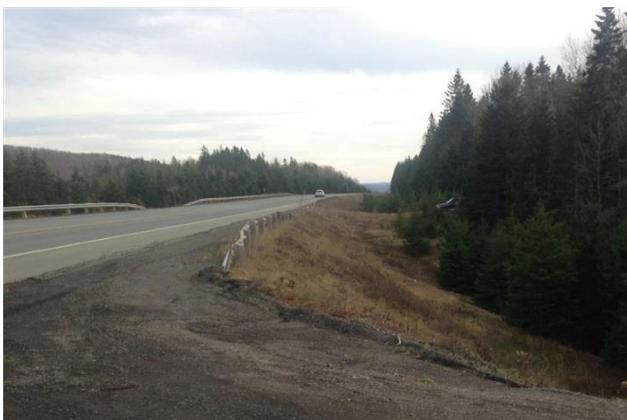
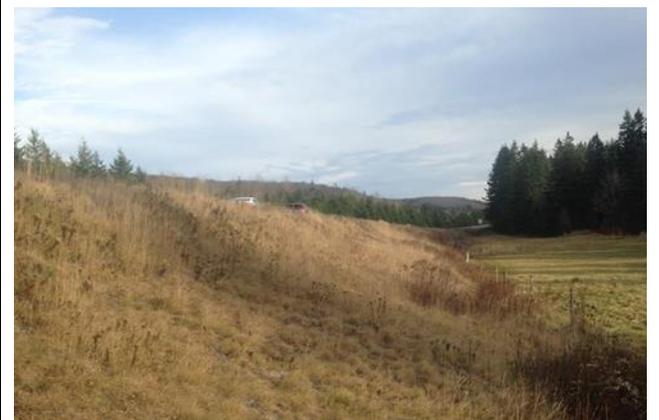
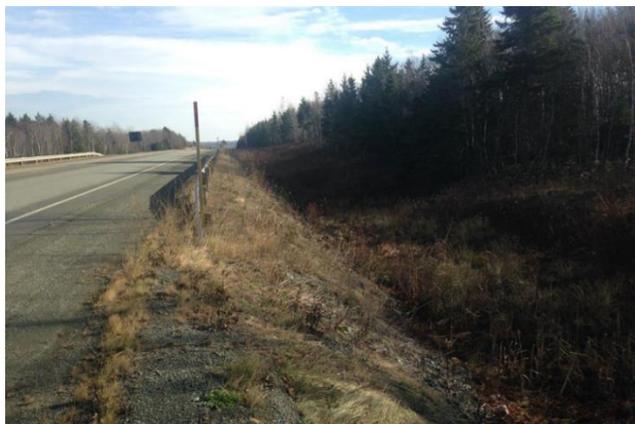
Issue 7 - Examples of Unprotected Roadside Slopes

Issue	Likelihood	Severity	Risk Rating
<p>7. Roadside Slopes – Current guidelines indicate that 2:1 slopes are considered hazards, 3:1 slopes are traversable but non-recoverable and that 4:1 and greater slopes are considered recoverable. Furthermore, on higher speed roads, the total width of the 4:1 and greater slopes should be equal or greater than the width of the clear recovery zone, assuming no slopes exceed 3:1. There are many locations along the corridor where the slopes fall short of these guidelines, and in some locations they are estimated to be as steep as 1:1. Once again, many of these slopes were observed in areas with no roadside barrier. Although these hazards generally do not cause collisions, they can increase the likelihood of rollovers.</p>	Frequent	Med -High	E - F
<p>8. Shoulder Drop-offs – There were several noted instances where the vertical drop between the paved edge of travelled way and the adjacent gravel shoulder exceeded NSTIR's desirable safe threshold of 100 mm. At some locations, the vertical drop was measured to be as high as 150 mm (or 6 inches). This presents a significant hazard as it makes it extremely difficult for drivers to maintain control of their vehicle in the event they need to pull over or if they temporarily off-track onto the shoulder. This can lead to loss of control or possible rollovers.</p>	Infrequent	Med- High	C - D

17. Install additional guard rail to shield fixed hazards roadside slopes	\$\$\$\$ -	⊙	●	○	○	○	○	6,7	E-F
18. Flatten roadside slopes to 4:1 or less	\$\$\$	○	●	○	○	○	○	7	E-F

case in large fill areas. Areas with the deepest slopes should be considered top priority, particularly those locations with some other type of fixed hazard located nearby (e.g. drainage structures). Example locations identified during the safety review include km 199.5 in the eastbound direction and km 204 in the eastbound direction.

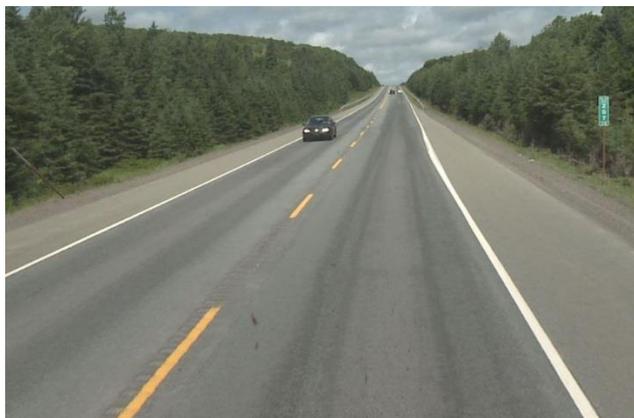
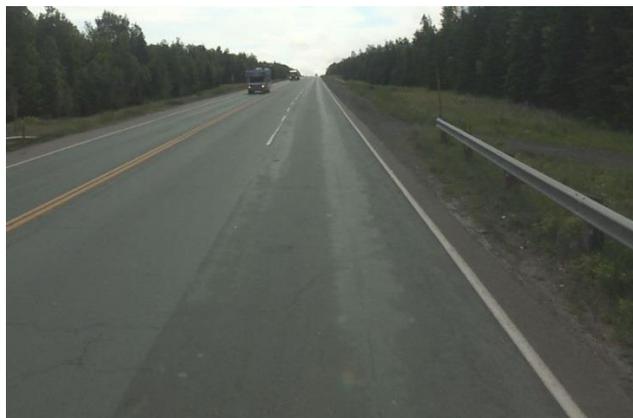
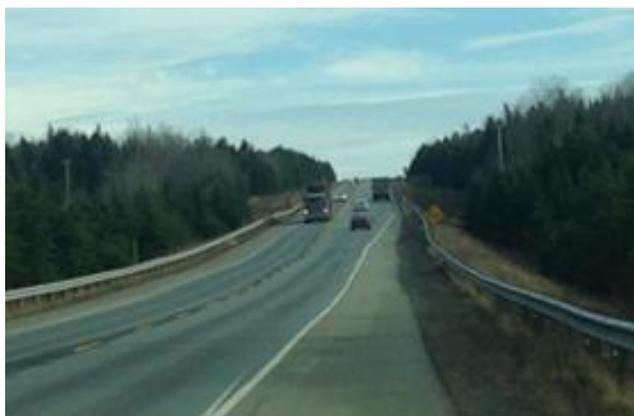
Issue 9 - Examples of Shoulder Narrowing at Climbing Lanes

<p>9. Unpaved or Partial Paved Shoulders – It was observed that many of the shoulders were gravel surfaced, with some having partial pavement, particularly on the sections with climbing lanes. Gravel shoulders can lead to loss of control as the vehicle transitions from a high friction surface to a low friction surface. This is especially apparent at higher travel speeds. Gravel shoulders also have a tendency to rut, slump, or erode if not properly and regularly maintained. This can lead to loss of control or rollovers.</p>	Infrequent	Med- High	C - D
<p>10. Roadside Access – The provision of land access along the corridor is not consistent with adjacent sections. Drivers may not be expecting this situation. Accesses provide conflict points which can lead to angle type collisions, which can be severe.</p>	Rare - Infrequent	High	C - D
<p>11. Substandard Horizontal Geometry – A review was undertaken for five of the horizontal curves along the corridor. At two of the locations the combination of curve radius and superelevation, obtained from the ARAN database, indicated that the design speed was close to the posted speed. At two other locations, it was found that although the curve radius was acceptable the superelevation was deficient. In fact, at the James River interchange, the combination of radius and superelevation would suggest a 50km/h design speed. The fifth curve, located at Barney's River near km 198.3, has a radii which is less than what is required for a 100 km/h design. All of these curves have little or no advance signage indicating their presences. There may be other curves along the corridor which do not meet current guidelines. Inadequate horizontal geometry can lead to run off road and head on collisions due to loss of control, especially in adverse weather conditions.</p>	Occasional	Med - High	D - E

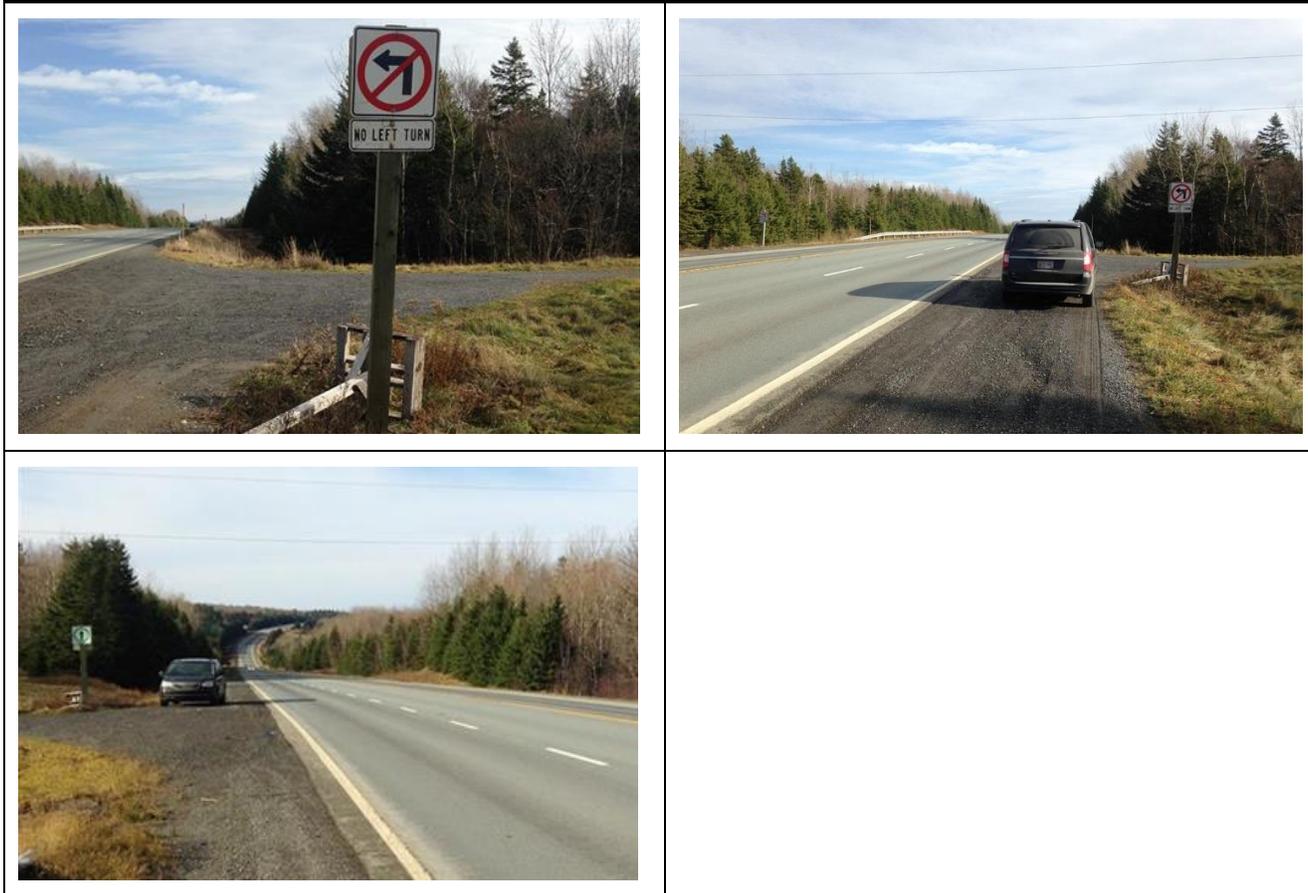
Issue 12 - Examples of Restricted Movement Signage at Intersections

Issue	Likelihood	Severity	Risk Rating
<p>12. Restricted Turning Movements at Intersections – There were three at-grade intersections located within the corridor with restricted turning movements and permitted through movements for both roadways. This type of access is not easily understood and likely not effective. Even though they are signed, motorists are likely using them to access Highway 104. In fact, this illegal movement was observed during the field investigations. This type of intersection can lead to right angle and rear end type collisions.</p>	Rare - Infrequent	High	C - D
<p>13. Naming Convention for At-Grade Exits – It was observed that exit numbering and signage for the at-grade intersections followed the same convention as the grade separated interchanges. This can create a condition of driver expectations not being met, which can lead to various types of collisions.</p>	Rare	Medium	B

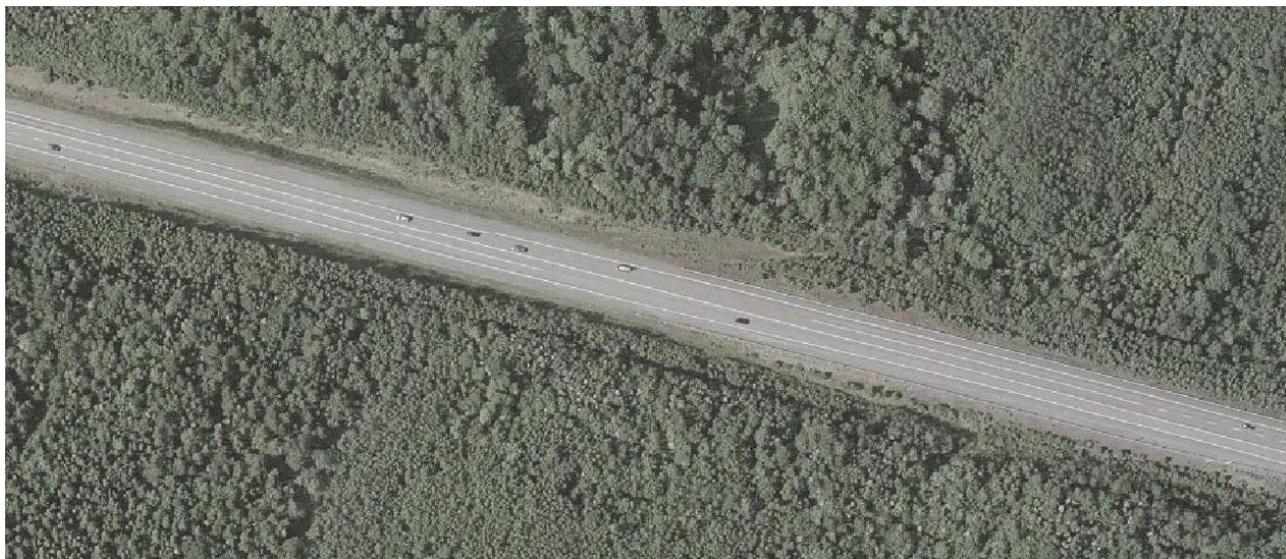
Issue 16 - Example of Termination of Climbing Lane

<p>16. Termination of Climbing Lanes – The climbing lanes provided along the corridor appear to terminate at various points along the crest curves. Some terminate before the crest, some on the crest and some after the crest. The preferred location is in an area where the merge condition is clearly visible and where the speed differentials between passenger vehicles and trucks are less than 15 km/h. Of particular concern is the termination of opposing climbing lanes at the same location. As drivers merge at the end of the lanes, there is the possibility that they are forced into the opposing lanes or that aggressive drivers illegally use the opposing lane to complete their overtaking manoeuver. Since these transition areas are high risk zones, it's preferable that the opposing lane terminations do not occur in the same area, which can cause unexpected situations.</p>	Infrequent - Occasional	High	D - E

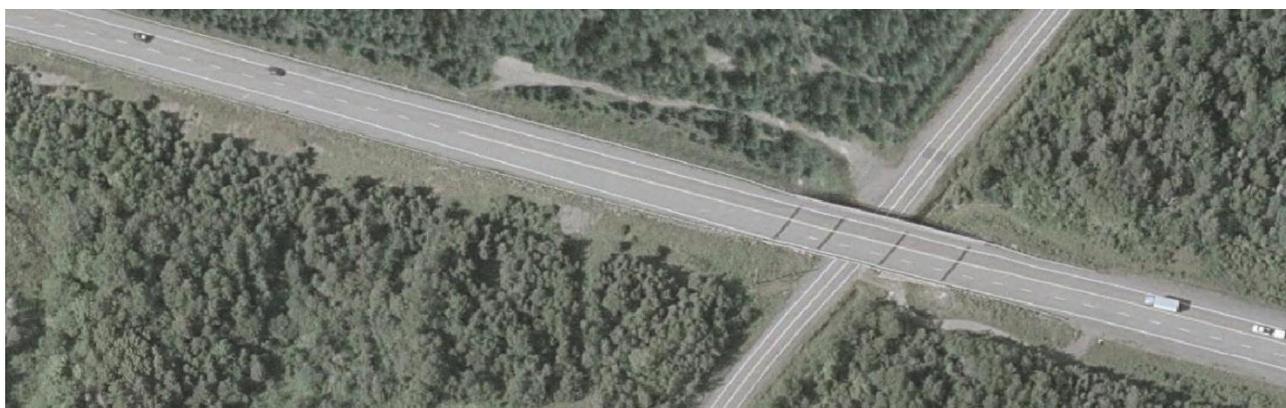
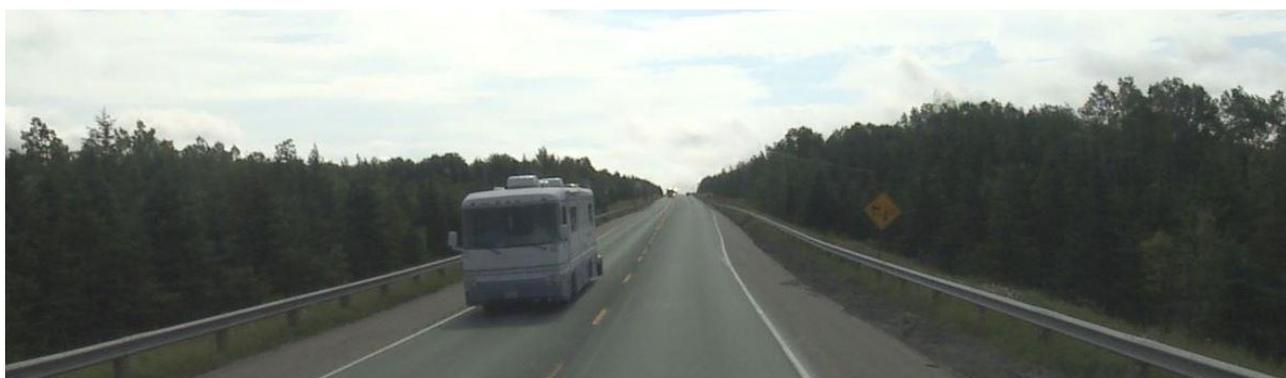
Issue 17 - Examples Proximity of Passing Zone to Climbing Lanes

<p>17. Proximity of Passing Zones to Climbing Lanes – It was observed that some passing zones terminate at the beginning of climbing lanes. This creates a situation where a passing vehicle who started overtaking in the passing zone may complete their manoeuver adjacent to the climbing lanes. If vehicles are simultaneously overtaking in the climbing lanes, this can create an unsafe condition in which three vehicles are travelling side by side in the same direction. Possible collision types are side swipes and head-ons.</p>	Infrequent - Occasional	High	D - E

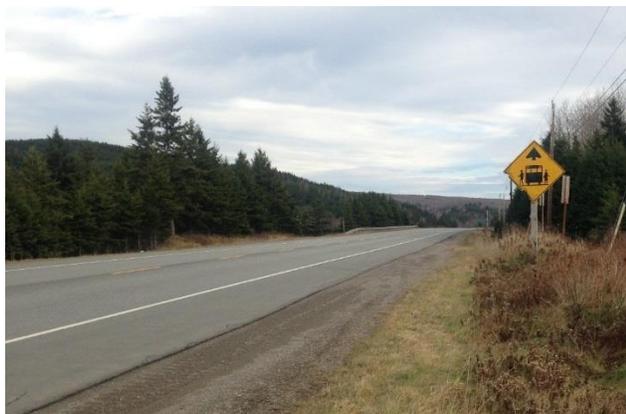
Issue 20 - Example of Obsolete Signage

20. Obsolete Signage - There is a bus stop near km 202.5 with advance warning signs in each direction. However, school board officials confirmed during consultations that this site is no longer active. The advance warning signs could potentially lead to drivers unnecessarily reducing their speed for a non-existent situation. Furthermore, obsolete signage can reduce the effectiveness of similar signs installed at other locations where a hazard is actually present.	Infrequent	Low	B

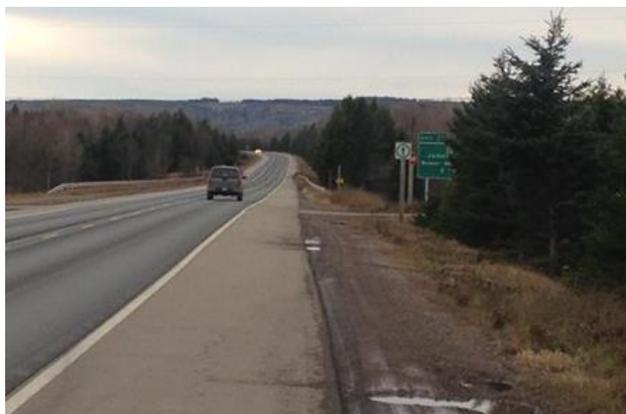
Issue 27 - Example of Signage Obstructed by Vegetation

27. Obstructed Sightlines – There are some locations where sightlines are restricted by roadside vegetation, thus limiting the driver's ability to perceive and react to roadside features such as signage and other potential hazards that may exist within the clear zone.	Infrequent	Med - High	C - D
