**DND EA Form**

**1.0 Project Title:** Sackville River Wetland Compensation Project at the Bedford Rifle Range

**1.3 Project Location:** Bedford Rifle Range, Bedford, NS

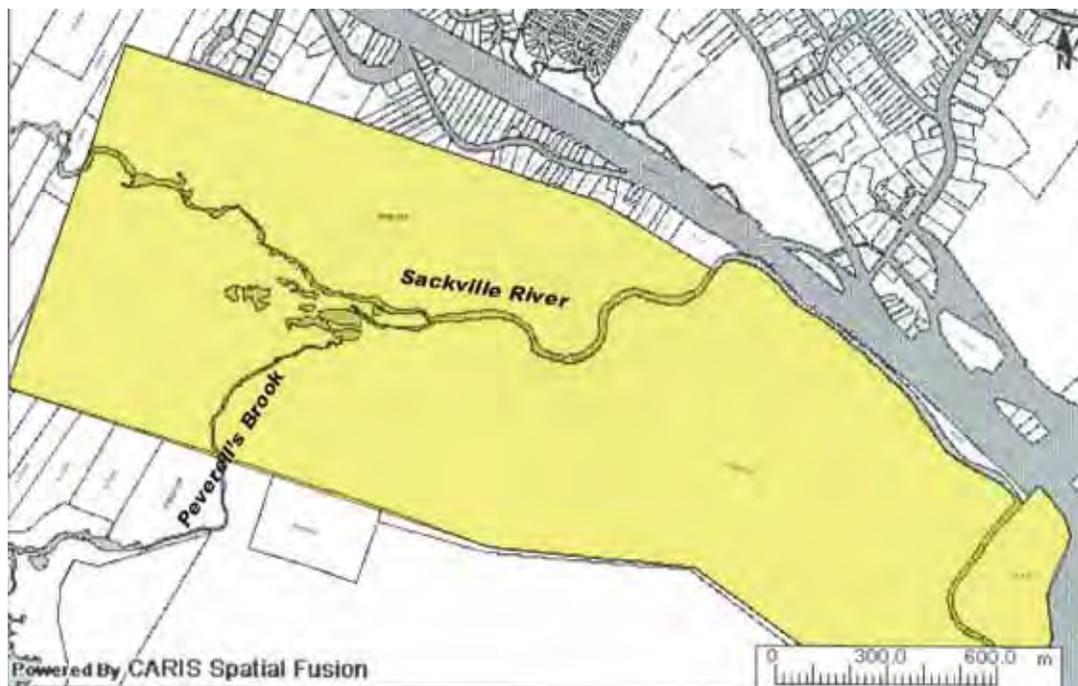
**Figure 1:** The yellow block identifies PID 0361212 owned by the Department of National Defence, and the site of proposed wetland compensation activities. The proposed compensation activities are to take place adjacent to the Sackville River from its confluence with Peverell's Brook in an upstream direction to the west property boundary.

The following is a summary of field identified opportunities for wetland compensation on the DND Rifle range property in Sackville, Nova Scotia along the Sackville River (see Figure 1). The project site was a former gravel quarry that was active until the 1960's. This area of focus is within the Sackville River floodplain from the confluence of the Sackville River and Peverell's Brook in an upstream direction to the DND property boundary, a linear distance of 1.1 km and an area of approximately 18 hectares.

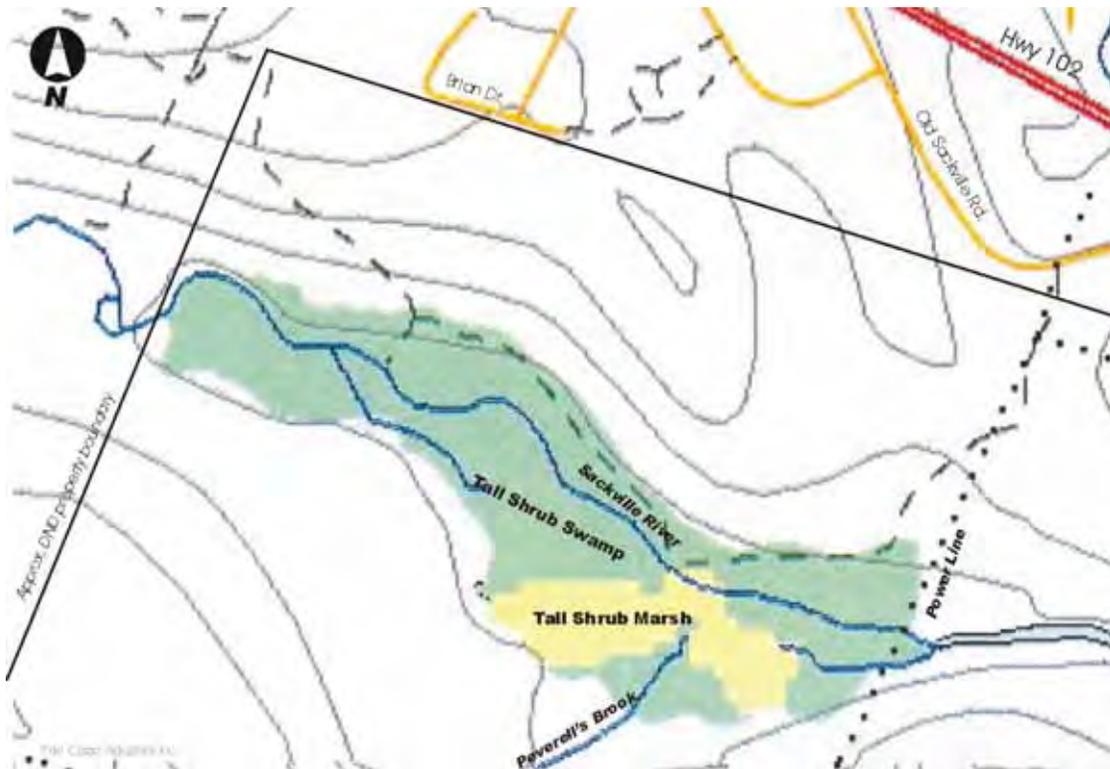
**Figure 4:** Nova Scotia Department of Natural Resources wetlands database mapping indicates 15.31 ha of tall shrub swamp (green) and 3.37 ha of tall shrub marsh (yellow) exist on the Sackville wetlands site (Source: modified from NSDNR 2009c).

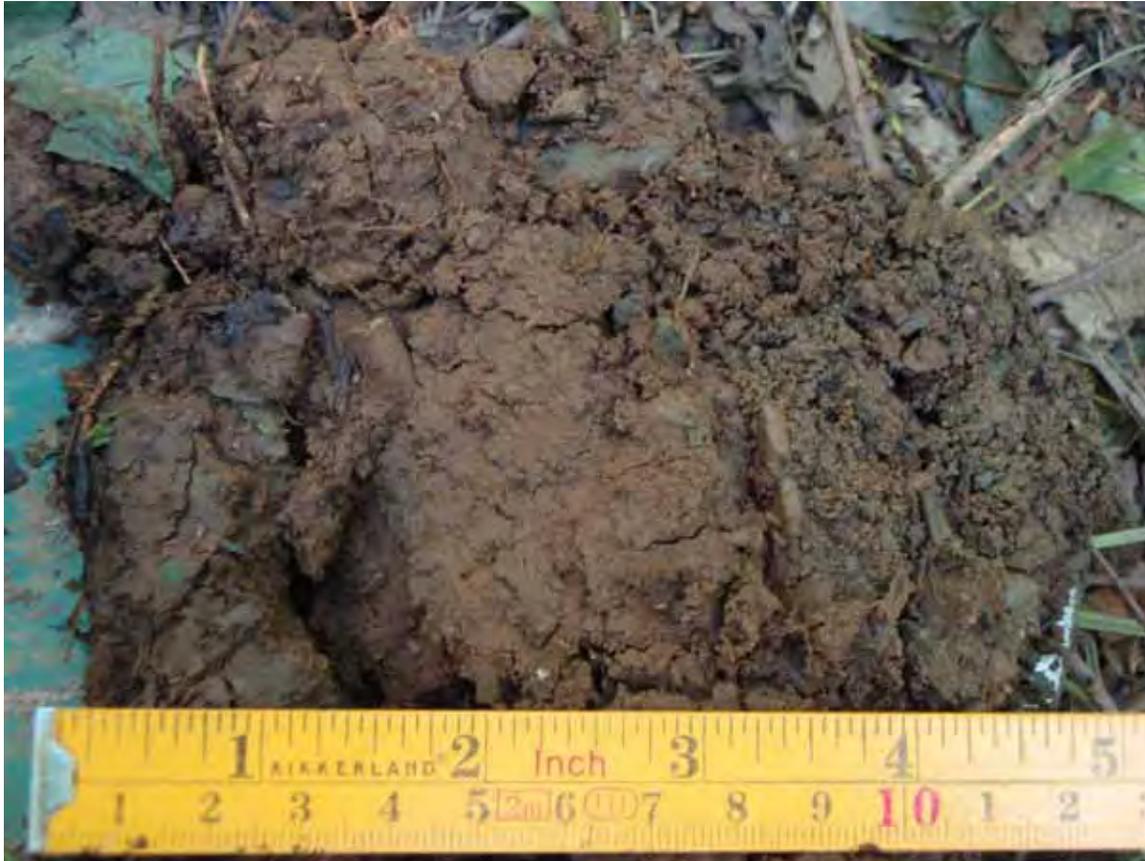
**Figure 6:** Wet 1 soil profile from Alder 5 shows consistent coloring (10 YR 3/2). Note gravel and rock fragments below 10 cm.

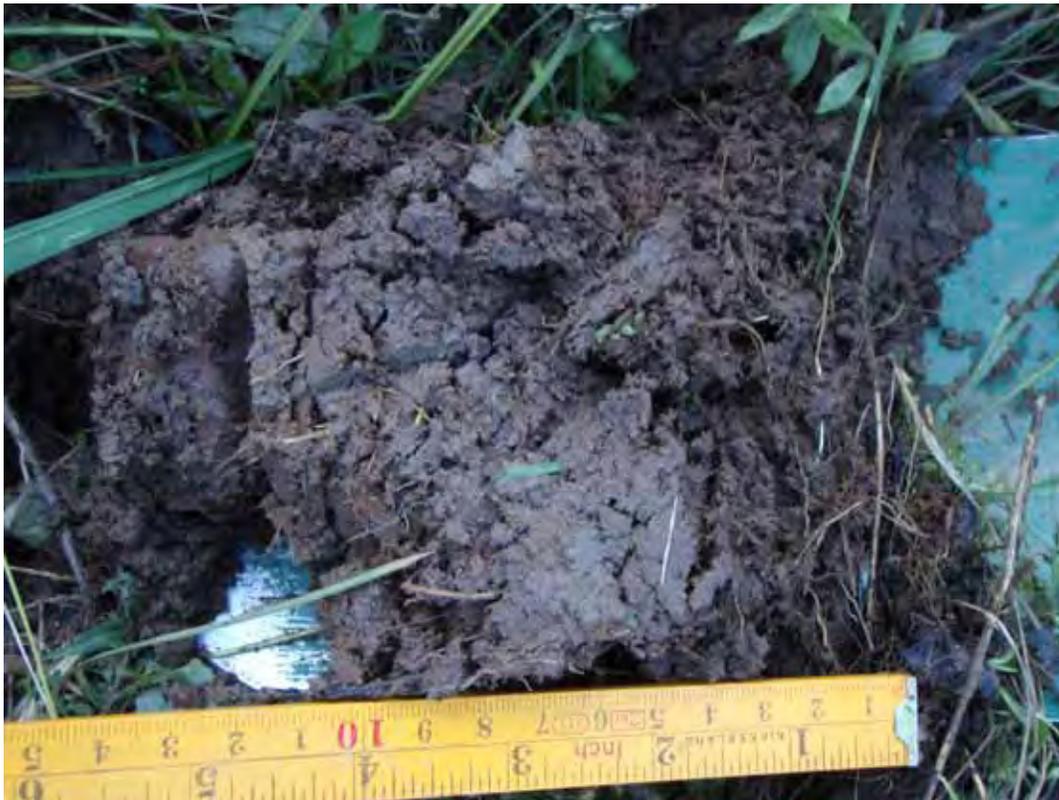
**Figure 7:** Soil profile at site Wet 3 located in Marsh 5 on the southern extent of the project area. Undecomposed roots are visible throughout the matrix. Note the large stone at 12 cm. Sand/gravel/stone layer existed below 15cm.

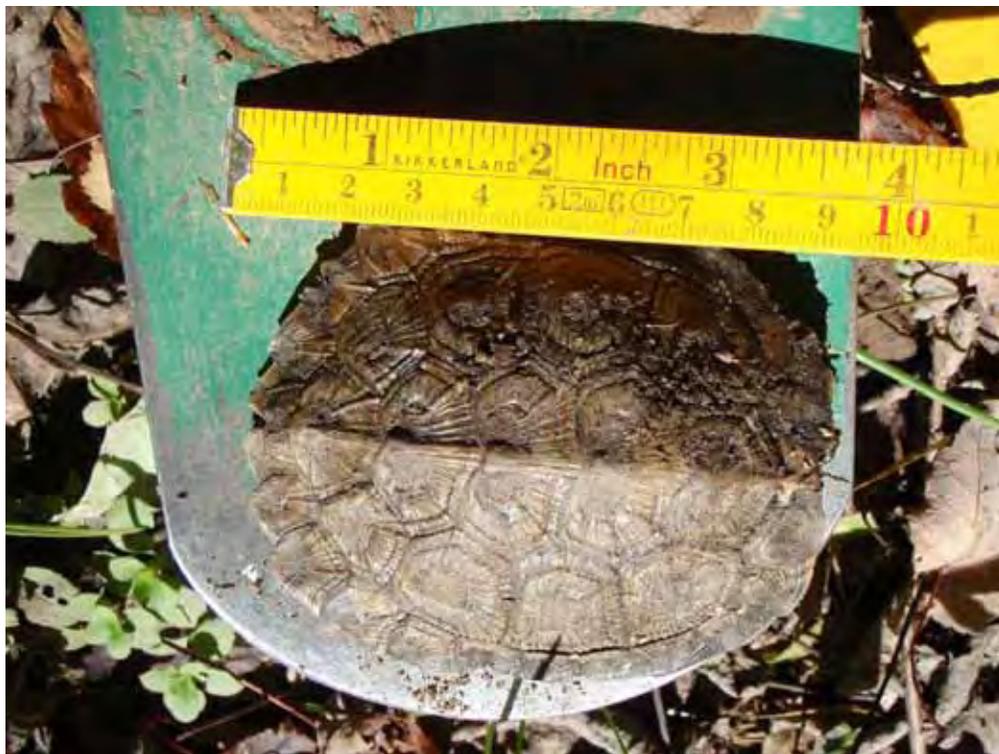
**Figure 9:** Wood turtle (*Glyptemys insculpta*) shell was found within Alder 1. Legs and tail were visible within the 9cm x 7.5cm carapace, but the head appeared to have been removed by a predator.

Of all the species in Table 8, Wood turtle was the only one for which evidence was found within the Sackville Wetland Complex during the fall 2009 field surveys. A recently predated juvenile Wood turtle was found during field surveys on the north side of the river within wetland sub unit Alder 1 (see Figure 8). No White Cedar or Rusty Blackbird was noted, although portions of the

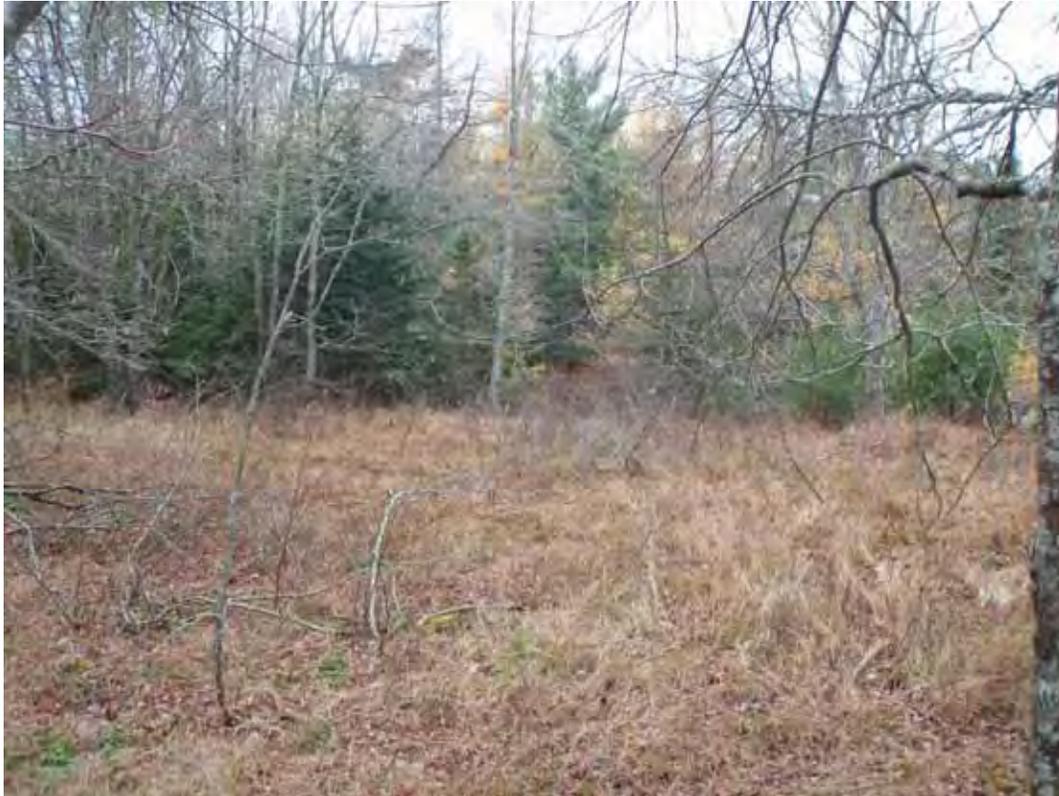
**Figure 11:** Project potential site for a fringe wetland associated with Pond 2 (pond lies at evergreens in photo background). A 20+ m<sup>2</sup> fringe wetland could be created by removing 0.5-0.75 m of gravel overburden adjacent to the pond to create a lacustrine shore marsh.

The Pond 1 and Pond 2 habitats also provide significant opportunity for complexing that would provide waterfowl perches and turtle basking sites. There are no rocks or large logs within these wetland ponds that functionally provide these habitat requirements. Large logs can be keyed into the shoreline to prevent floating and displacement. The most readily available source would be derived from pushing grown trees over as access routes are established, and utilizing these trees for pond placements and for other project placements. Placed approximately parallel to the water surface the logs will provide perch and basking habitat to a number of species through a range of water levels. Similarly, if large boulders are available they can be placed such that they remain partially exposed through a range of water levels. Based on 2009 observations it is believed that water levels in these two ponds remains relatively constant and therefore provide a stable environment in which to install habitat complexing features.

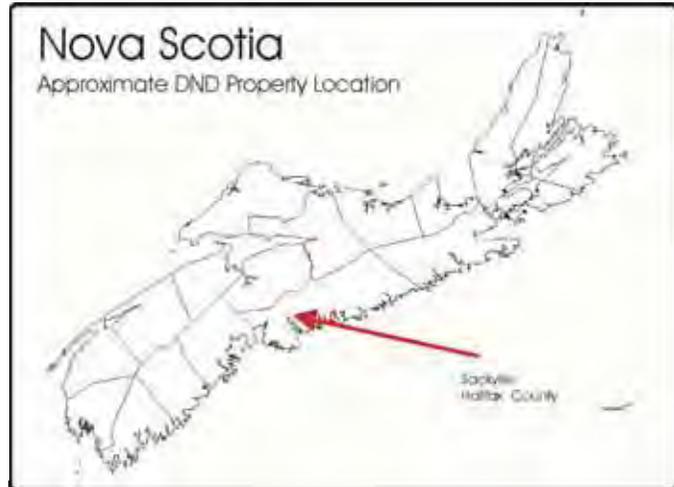
**Figure 1:** General location of DND property and assessed wetland at Sackville, Halifax County.

The wetland assessed for this Alteration Approval, herein referred to as the Sackville Wetland Complex, is located south of Highway 101 and the community of Lower Sackville, Halifax County, Nova Scotia (see Figure 1). The site is part of the Eastern Interior ecodistrict in the Western ecoregion (NSDNR 2003). The wetland assessed is not a coastal wetland, but a freshwater floodplain system of the Sackville River. The Sackville River flows to the Bedford Basin and head of tide, approximately 4km downstream of the Sackville Wetland Complex.

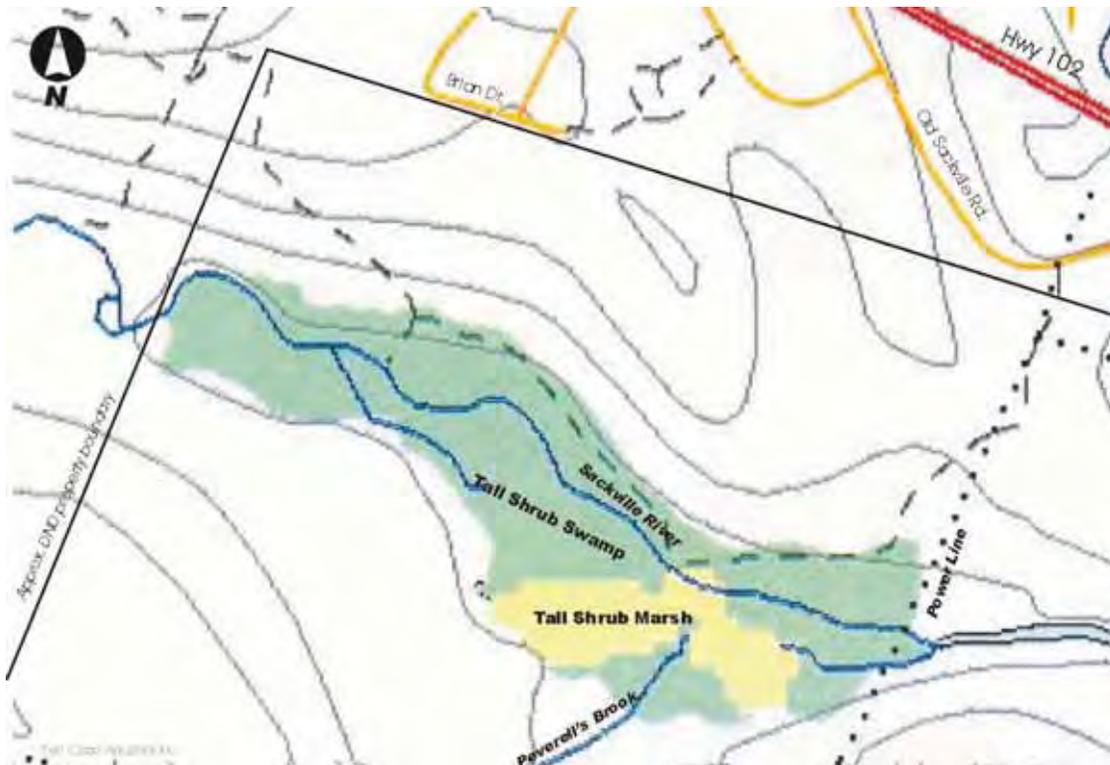
**Figure 2:** Nova Scotia Department of Natural Resources wetlands database mapping indicates 15.31 ha of tall shrub swamp (green) and 3.37 ha of tall shrub marsh (yellow) exist on the Sackville Wetland Complex (Source: modified from NSDNR 2009c).

As shown in Figure 2, the Nova Scotia Department of Natural Resources (NSDNR) has identified the Sackville Wetland Complex within their Significant Species and Habitats database (NSDNR 2009c), although at a slightly greater area (18.67 ha) than the field verified boundary. Approximately 880 ha of wetlands have been identified by the Department within the Sackville River watershed upstream of the project site, or 8.8% of the watershed area. It is likely that the wetland area is somewhat greater than that which is currently reported.

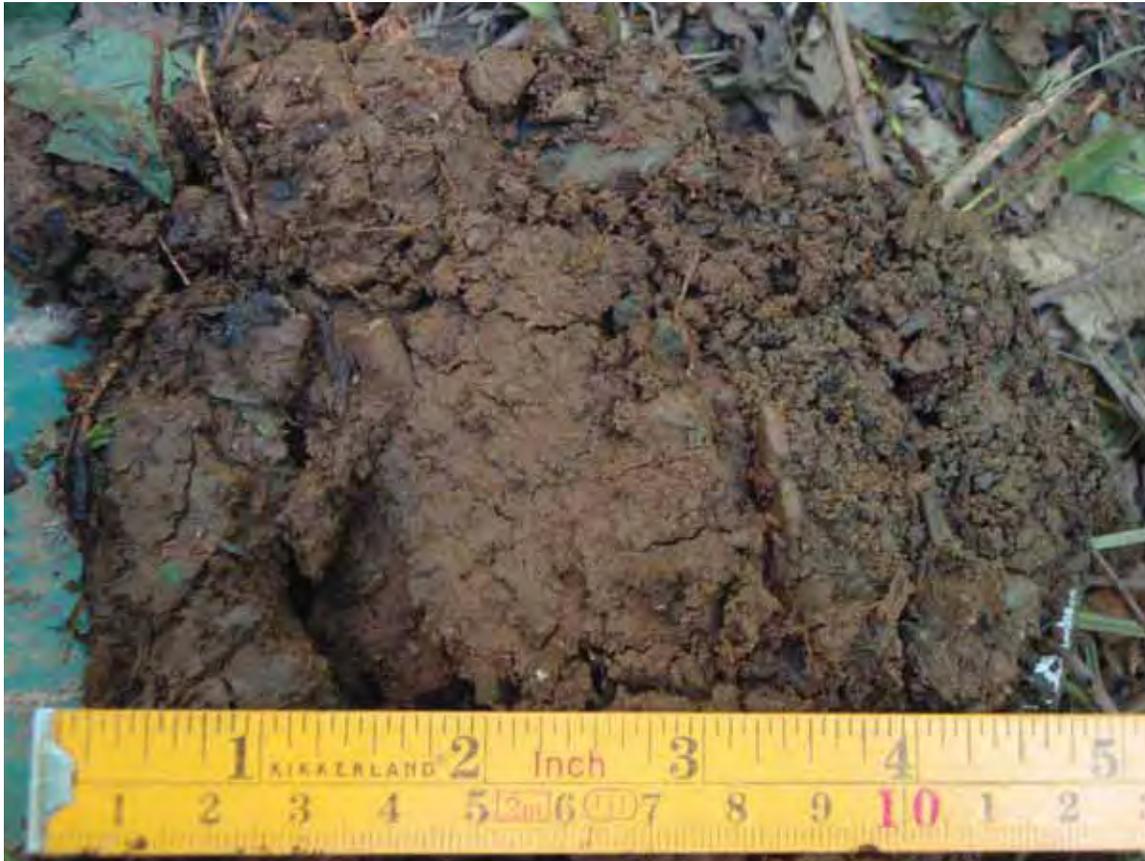
**Figure 4:** Wet 1 soil profile from Alder 5 shows consistent coloring (10 YR 3/2). Note gravel and rock fragments below 10 cm.

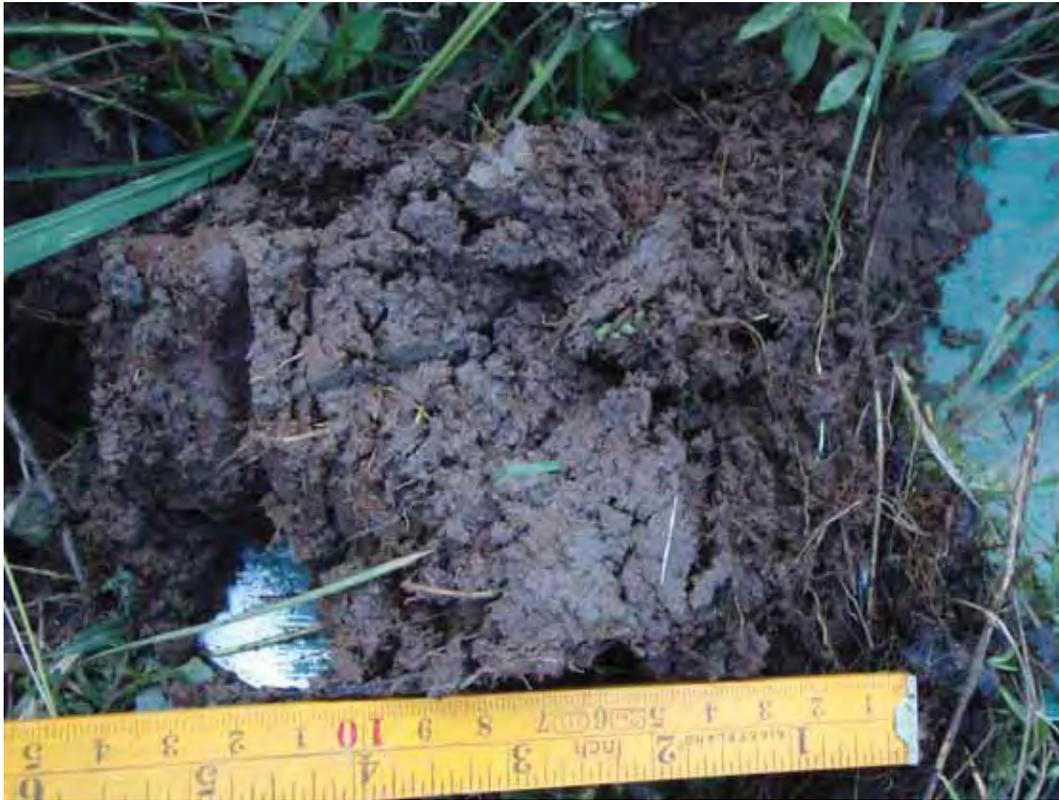
**Figure 5:** Soil profile at site Wet 3 located in Marsh 5 on the southern extent of the project area. Undecomposed roots are visible throughout the matrix. Note the large stone at 12 cm. Sand/gravel/stone layer existed below 15cm.

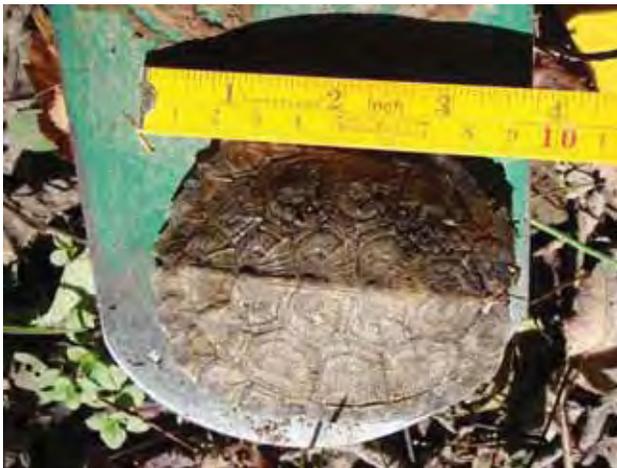
**Figure 7:** Wood turtle (*Glyptemys insculpta*) shell was found within Alder 1. Legs and tail were visible within the 9cm x 7.5cm carapace, but the head appeared to have been removed by a predator.

A single individual Species at Risk was identified during field surveys of the Sackville Wetland Complex. As shown in Figure 7, a juvenile Wood Turtle (*Glyptemys insculpta*) was found in association with subunit Alder 1 on the north side of the Sackville River. It had been a recent mortality, and its size would suggest that reproduction could be occurring in the area. Plants in the Wood turtle diet include strawberries, blackberries, cinquefoil, violets, algae, moss, willow, as well as alder leaves and grasses (MacGregor and Elderkin 2003). The presence of a number of *Rubus spp.* (blackberries and raspberries) observed across the project area may provide an appropriate food source to the Wood turtle. This could be particularly true for areas such as Gram 5 where *Rubus spp.* are found in the marsh portions of the wetland. Cherry trees, another fruit consumed by the Wood turtle, has also been identified in different areas of the Sackville Wetland Complex, and alder dominants much of the landscape. Alder thickets and alder swale have been identified as the preferred or most-used habitats in numerous locations, including Nova Scotia (COSEWIC 2007). As noted earlier, field surveys identified alder swamp (NovaWAM 2009) as covering as much as 78 % of the Sackville Wetland Complex.

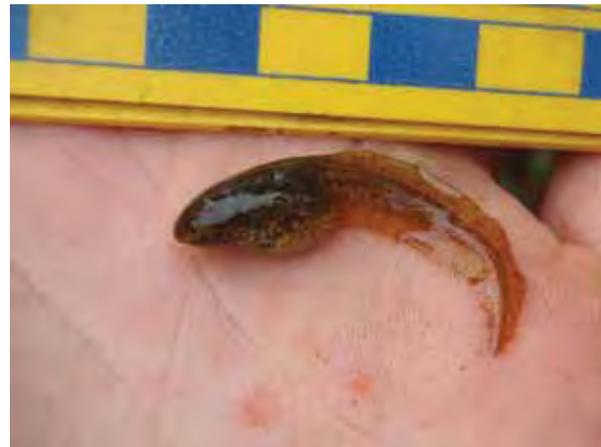
**Figure 8:** Green Toad (*Rana clamitans*) tadpole found in a small pool north of Pond 1 on Oct. 29<sup>th</sup>, 2009.

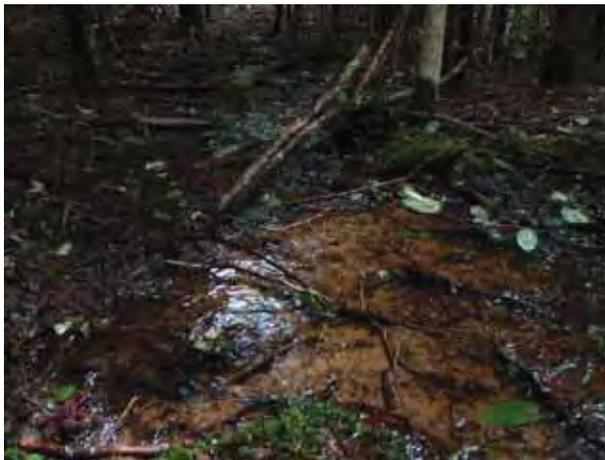
**Figure 9:** This small spring in the north side location of plot Up2 was flowing on the surface some 30m to subunit Alder 2.

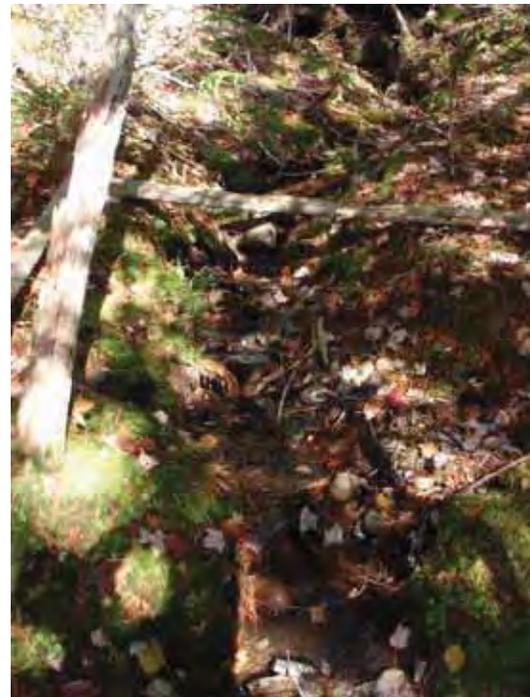
**Figure 10:** This small inflow channel (~0.5m width) to subunit Perched 1 is typical of the surface water features that flow into the Sackville Wetland Complex.

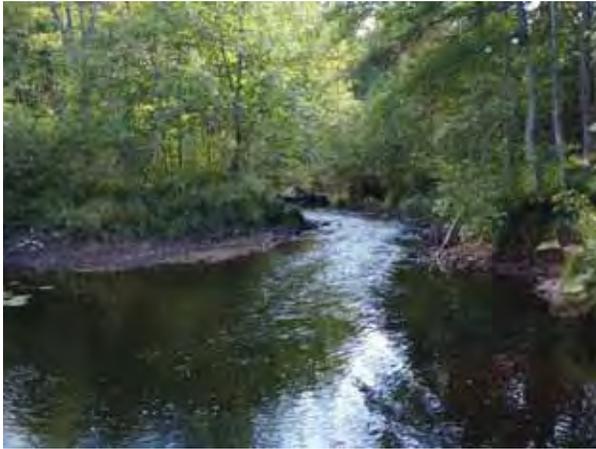
**Figure 11:** Peverell's Brook as it enters Pond 5 in the southeast portion of the Sackville Wetland Complex.

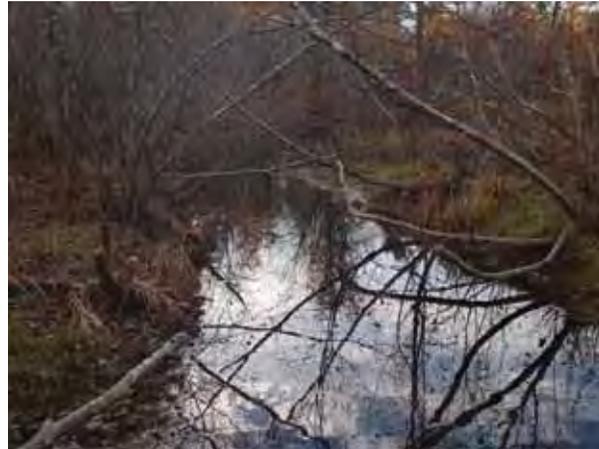
**Figure 12:** This floodplain drainage channel is characteristic of the larger (~2.5 m wide) channels that drain floodplain water to the main river.

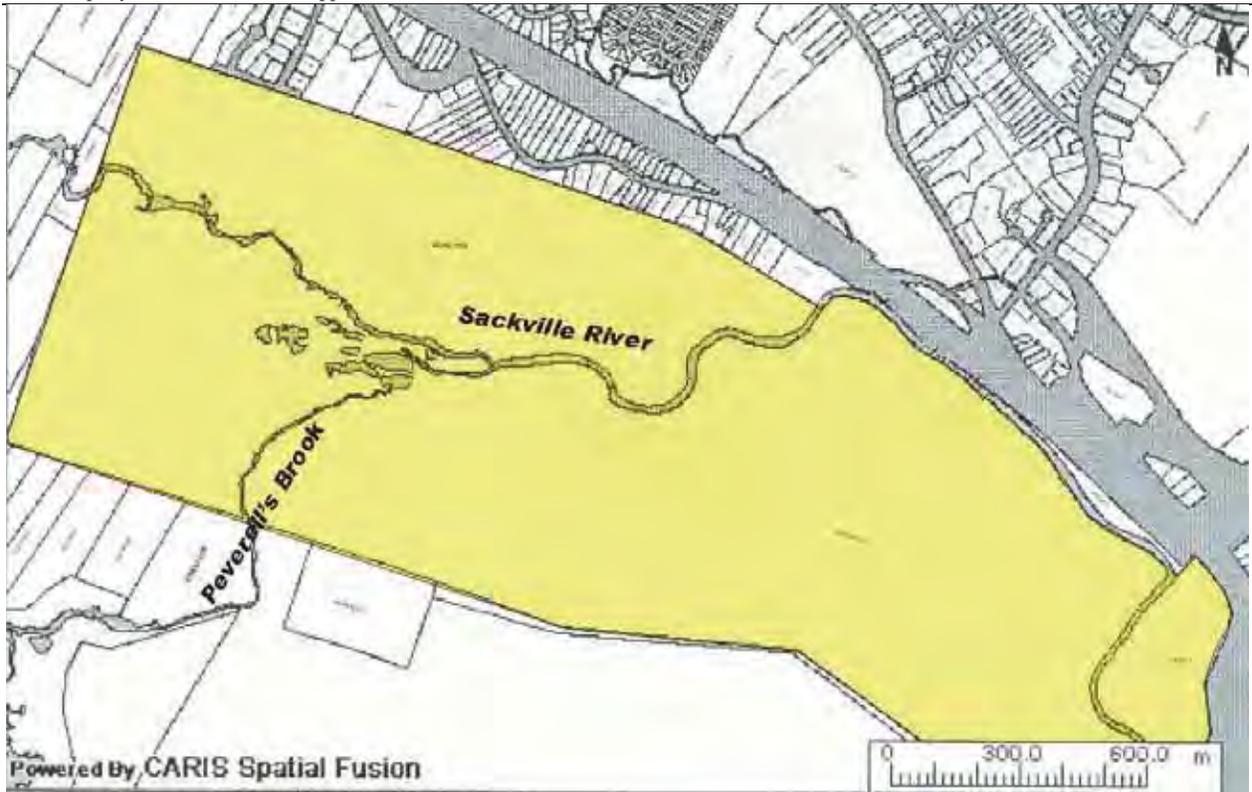
Figure 14: PID number 00361212 is the relevant property for the proposed Sackville Wetland Complex alteration.

The assessed Sackville River Wetland area exists entirely on PID 00361212, which is owned by Department of National Defence. The proponent is the Provincial Department of Transportation and Infrastructure Renewal (see Figure 14 in Section 8 for property boundary map image).

The requested alteration approval is for work to be completed on a single property. The Service Nova Scotia and Municipal Relations (SNSMR) Land Information Centre identifies the property as PID 00361212 owned by the Department of National Defence. The SNSMR mapped property boundaries are presented on the property map shown in Figure 14. The relevant property identification number for this Wetland Alteration Approval is:
