# **As-Built Report for the Flat Lake, Highway 103, HADD Compensation Project: Shoreline and Slope Vegetation in 2005**

Diane LaRue, Vegetation Consultant  
Environmental Services, TPW  
December 2005

Flat Lake is part of the East River Watershed, a drainage basin located in the northeastern portion of St. Margarets Bay in the Halifax Regional Municipality (HRM). The twinning of Highway 103 required a partial in-filling of Flat Lake to accommodate new lanes and the westbound off-ramp at Exit 5. In order to protect lake water quality and restore habitat, native and indigenous (to the area) topsoils, woody material and herbaceous plants were used to vegetate the newly constructed slope. Photographs are provided in two accompanying *PowerPoint®* files (see also the large-format overview drawing provided with this report).

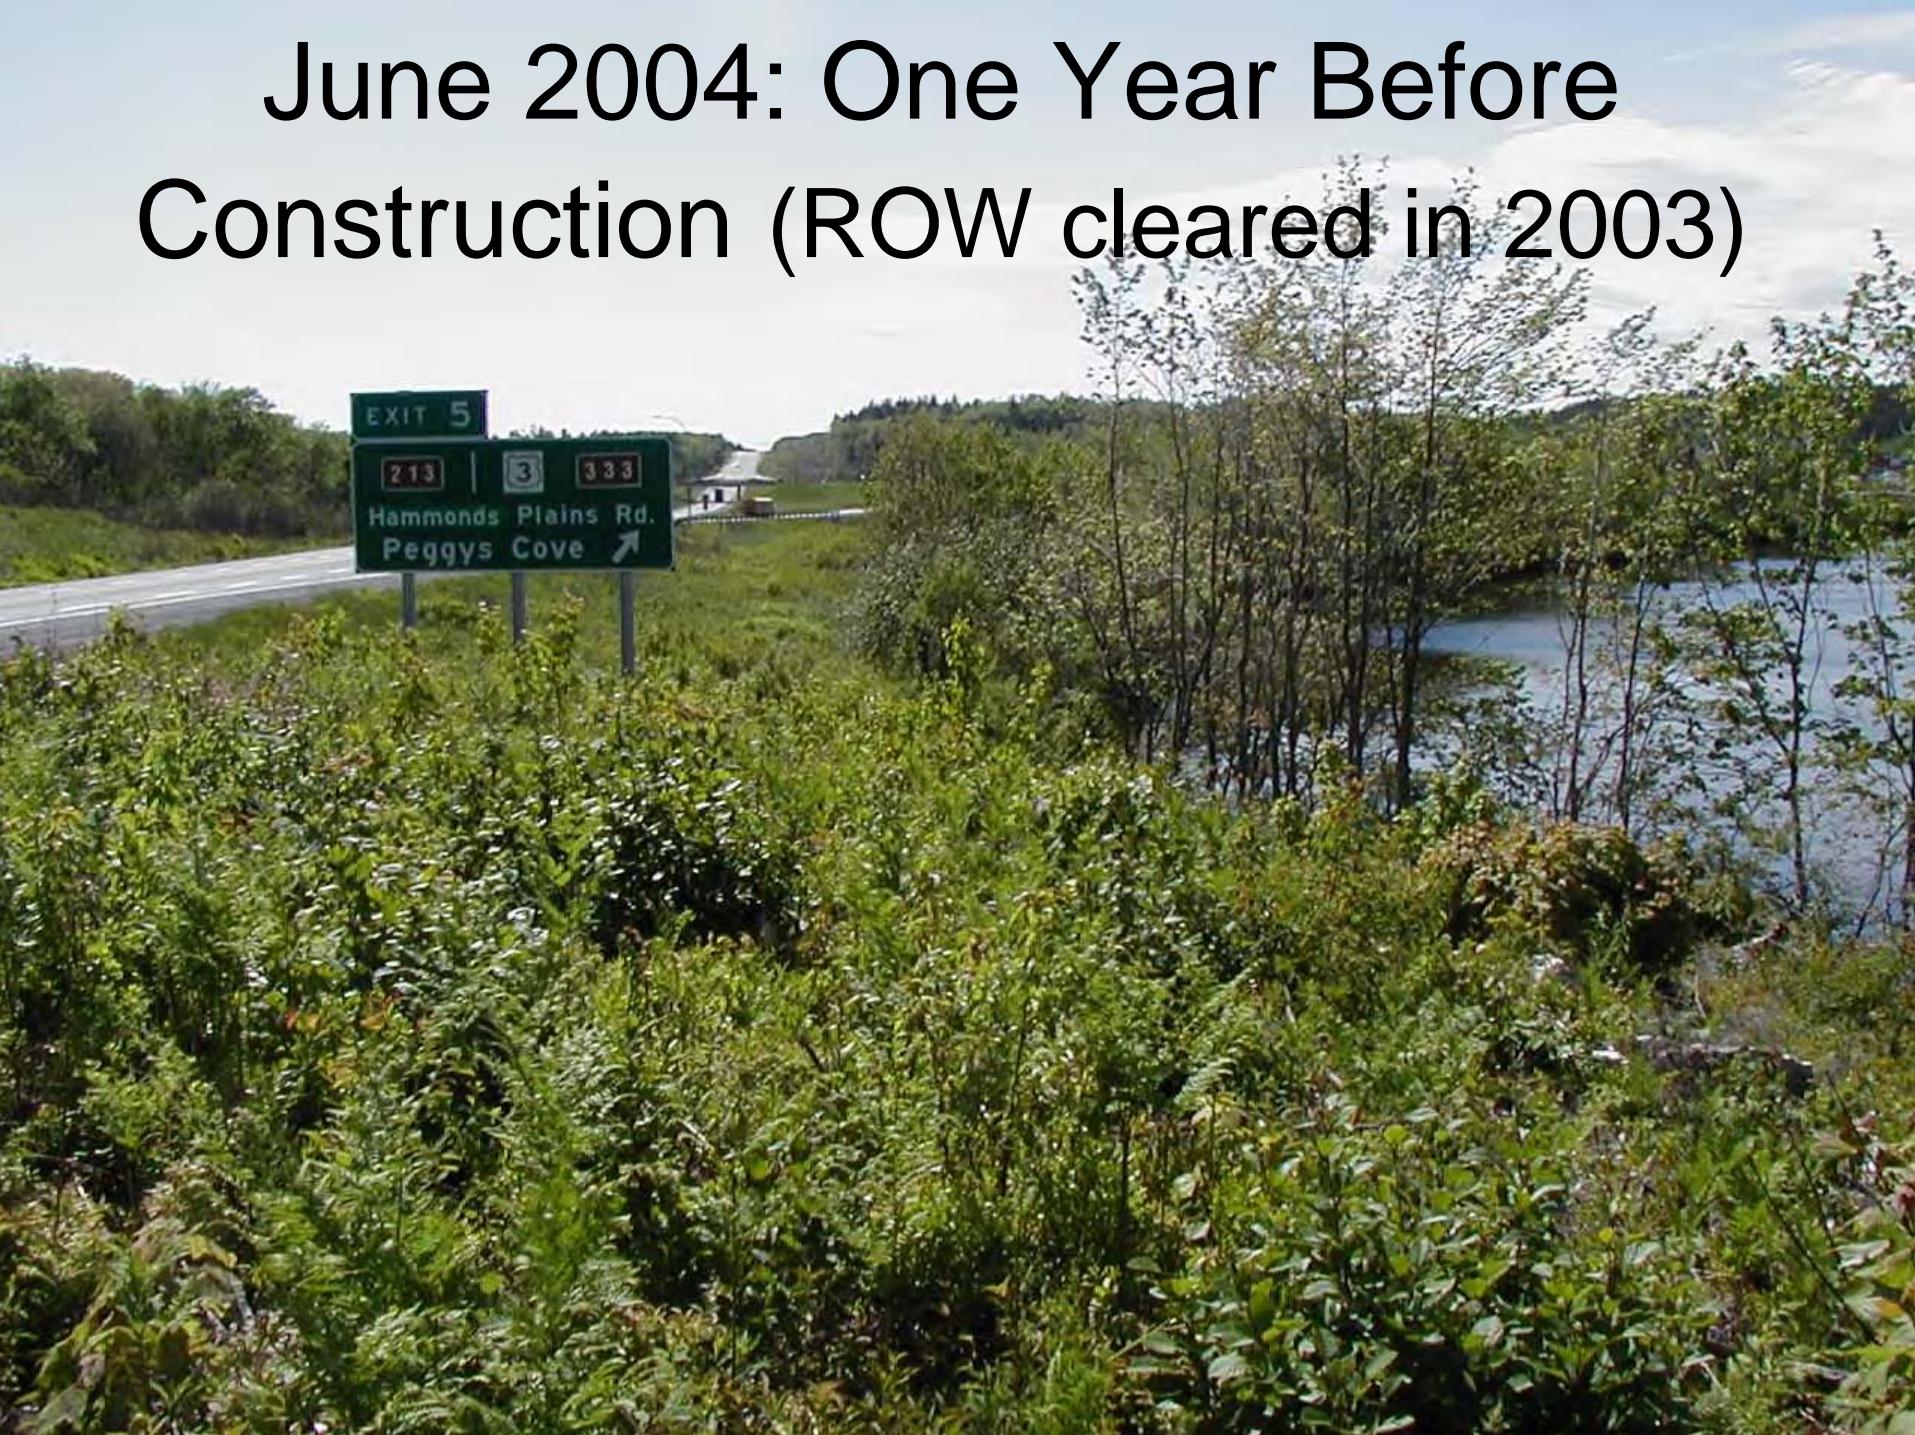
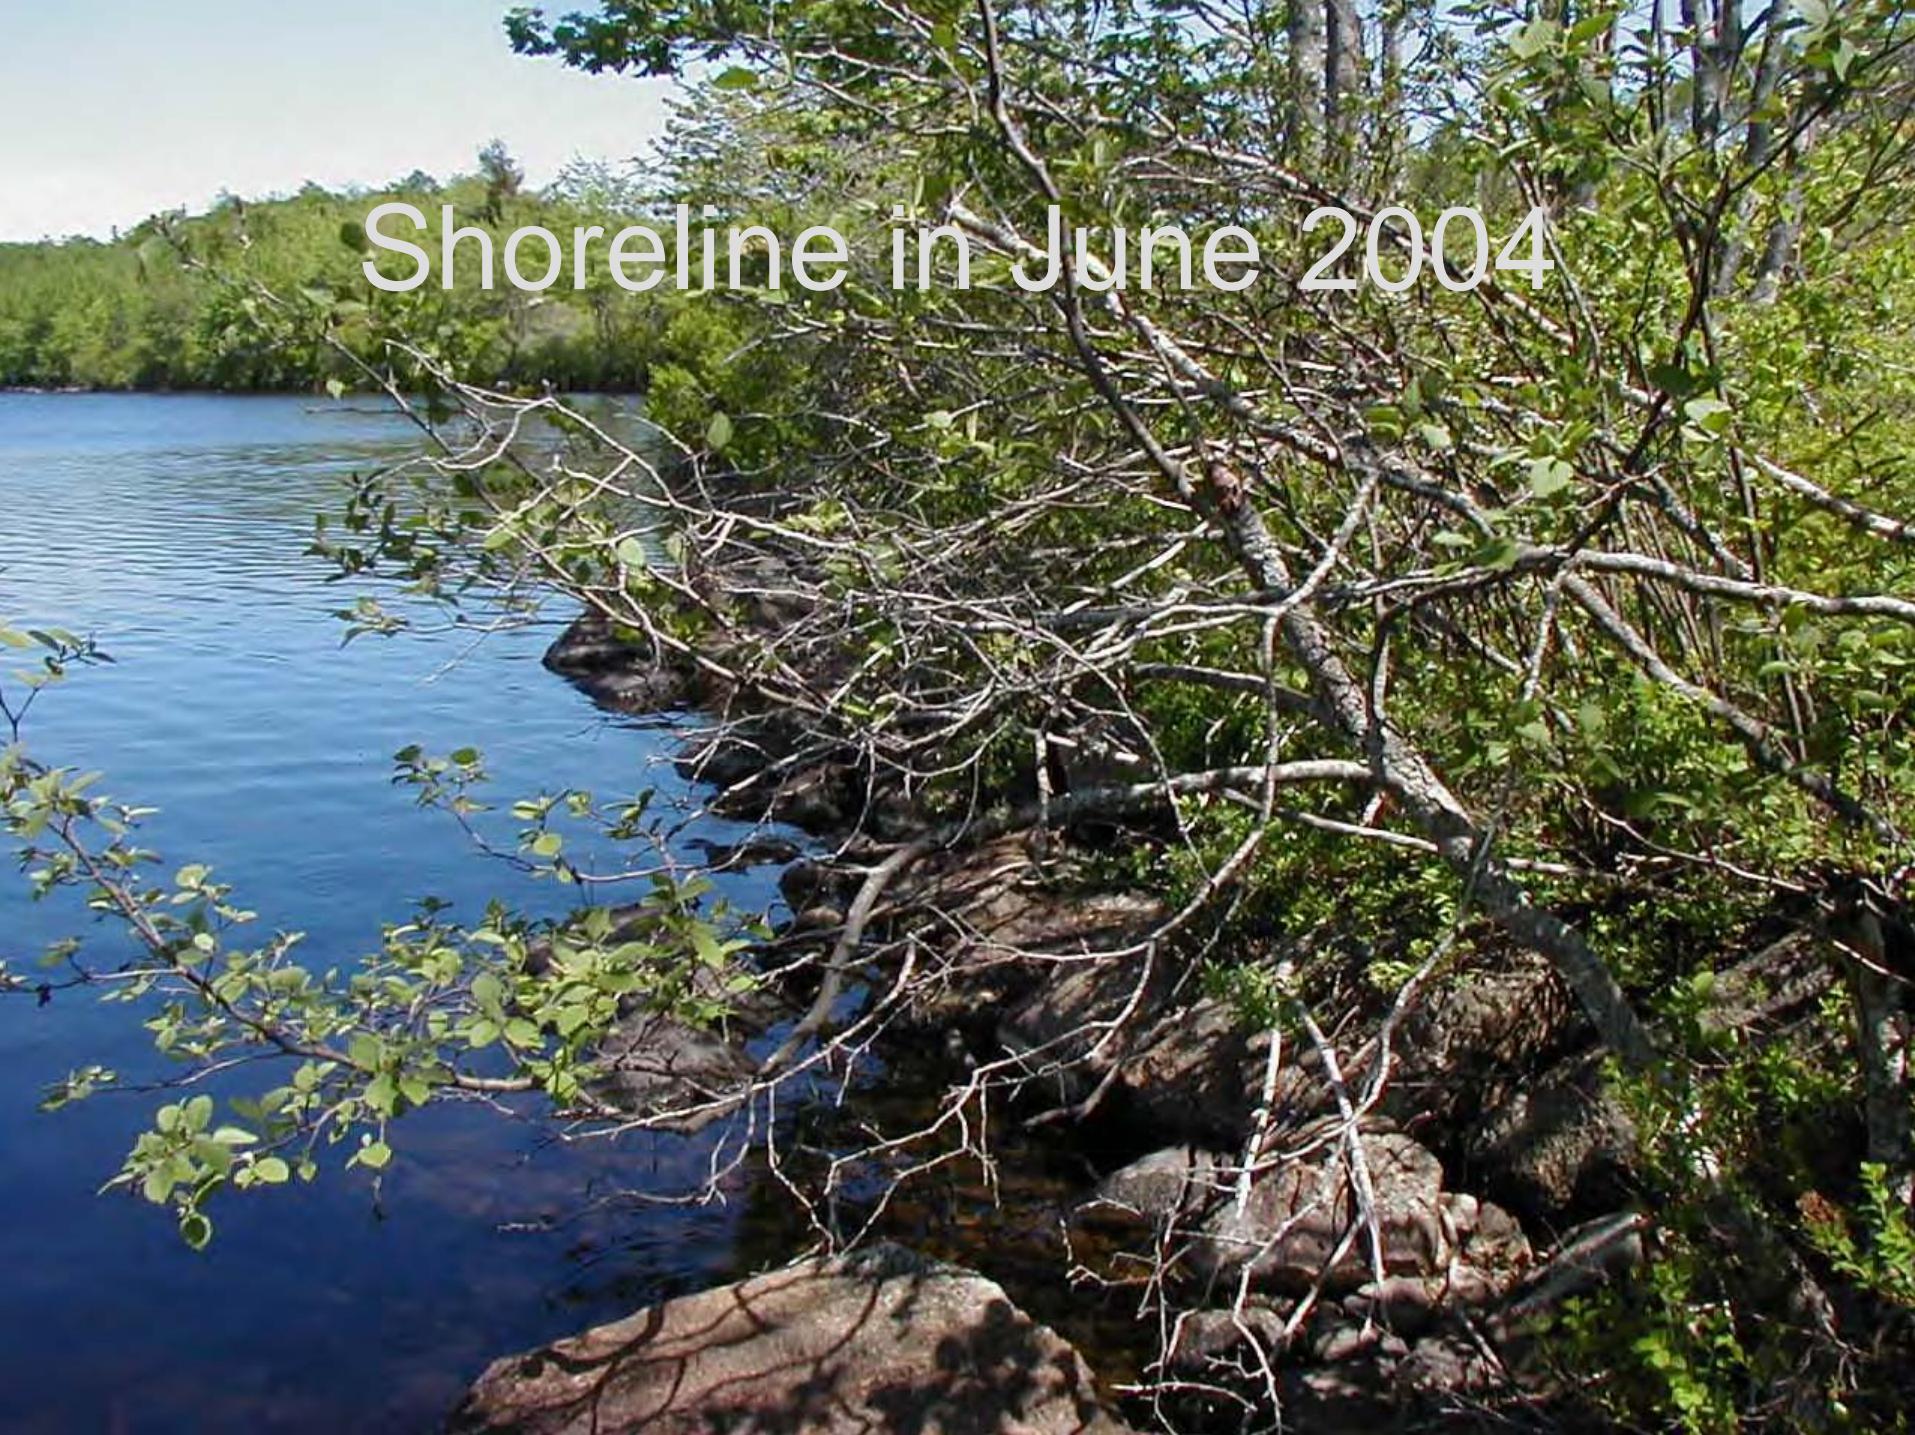
# June 2004: One Year Before Construction (ROW cleared in 2003)

Shoreline in June 2004

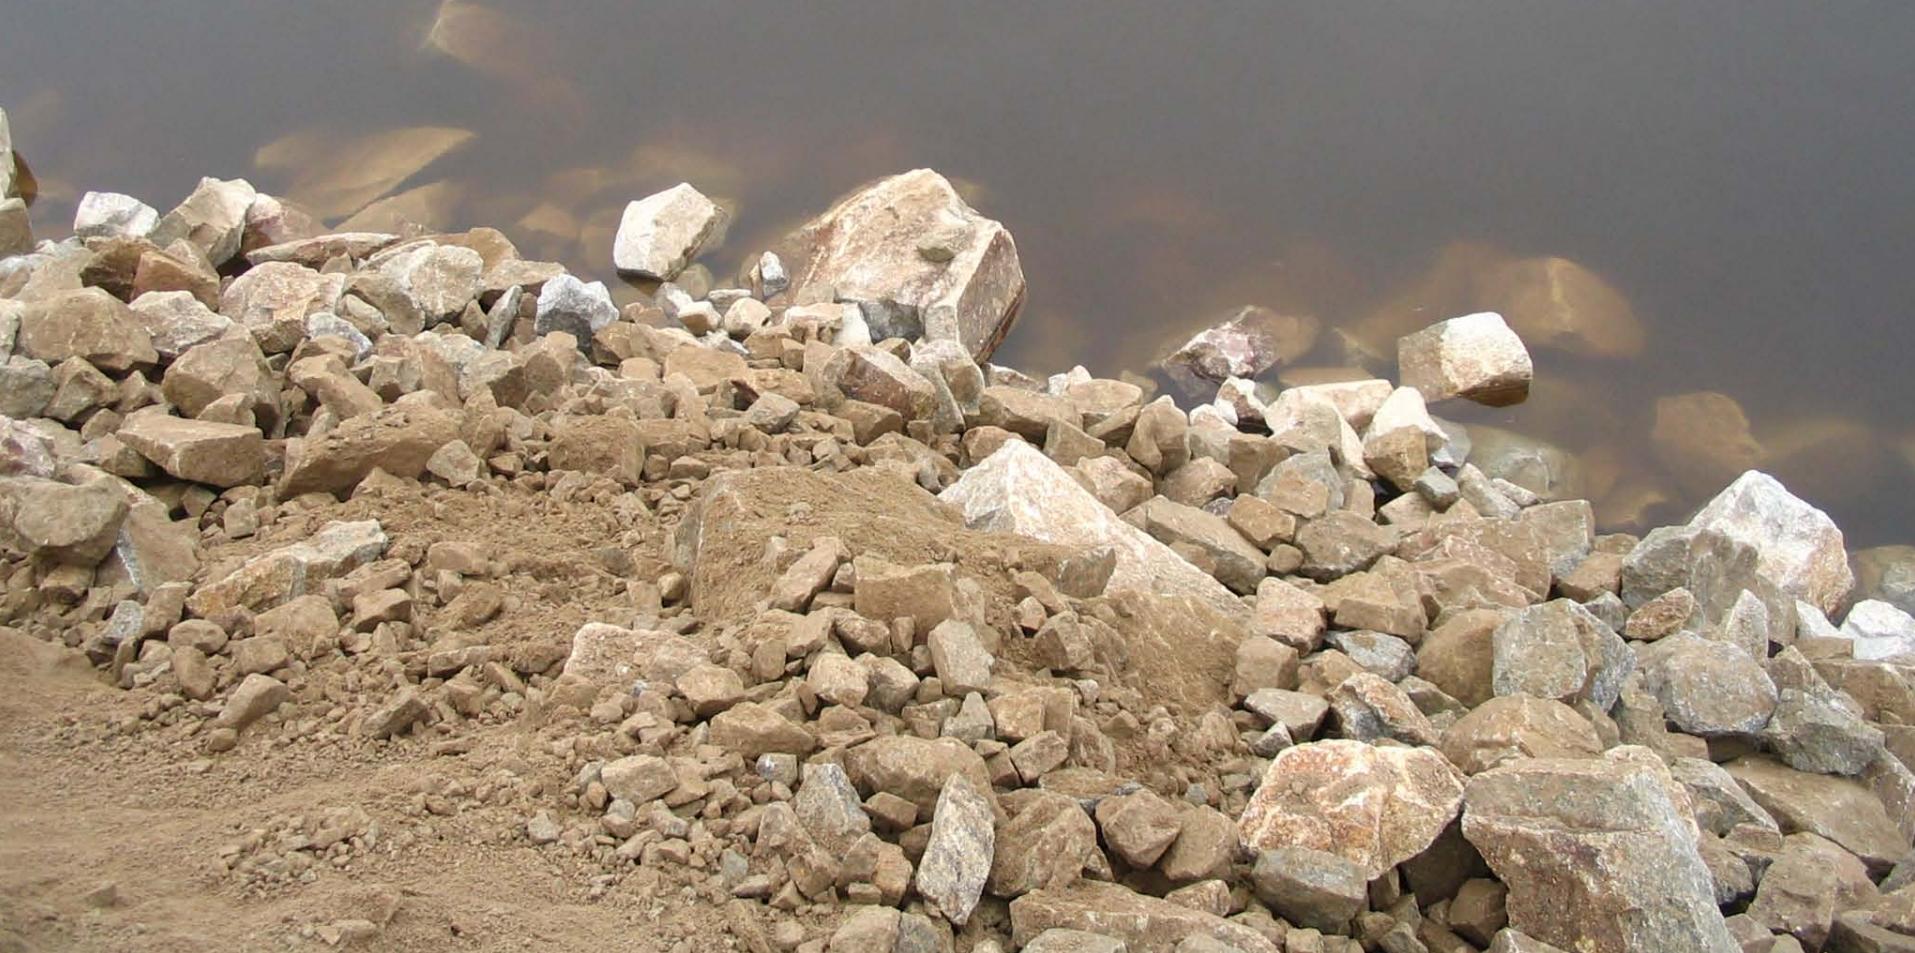
# In-Filling With Clean Rock; Common Fill and Rock Used in Upper Section of Slope

A new slope along a portion of the south shore of Flat Lake was constructed by filling in the lake with large armour rock, then smaller rock mixed in with common fill (see the accompanying *Power-Point®* As-Built file). The infilling process started at the east end of the lake, Station 33+80, and continued westward to Station 33+215 (see the large-format overview drawing). The design called for a 1:1 slope face which in turn would affect ~1,600 m<sup>2</sup> of lake bed. However, as the in-filling continued, the toe began to drop into the lake between Stations 33+120 and 33+140. In order to achieve a stable slope capable of supporting the highway, more rock and fill were used from east of Station 33+140 westward which resulted in a slope that was more like a 2:1 slope. The resulting “area of compensation” is calculated as 2,576 m<sup>2</sup> (*i.e.*, the area between the old shoreline and the new toe-of-slope).

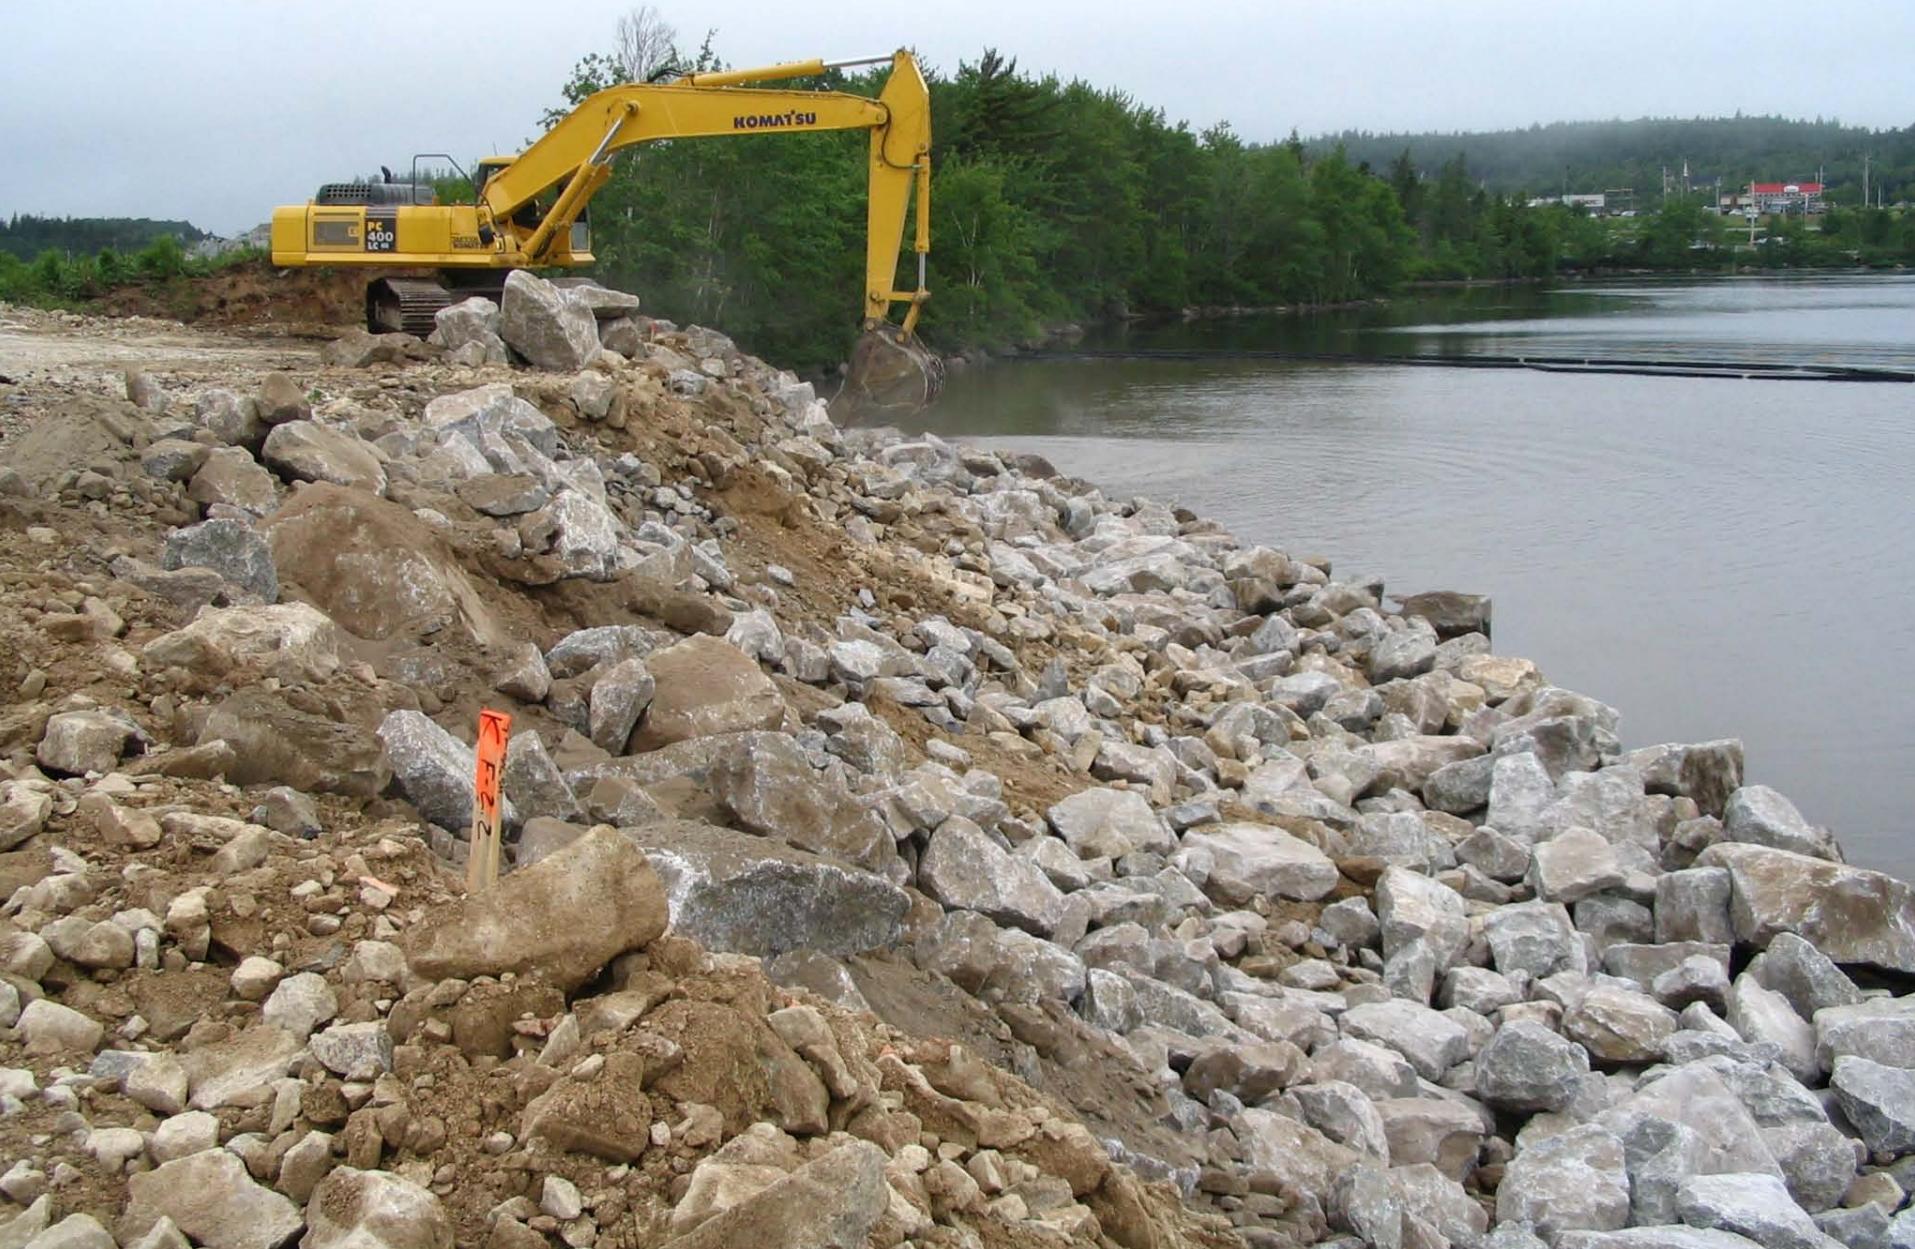
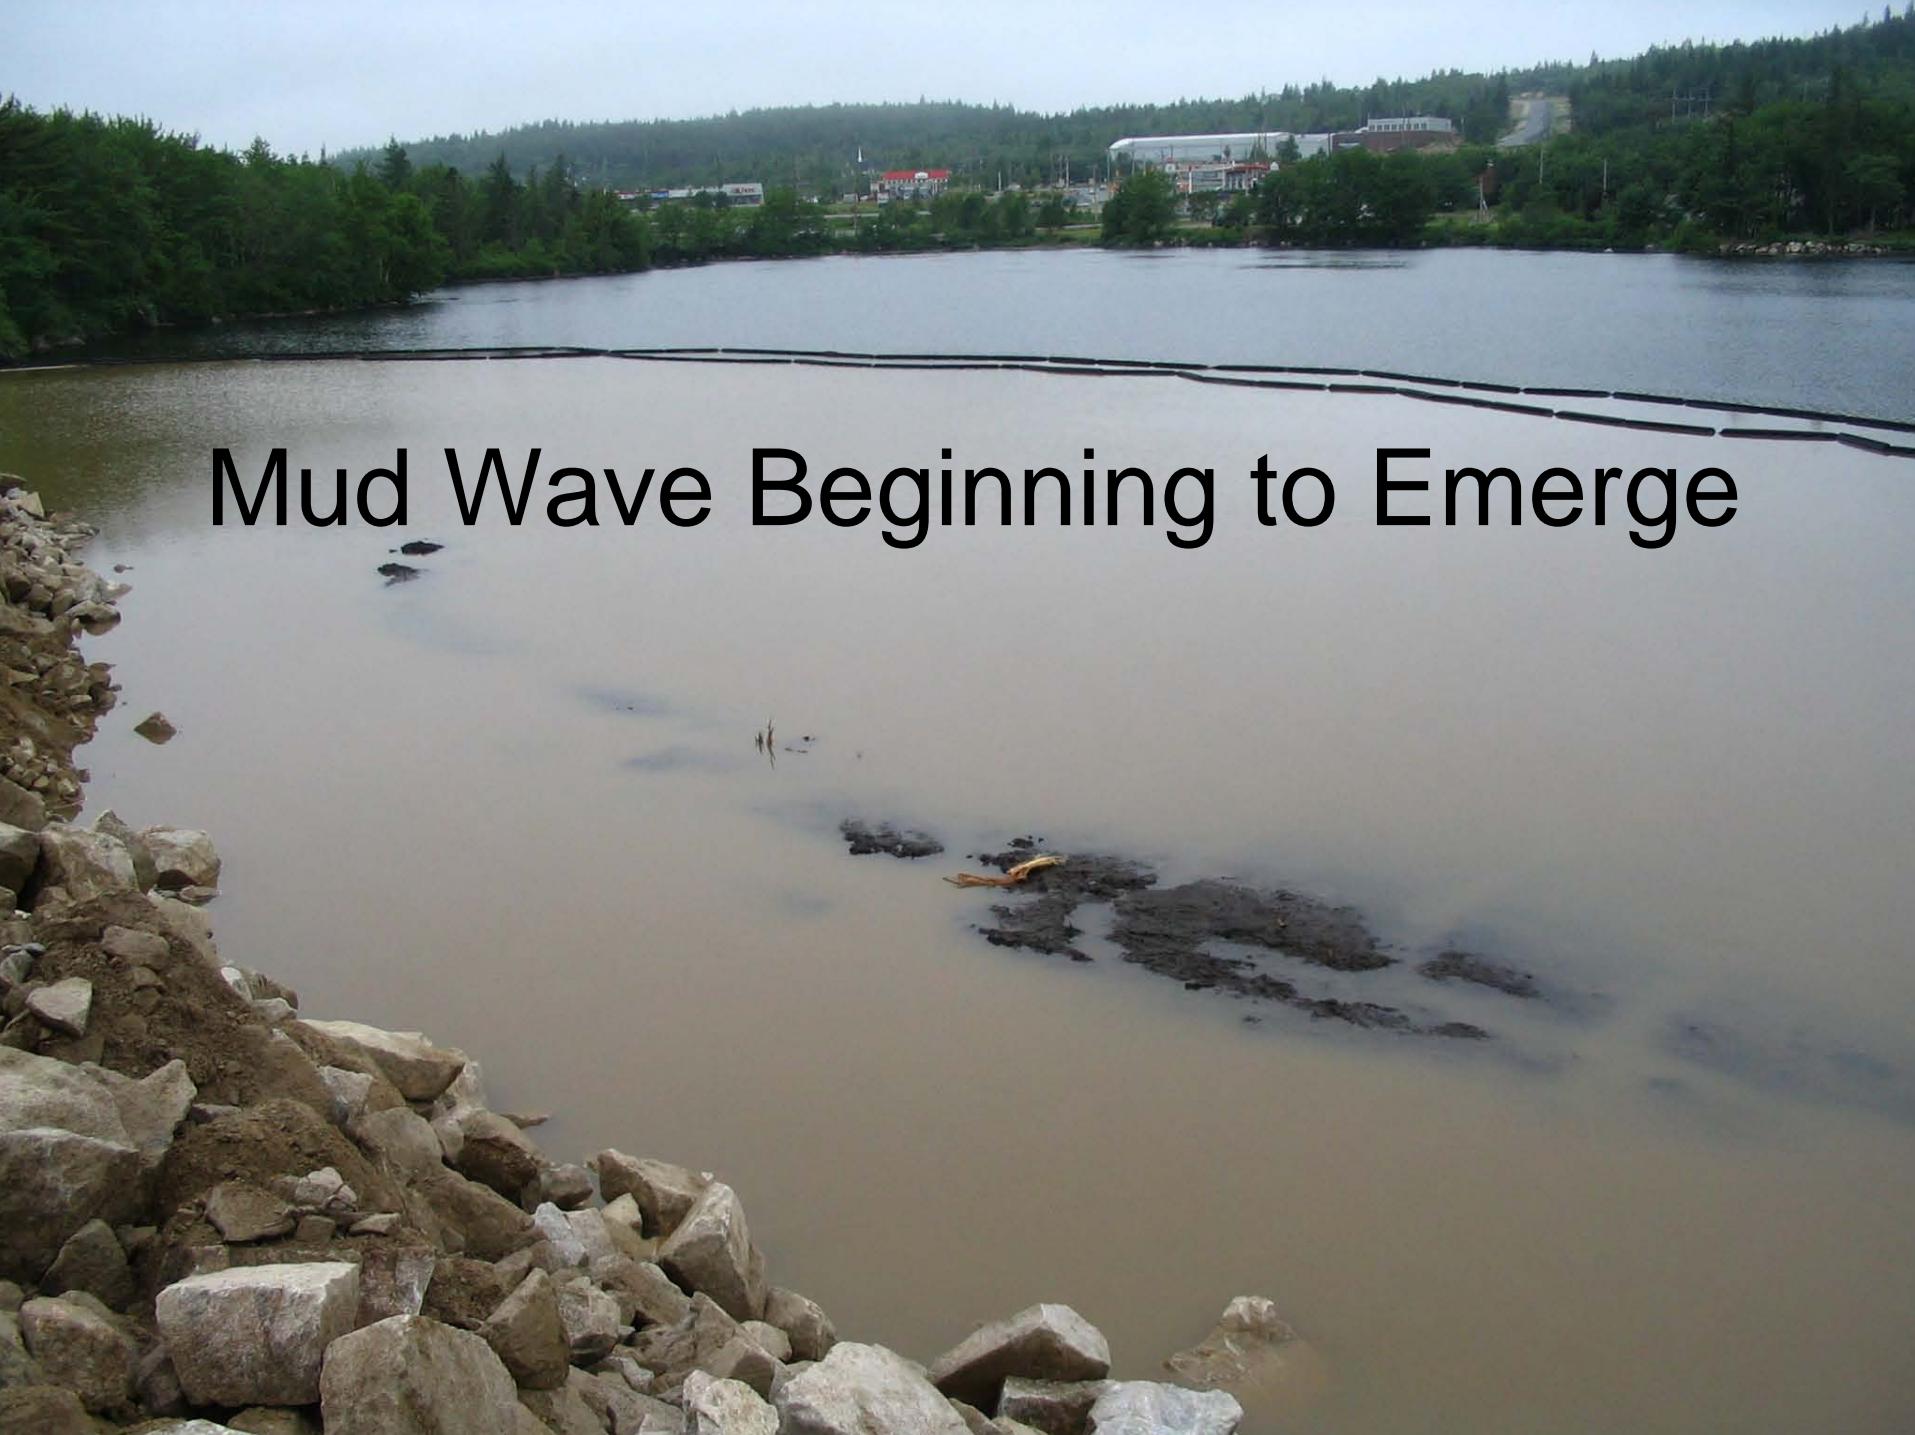
# Building Slope and Rock Sill

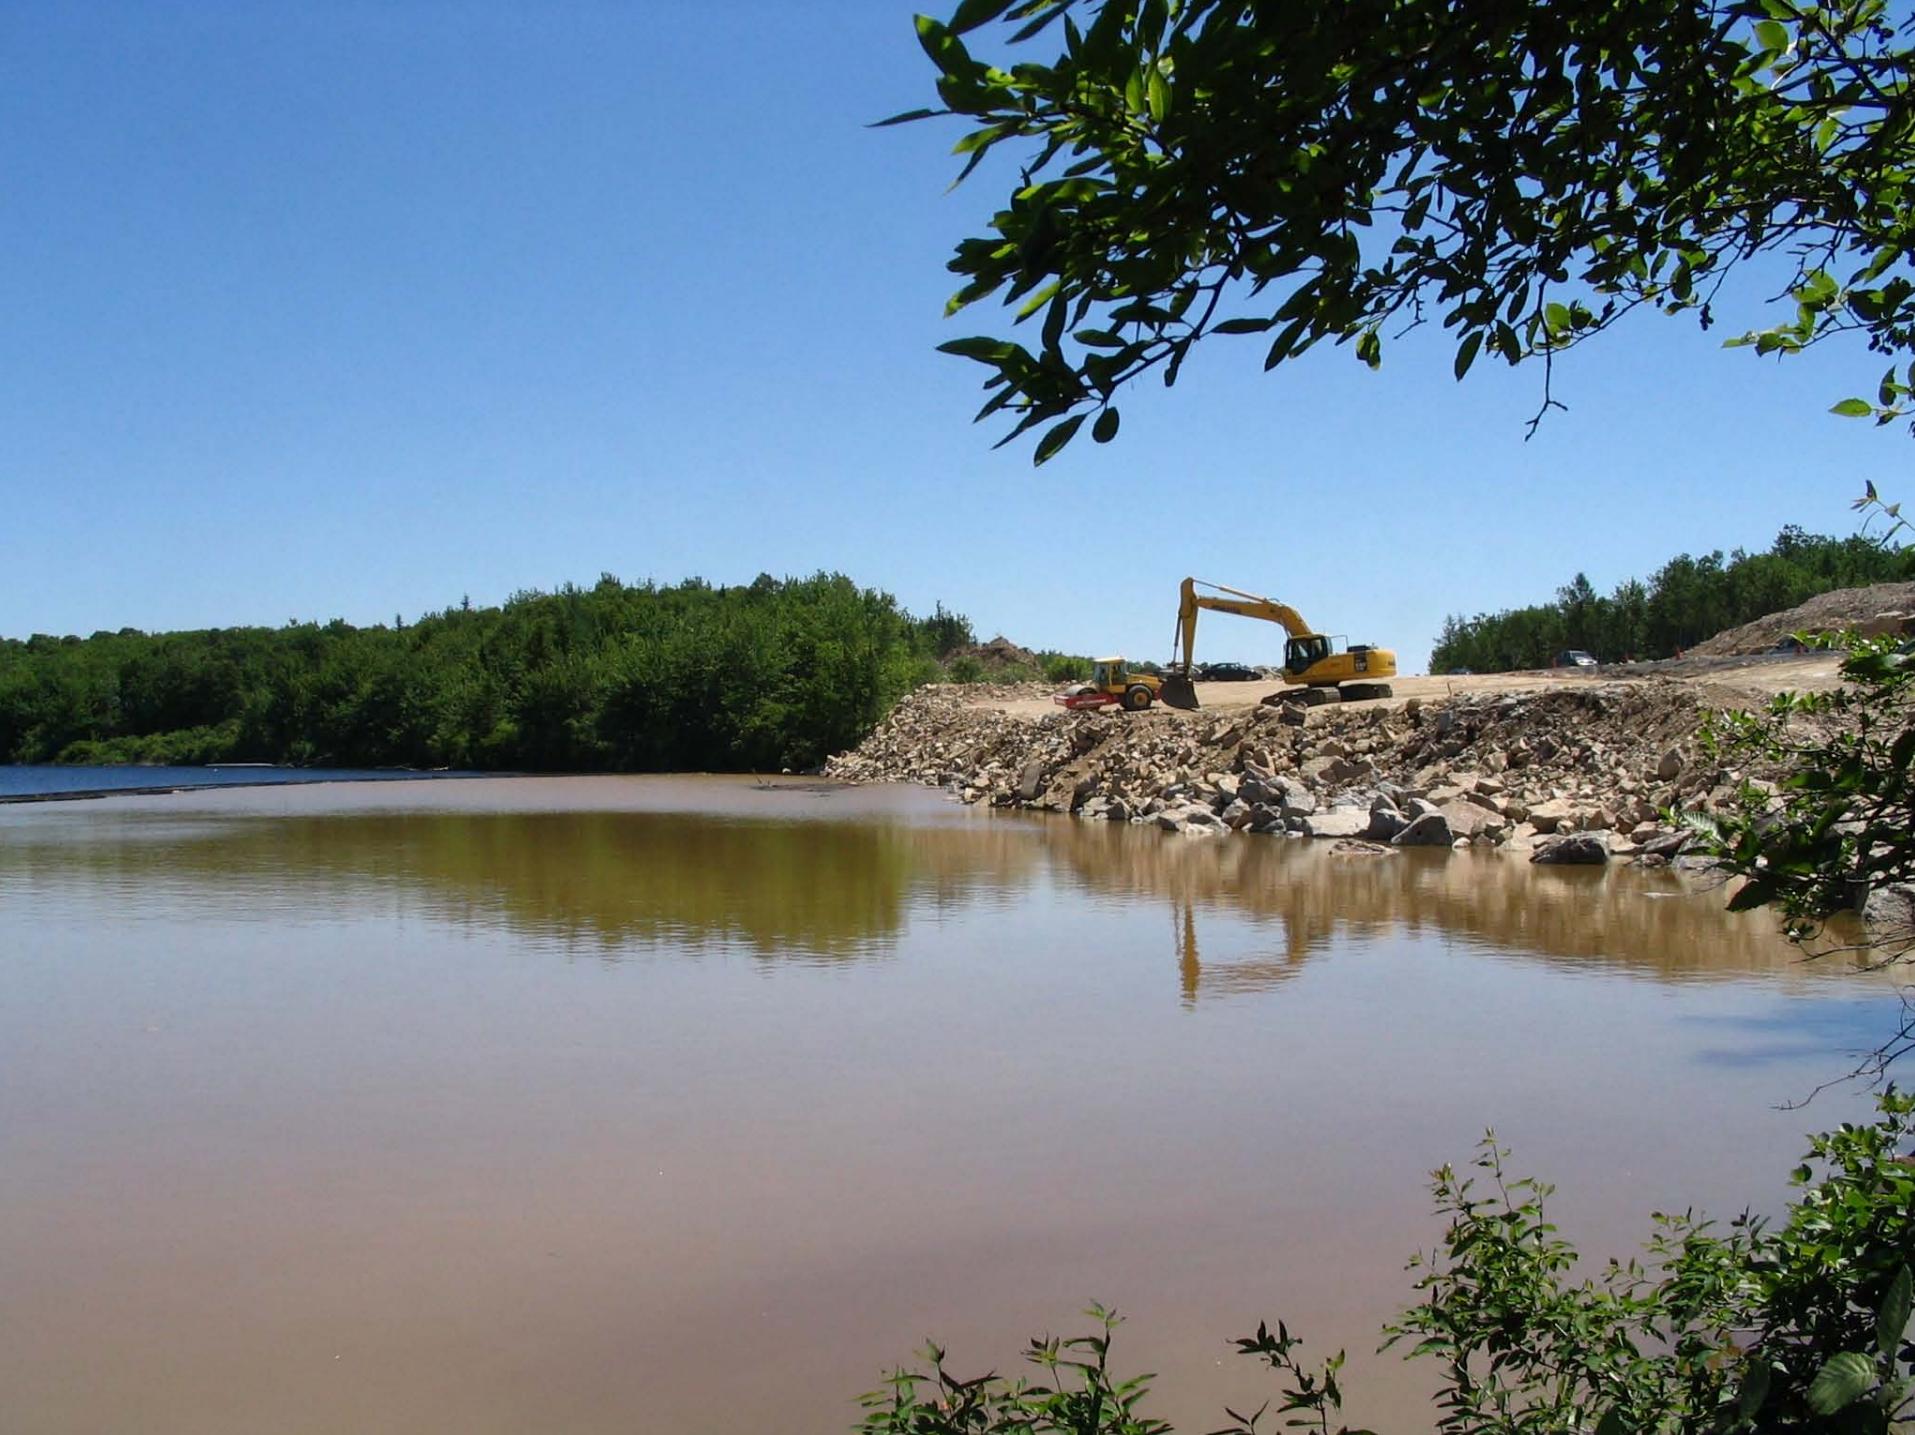
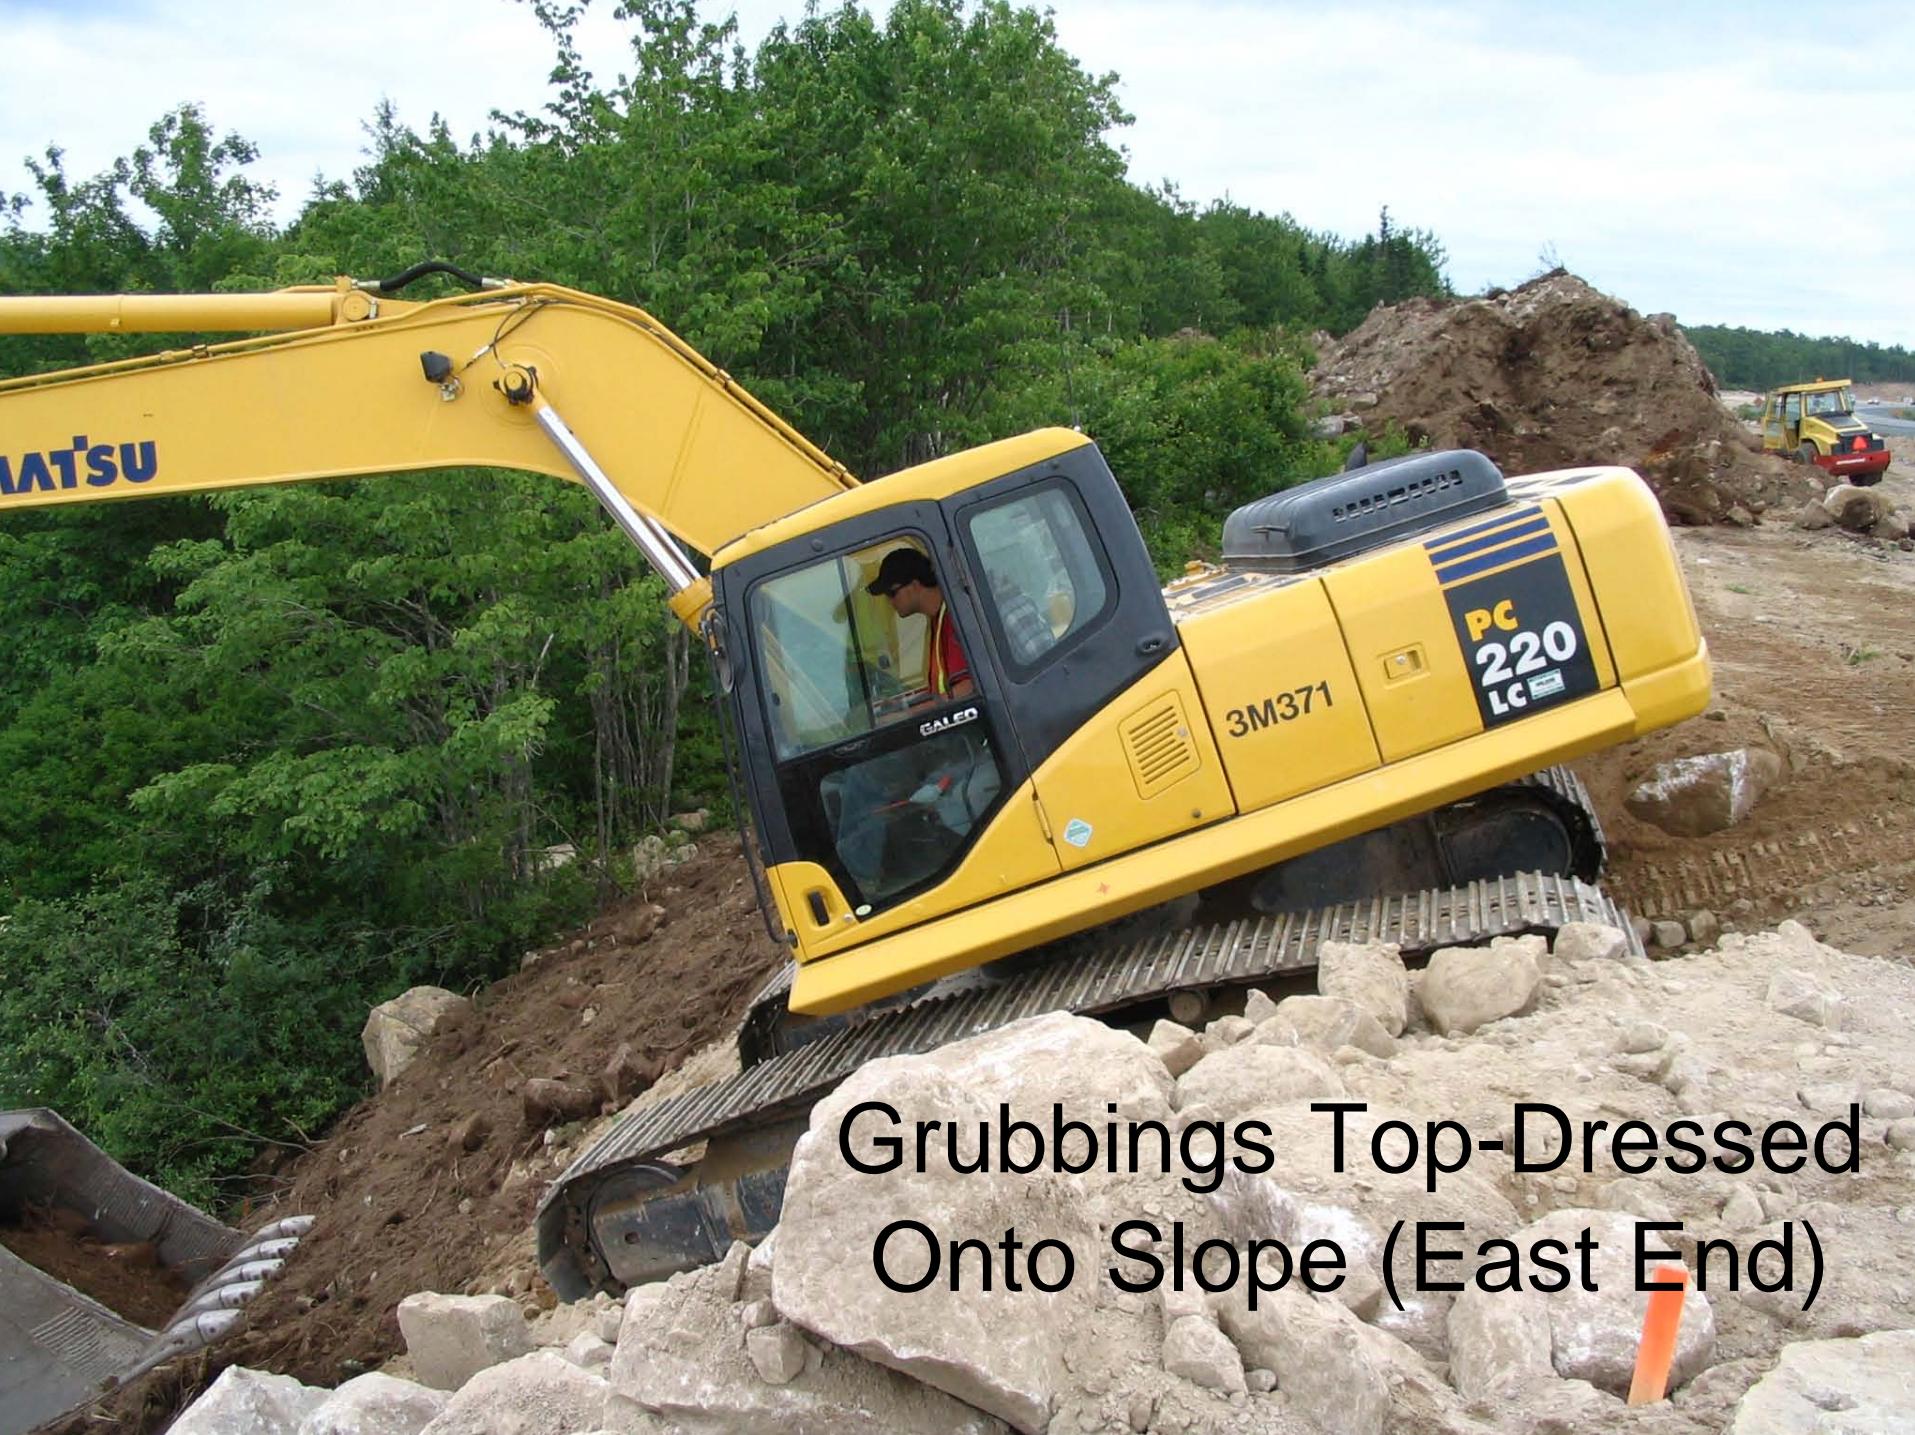
# Mud Wave Beginning to Emerge

After the rock and common fill slope was complete in early July, grubbing material was top-dressed over the slope to a thickness of about 30 cm. After placement of the grubblings, clumps of native vegetation and attached soil were transplanted into the grubblings and firmed-in using the excavator bucket. Clumps were initially placed several metres apart, but they were transplanted at denser numbers as the construction moved westward (see photos in the accompanying *Power-Point®* As-Built file). During the in-filling, a ‘mud wave’ appeared between the new slope and the twin turbidity curtains. Riparian species were transplanted into the mud wave by slinging them over by hand and by hand-planting from a small a boat.

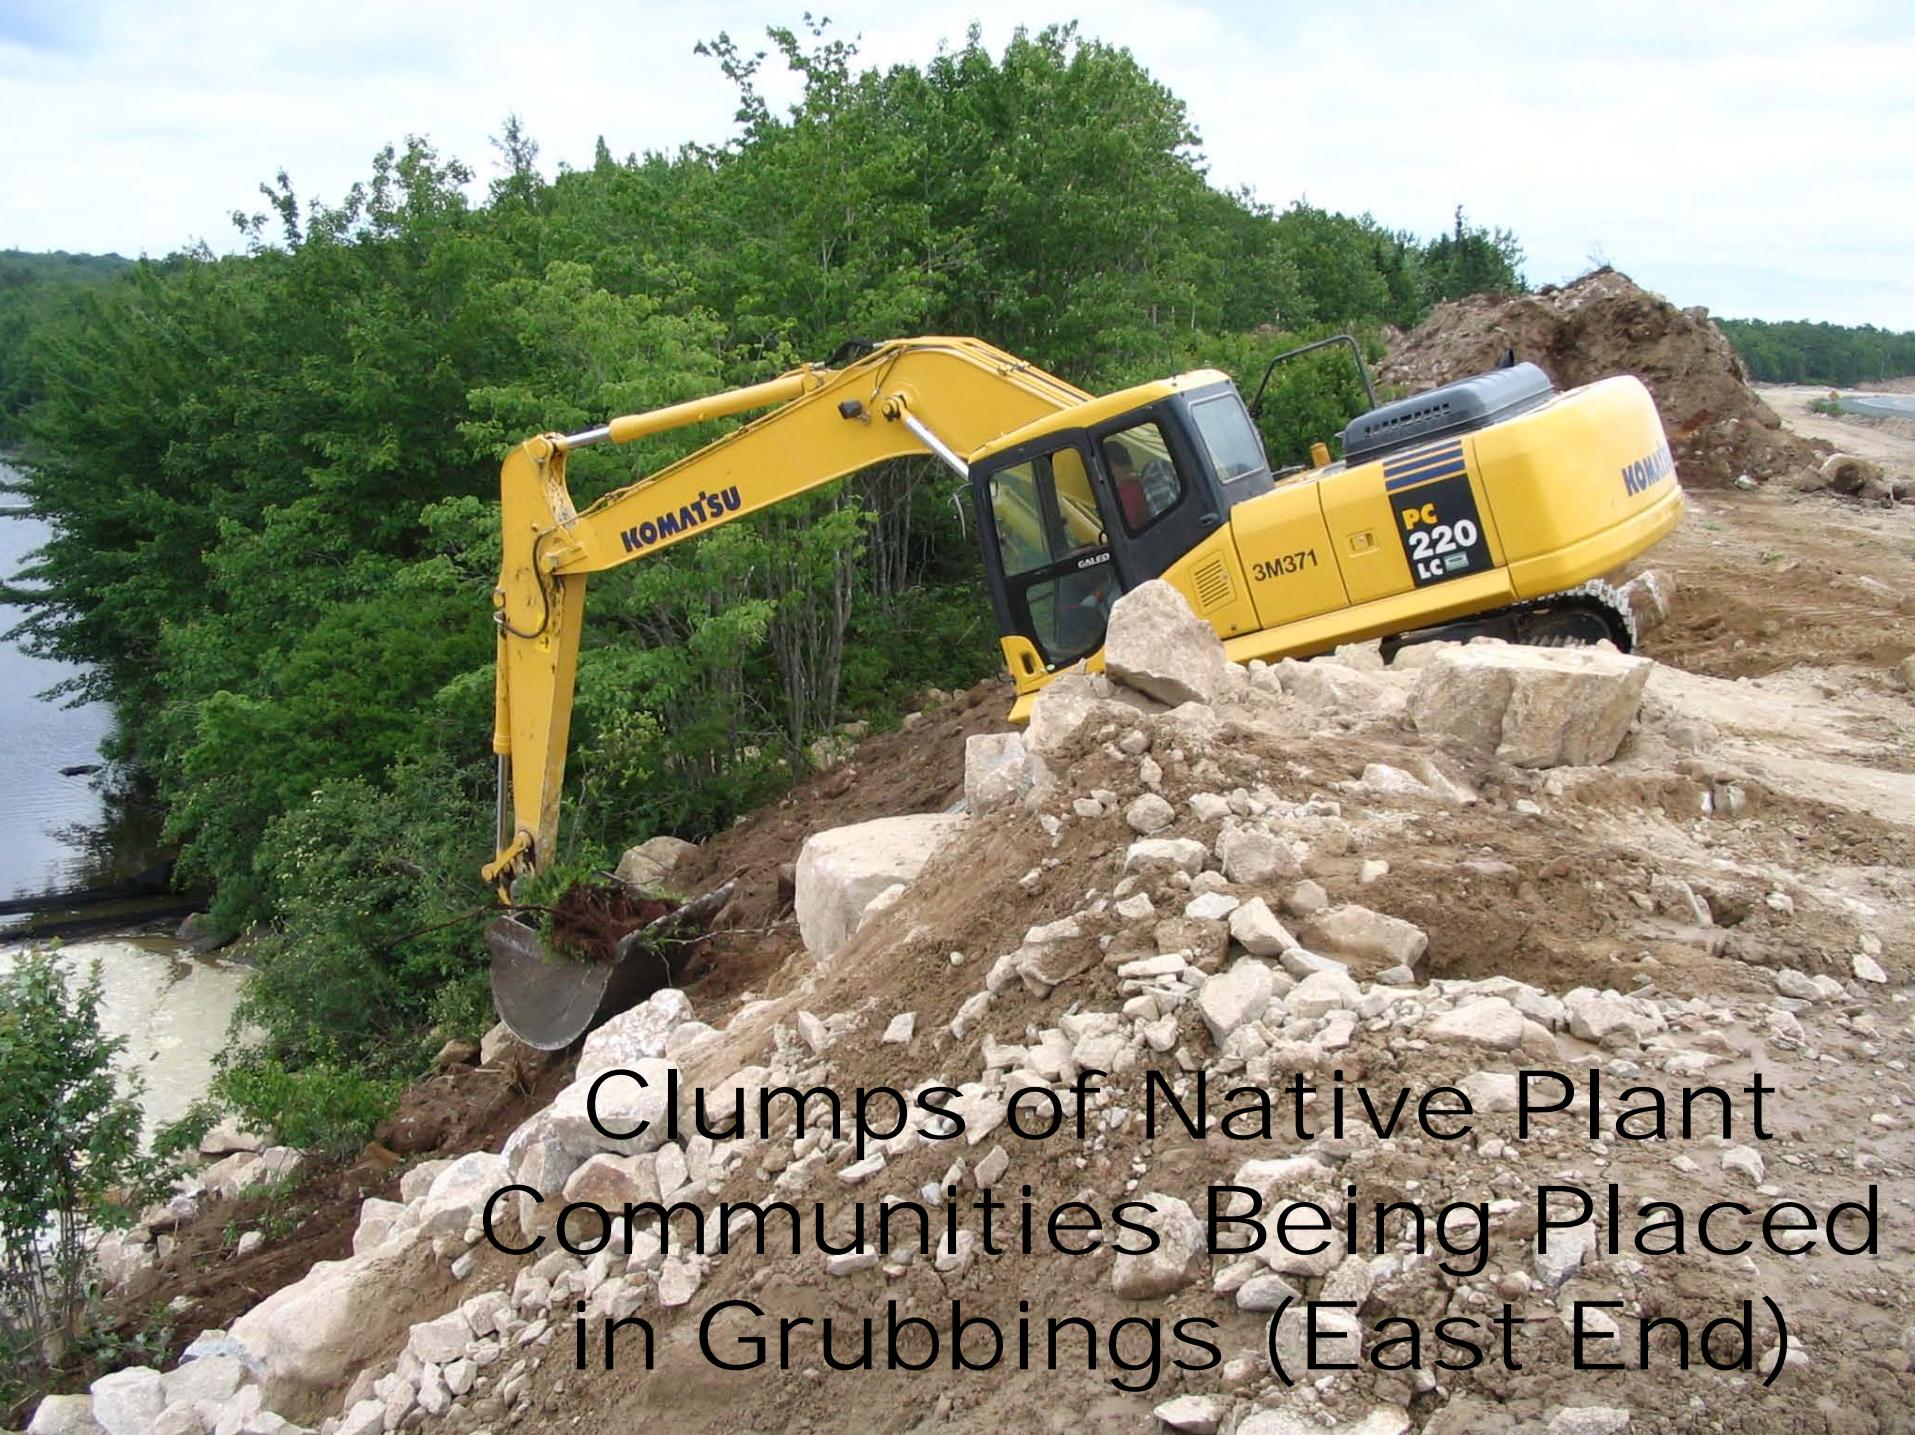
Grubbings Top-Dressed  
Onto Slope (East End)
