# **As-Built Report for the Flat Lake, Highway 103, HADD Compensation Project: Shoreline and Slope Vegetation in 2005**

Diane LaRue, Vegetation Consultant  
Environmental Services, TPW  
December 2005

Flat Lake is part of the East River Watershed, a drainage basin located in the northeastern portion of St. Margarets Bay in the Halifax Regional Municipality (HRM). The twinning of Highway 103 required a partial in-filling of Flat Lake to accommodate new lanes and the westbound off-ramp at Exit 5. In order to protect lake water quality and restore habitat, native and indigenous (to the area) topsoils, woody material and herbaceous plants were used to vegetate the newly constructed slope. Photographs are provided in two accompanying *PowerPoint®* files (see also the large-format overview drawing provided with this report).

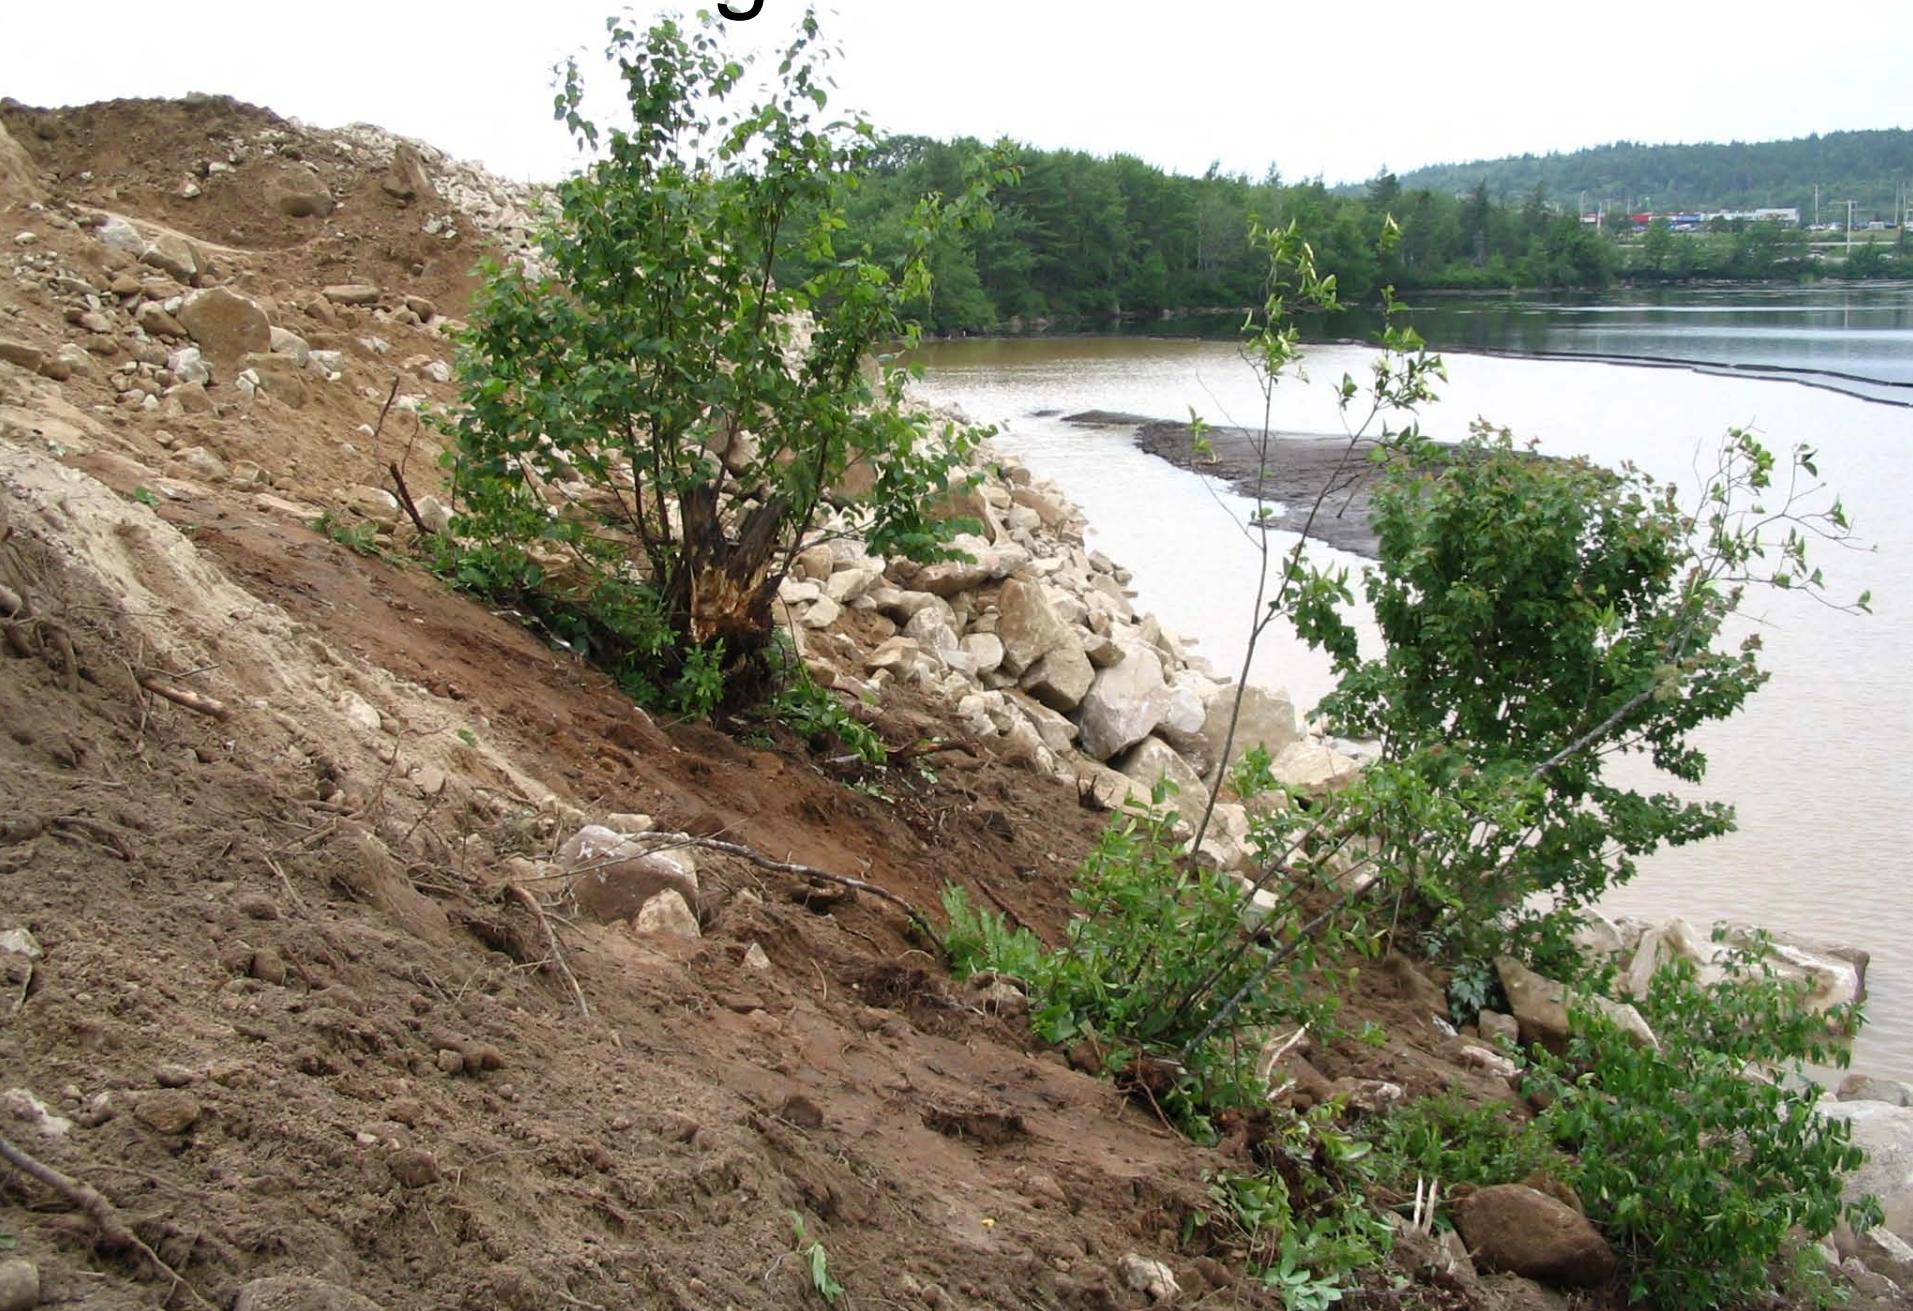
Clumps of Native Plant  
Communities Being Placed  
in Grubbings (East End)

An attempt was made to transplant the clumps to the appropriate area on the new slope to meet roadside as well as ecological vegetation goals. Species that prefer moister soil and/or taller growing species (*e.g.* Red Maple, Willows, and Alders) were placed, whenever possible, towards the bottom of the slope (however, at the end of the process, clumps of tall-growing species were placed at all levels of the slope). Lower growing species, or those that inhabit dryer soil and would spread rapidly to stabilize the slope, were also preferentially place towards the top (*e.g.* Wild Rose, Sweetfern, Bush Honeysuckle, and Blueberry).

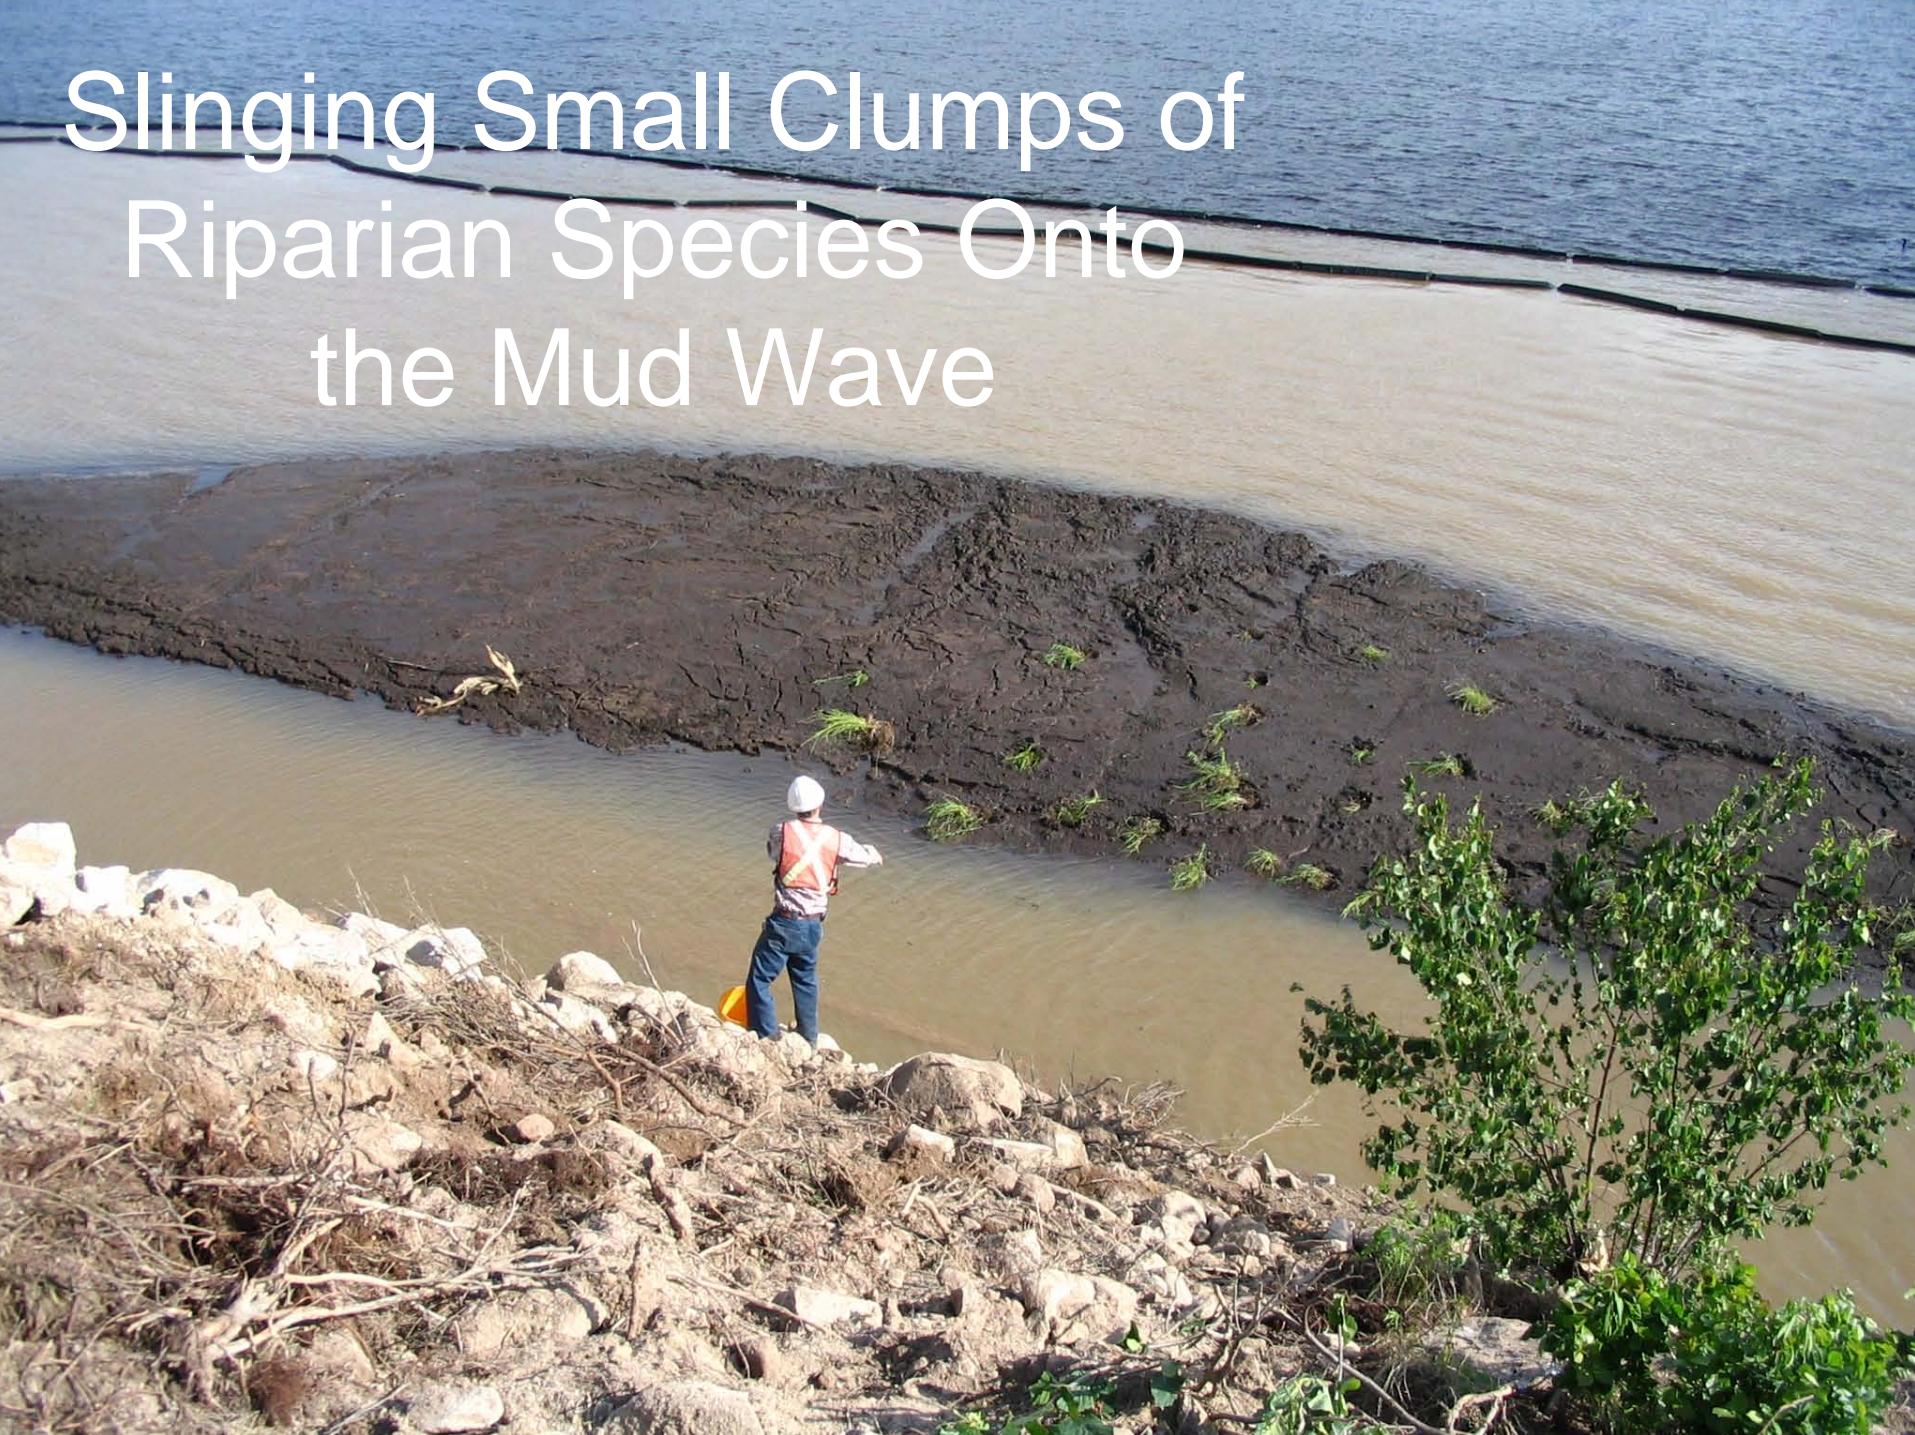
# Clumps of Riparian Species Brought By Excavator to Top-of-Slope; Ready for Division and Placement on the Slope, Edge of Sill, and the Mud Wave

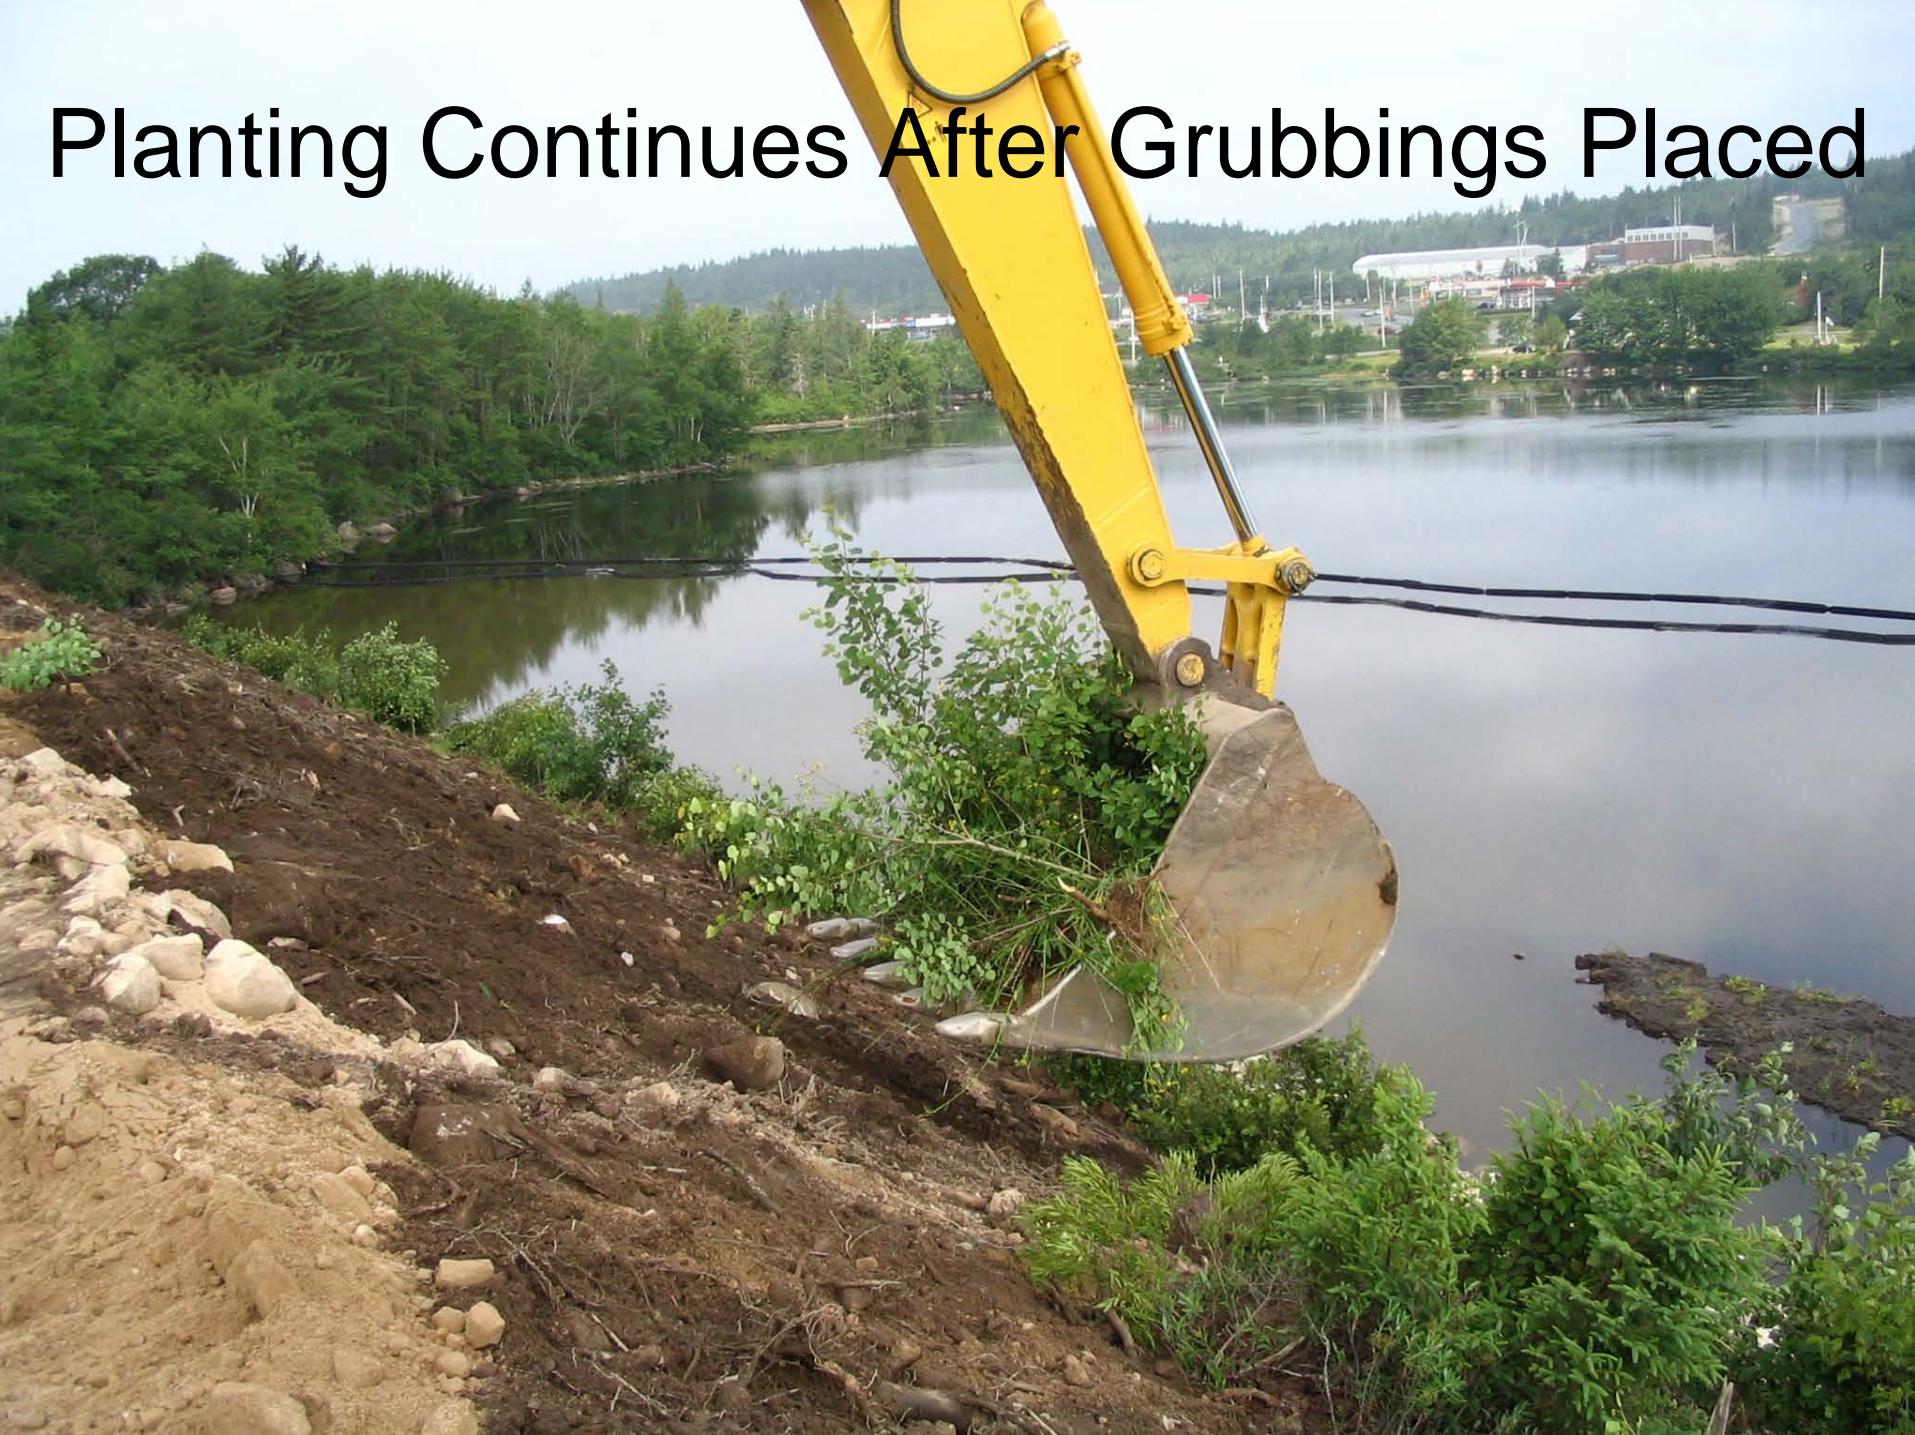
# Planting Continues After Grubbings Placed

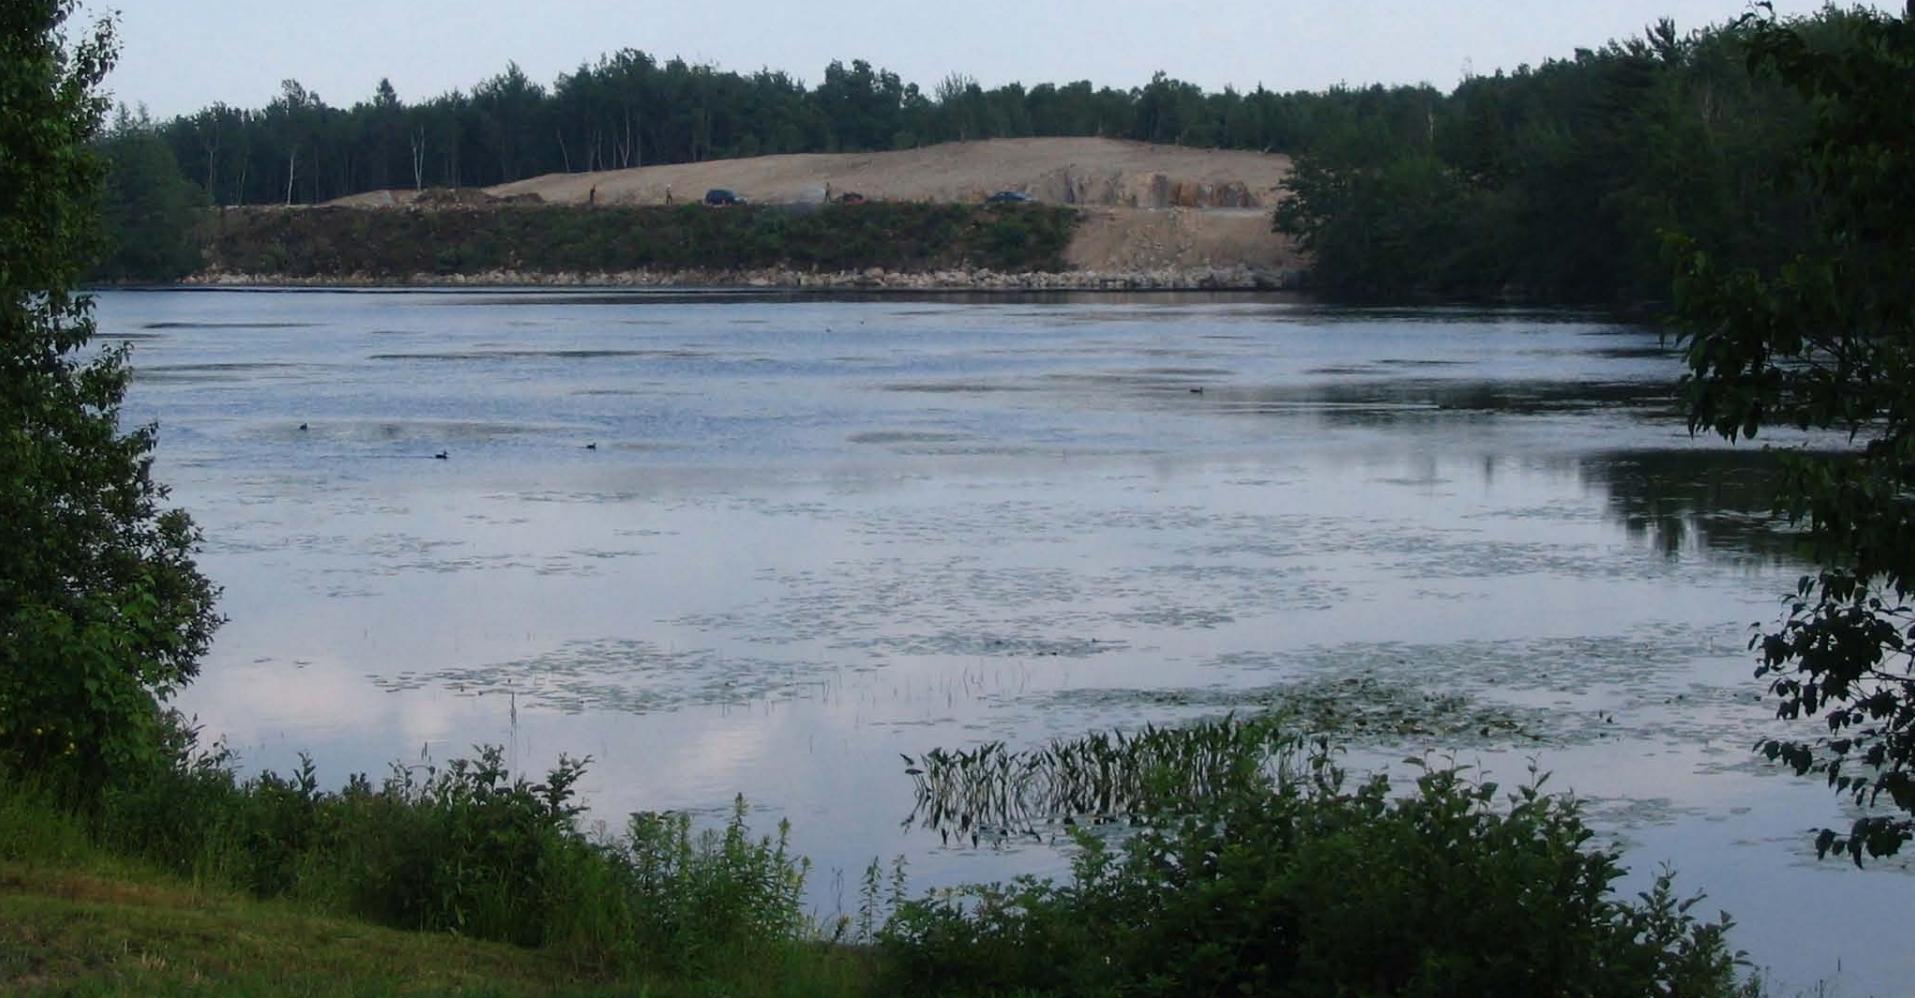
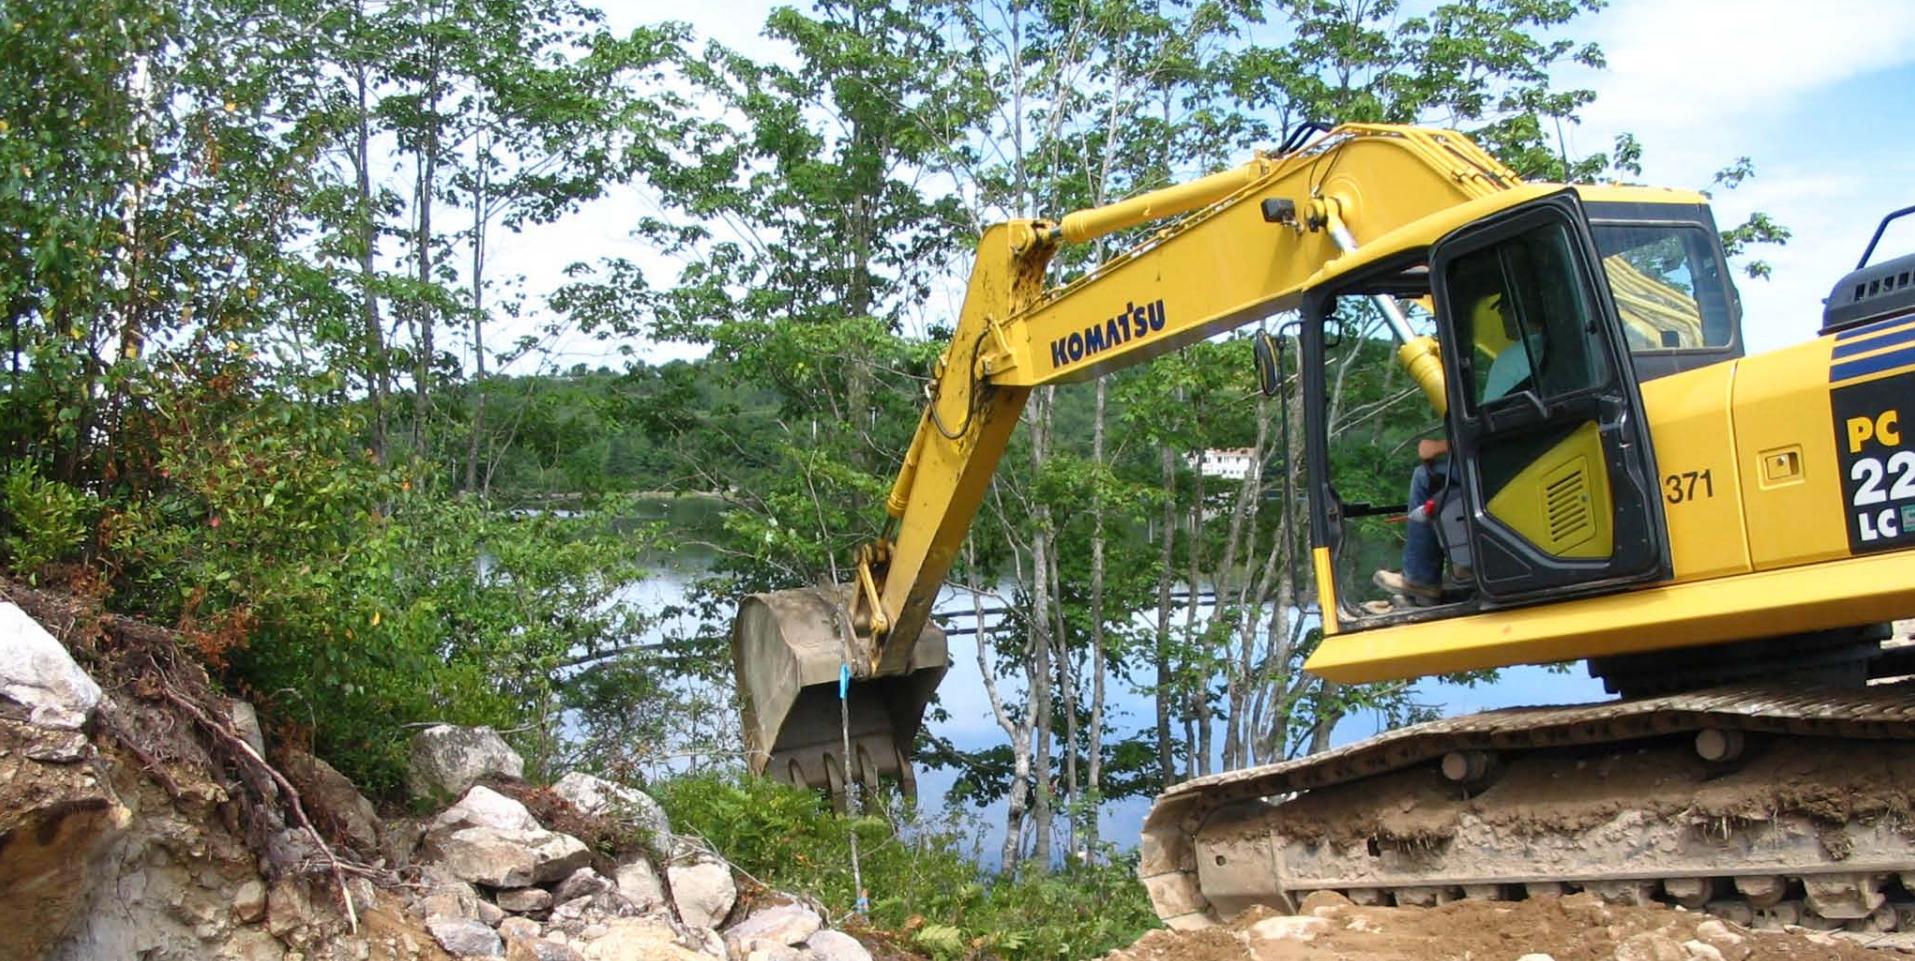
Slope From North Side of Lake:  
Most of Slope Has Grubbings and  
Vegetation Clumps

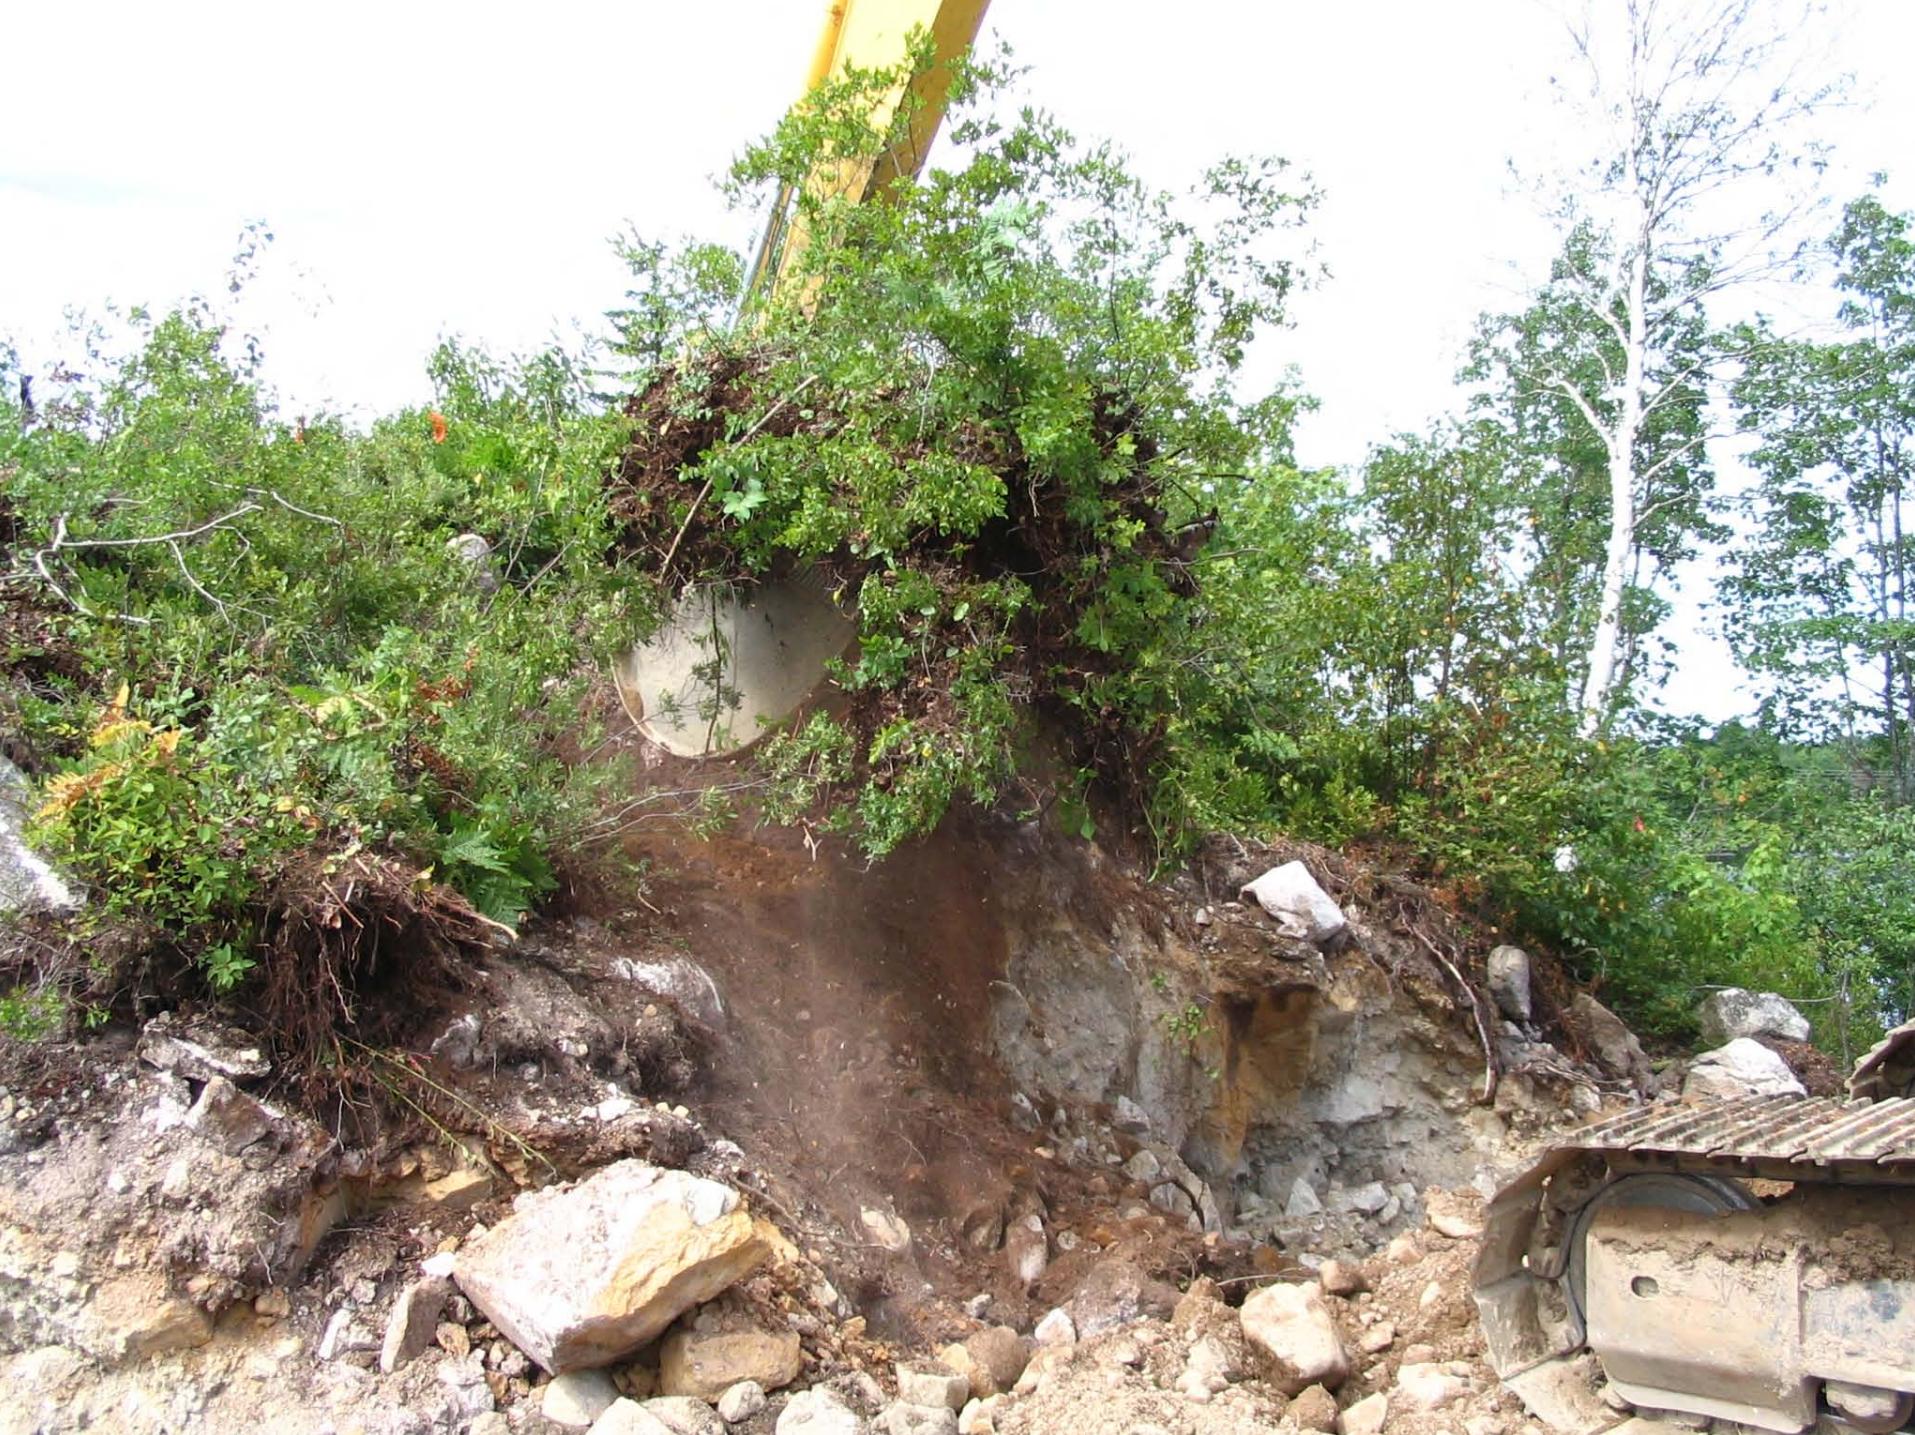
Vegetation Clumps Dug  
From Area to be Filled

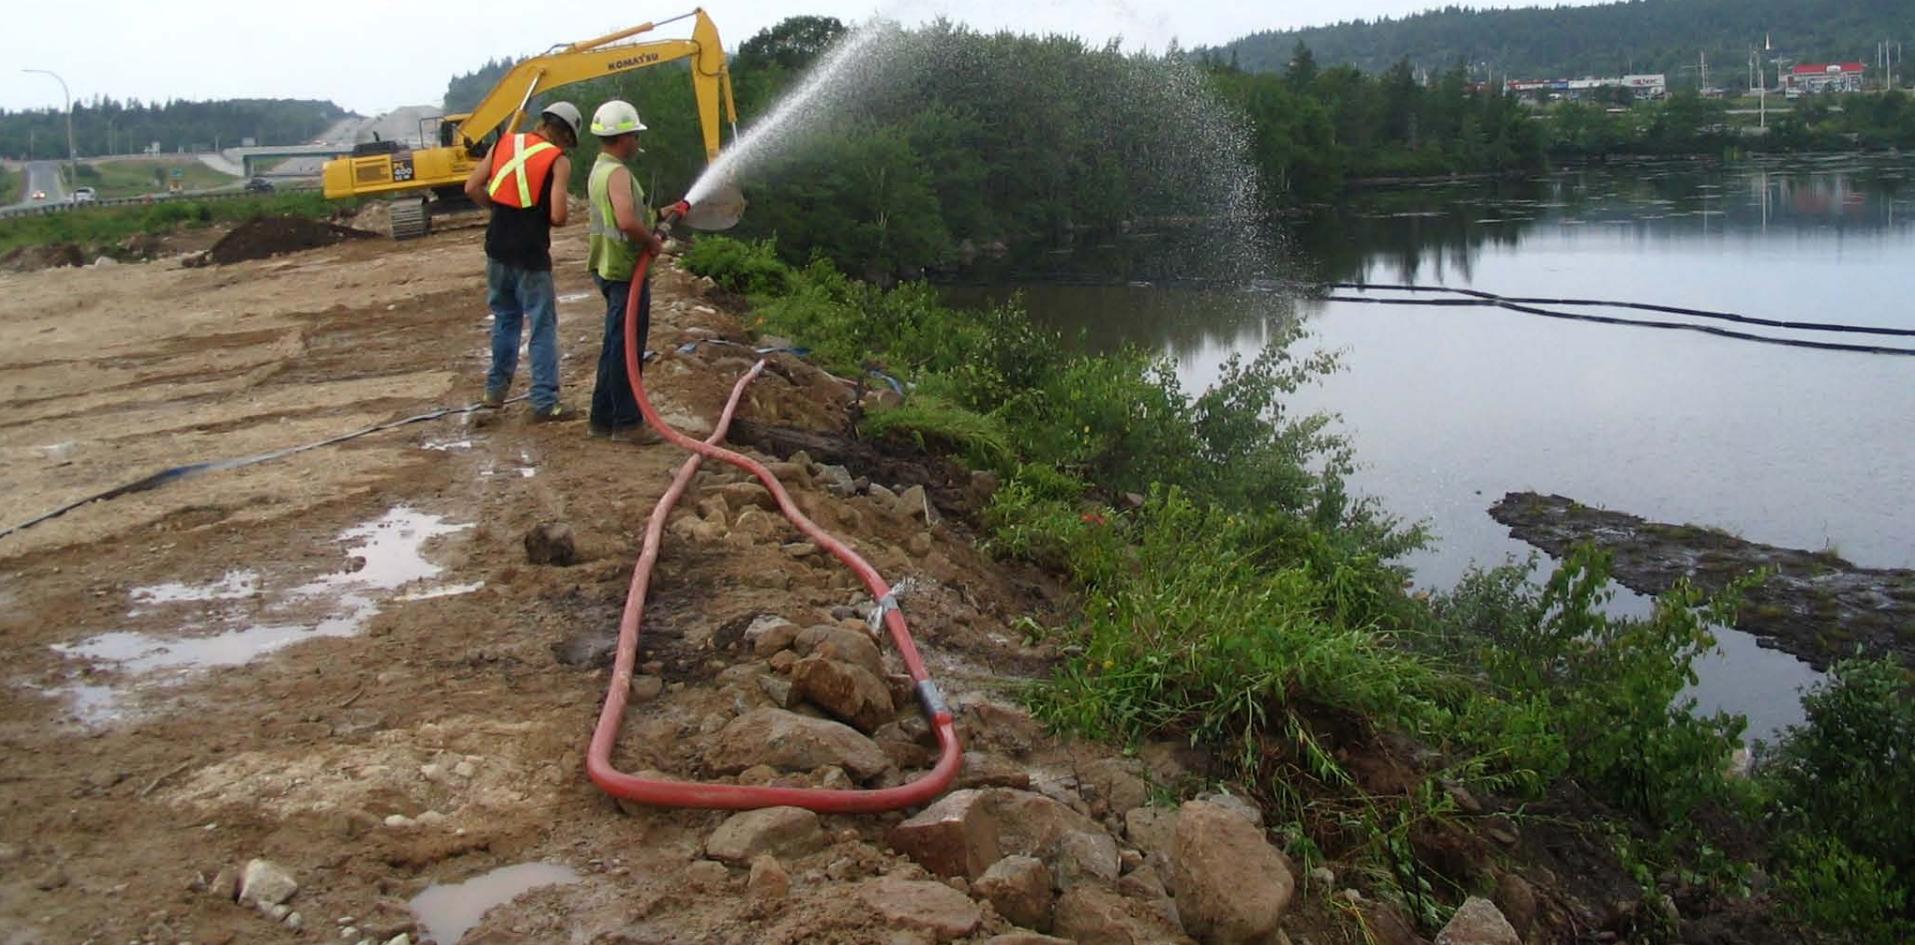
# Watering as Transplanting Completed to Top-of-Slope

Transplanting of clump vegetation took several weeks during July. The slope was periodically watered using pumped lake water both during and after planting. After planting, some *Nova Scotia Highway Seed Mix* was also hand spread on the steeper, eastern end of the slope (1:1 slope). Finally, hay mulch was hand-spread over bare soils on the entire slope. In total, 1,594 m<sup>2</sup> of slope and shoreline were vegetated. As noted earlier, additional shrub plugs will be transplanted within this area next spring.

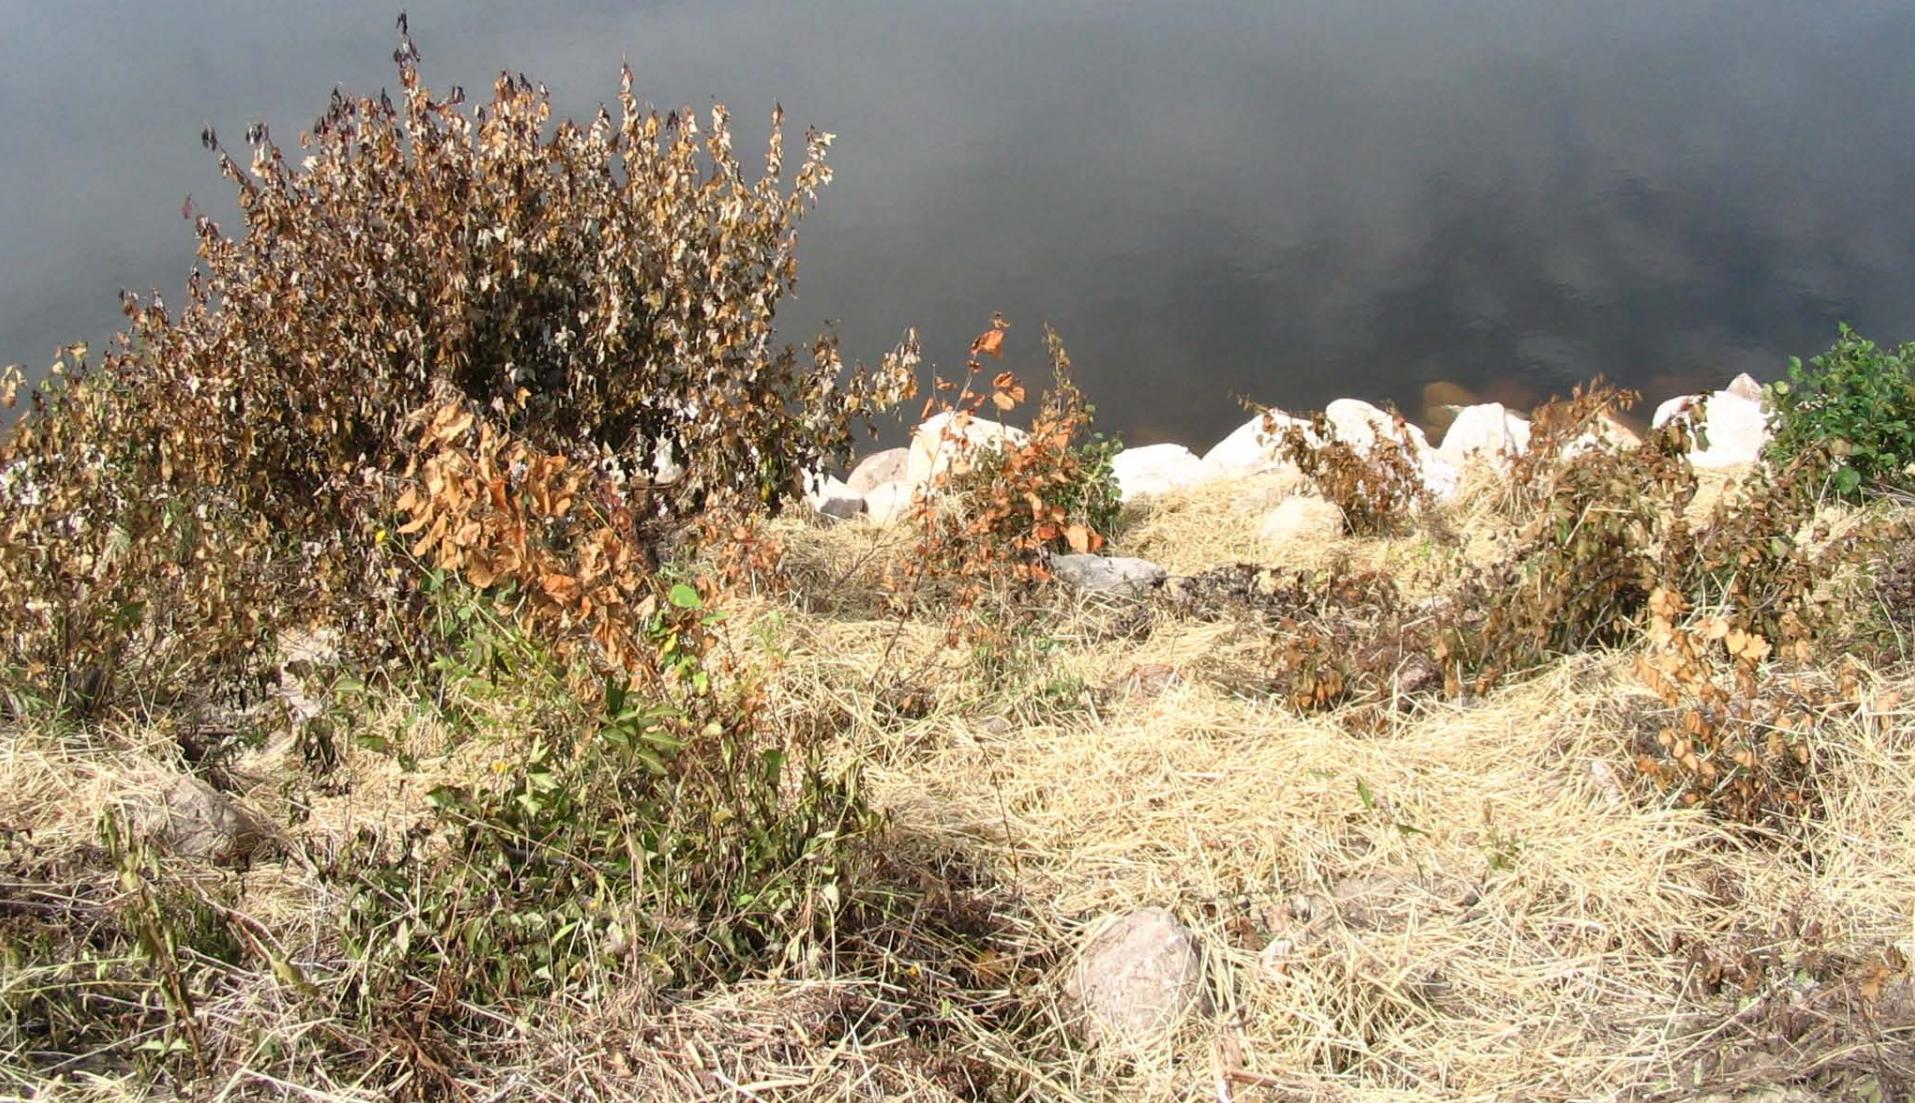
# Slope With Hay Mulch
