A Report for:
Nova Scotia Department of
Transportation and Infrastructure Renewal

Post-Restoration Monitoring (Year 7) of the Cheverie Creek Salt Marsh Restoration Project

Prepared by:
Tony M. Bowron, Nancy C. Neatt, Jennifer M. Graham, Dr. Danika van Proosdij,
Dr. Jeremy Lundholm, and Ben Lemieux

March 2013
Publication No. 33

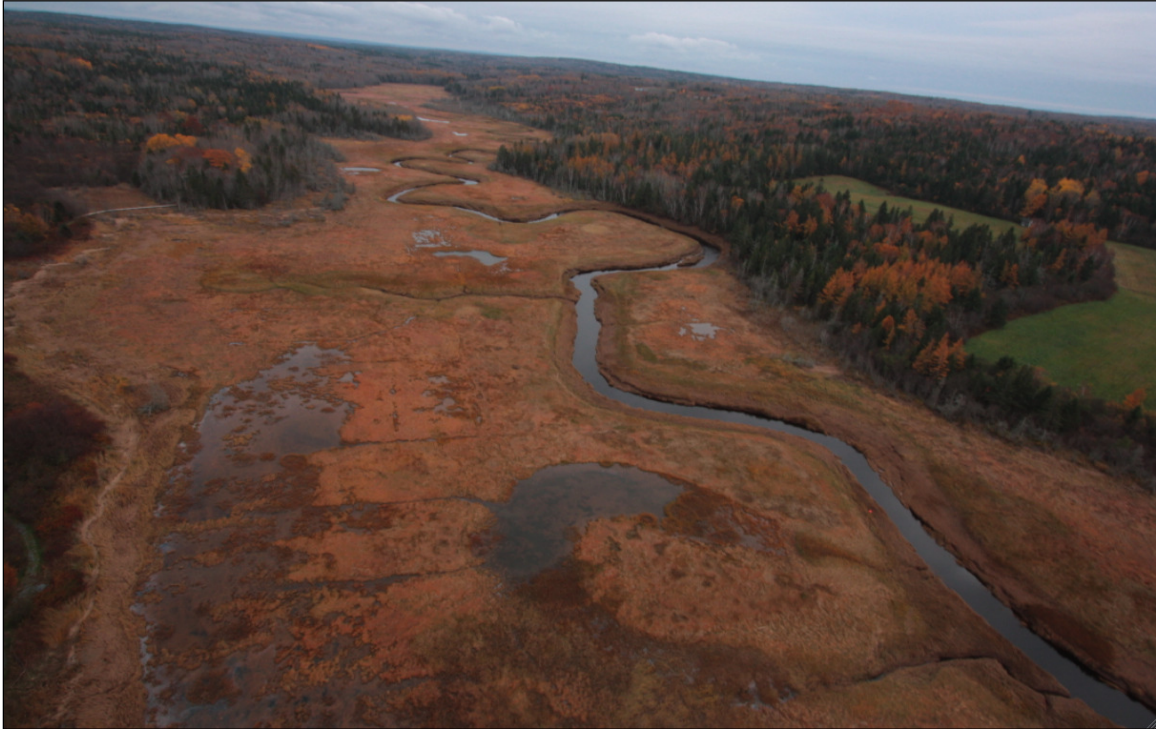
Figure 2 Low-altitude aerial photograph of CHV system as viewed from the front end of the marsh looking upstream. Photograph by CBWES, October 2010.

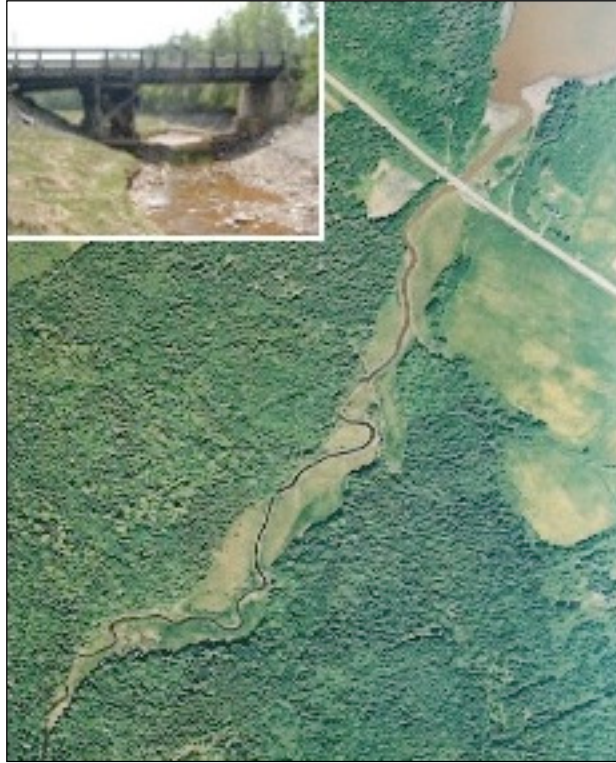
Figure 5 1992 aerial photograph of CHV-R causeway-bridge. (Modified from Department of Natural Resources, 2003). Inserted image is of the CHV-R bridge at low tide. Photograph by T. Bowron, 2001.

CHV-R is an unrestricted tidal river and salt marsh system located in Bramber, approximately 5 km north of CHV along Highway 215 ($45^{\circ} 11' 54.73''$ N $64^{\circ} 07' 57.79''$ W) (Figure 5). Similar to CHV, Highway 215 crosses the river near its mouth. However, unlike the crossing at CHV, the CHV-R crossing is a combination causeway-bridge structure, whereby the bridge section spans the width of the main river channel.

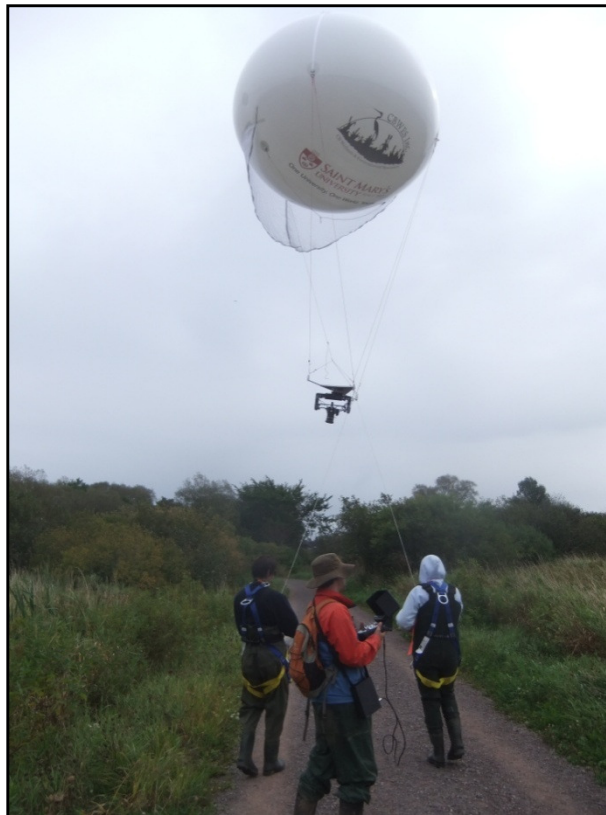
Figure 6 Small format aerial photographic platform using helium filled blimp with a suspended camera system. Photograph taken at Antigonish site by T. Bowron, September 2010.

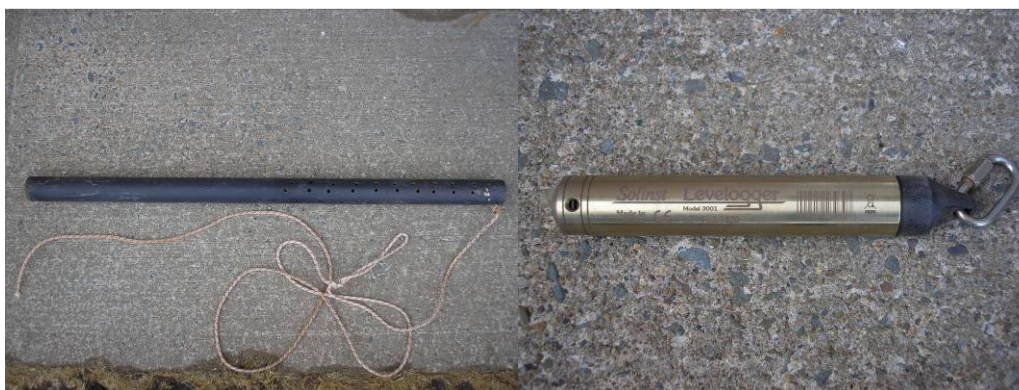
Figure 9 Solinst Model 3001 Levellogger Gold and still well. Photograph by N. Neatt, January 2008.

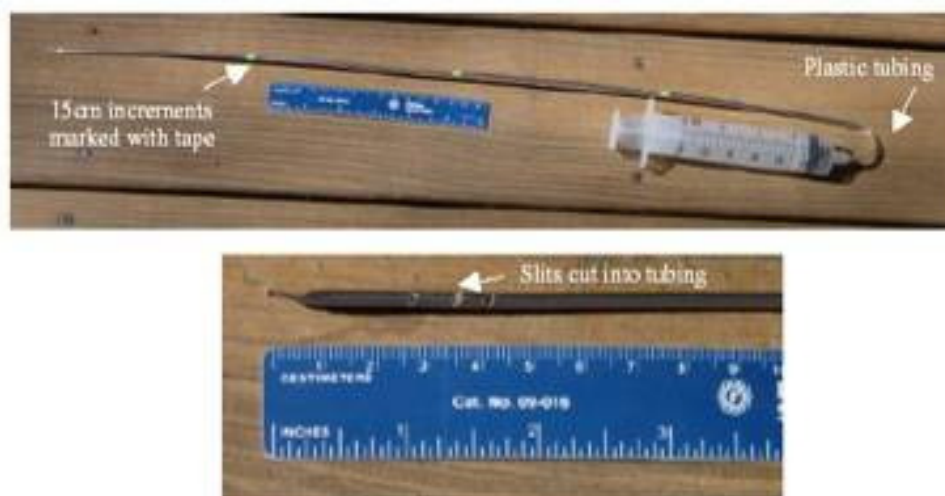
Figure 10 Photograph of a soil probe (sipper) used to take an interstitial pore water samples to test for pore water salinity (Roman et al. 2001).

Sampling locations for interstitial pore water salinity were matched with the depth to groundwater stations at both sites (Figure 7; Figure 8). During the 2003 to 2012 monitoring seasons, shallow (15 cm) and deep (45 cm) pore water samples were taken using a soil probe (sipper; Roman et al. 2001; Figure 10) and a handheld temperature compensated optical refractometer (nearest 2 ppt). For the 2012 monitoring season a FieldScout EC 110 Meter¹¹ was used to collect the in-situ readings. The previous method used refraction techniques to record salinity, while the EC 110 Meter, which uses electrical conductivity, allowed for a more precise reading to be recorded in the field and less prone to user error. Sampling was conducted at low tide on 13 June, 11 July, 7 August and 12 September 2012 at each of the seven (CHV) and six (CHV-R) sample plots.

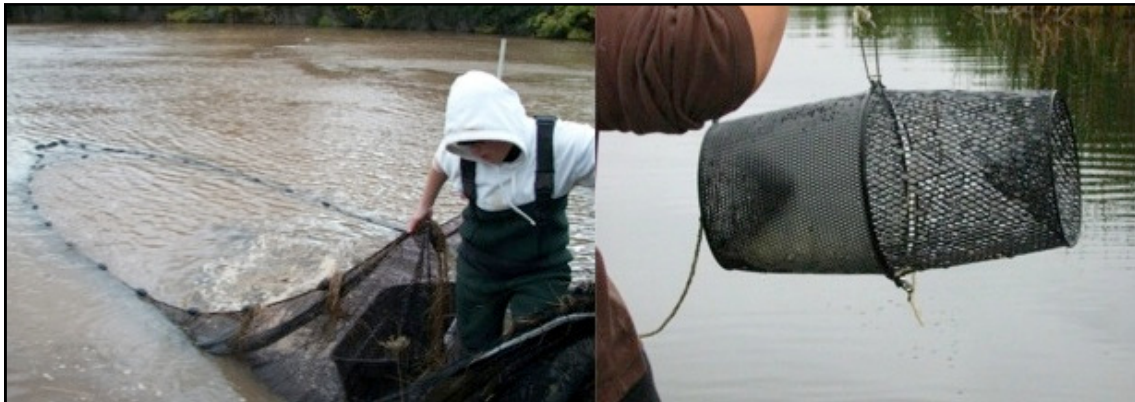
Figure 15 Fish sampling with a beach seine (left) and a minnow trap (right). Photograph by T. Bowron 2006.

Smaller species utilizing the salt pannes and tidal creeks were sampled using the minnow traps baited with bread. Traps were set in pannes intersected by transect one, four and seven and in the secondary tidal creek near transect six on each occasion at CHV (Figure 17). At CHV-R, traps were set within the main river channel at transects one, two and three and within the secondary channel adjacent to transect 4 (Figure 18). Traps were deployed in advance of high tide and retrieved once the tide level had dropped (approximately 3.5 hours).

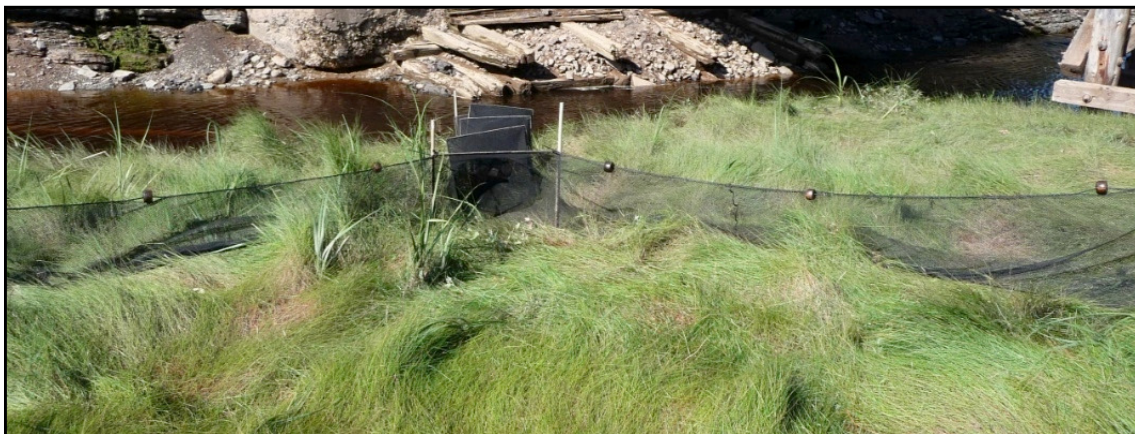
Figure 16 Fish sampling with the fyke net at CHV-R. Photograph by T. Bowron, 2008.

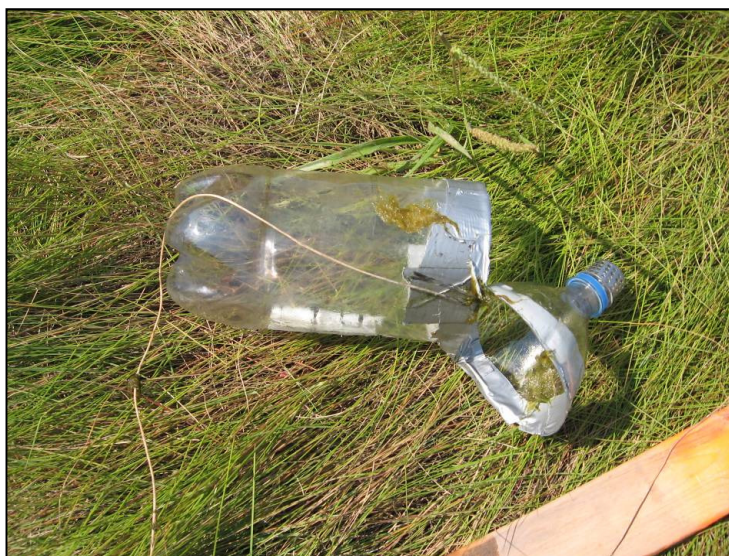
Figure 19 Invertebrate Activity Trap (IAT). Photograph by T. Bowron 2007.

The IAT were constructed from two litre clear plastic (pop) bottles; the top portion was cut off, inverted and taped in place with duct-tape (Figure 19). The top of each bottle was capped with a 3 mm screen in order to reduce the likelihood of capturing fish. The IAT were placed in four pannes (two at CHV and two at CHV-R), submerged and anchored to ensure the trap remained within the panne. Upon retrieval, samples were sieved (0.5 mm) and remaining materials and organisms were field preserved in 70% isopropyl alcohol. EnviroSphere Consultants Limited then performed the species identification according the approach described for the RCA sample.

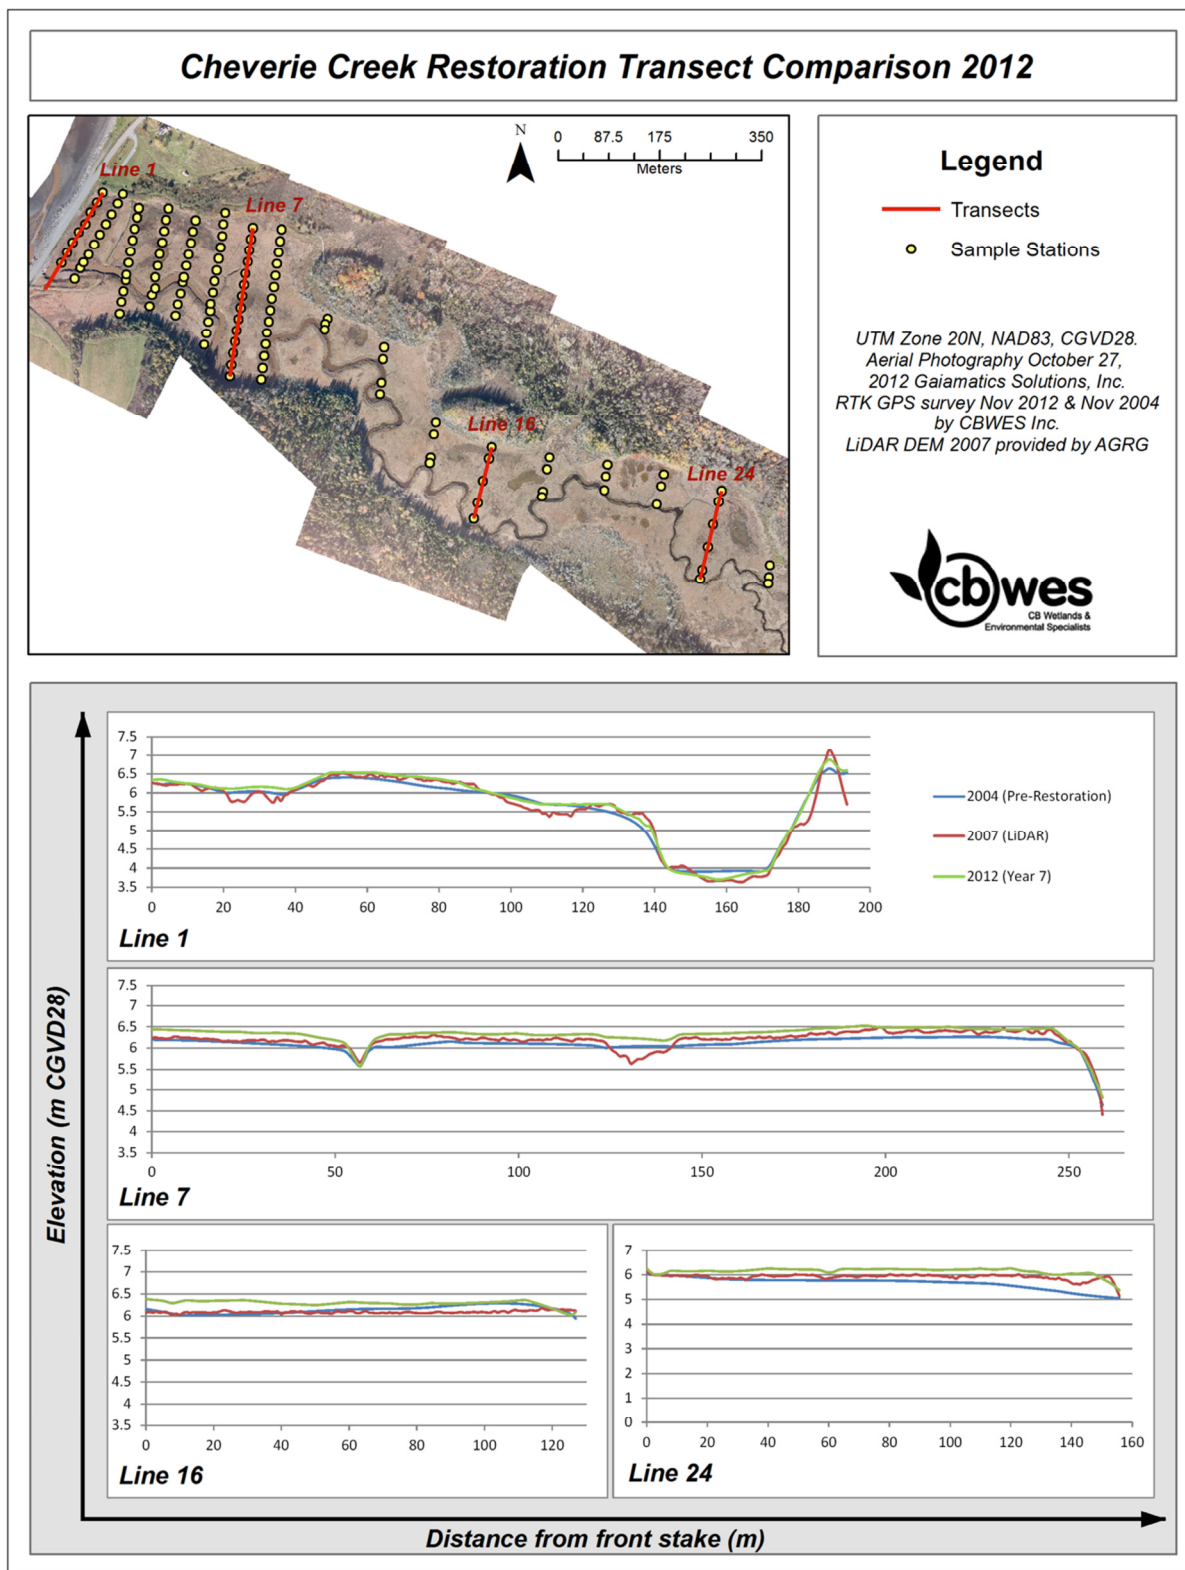
Figure 22 Change in marsh surface elevation at CHV pre- versus post-restoration, utilizing representative transects.

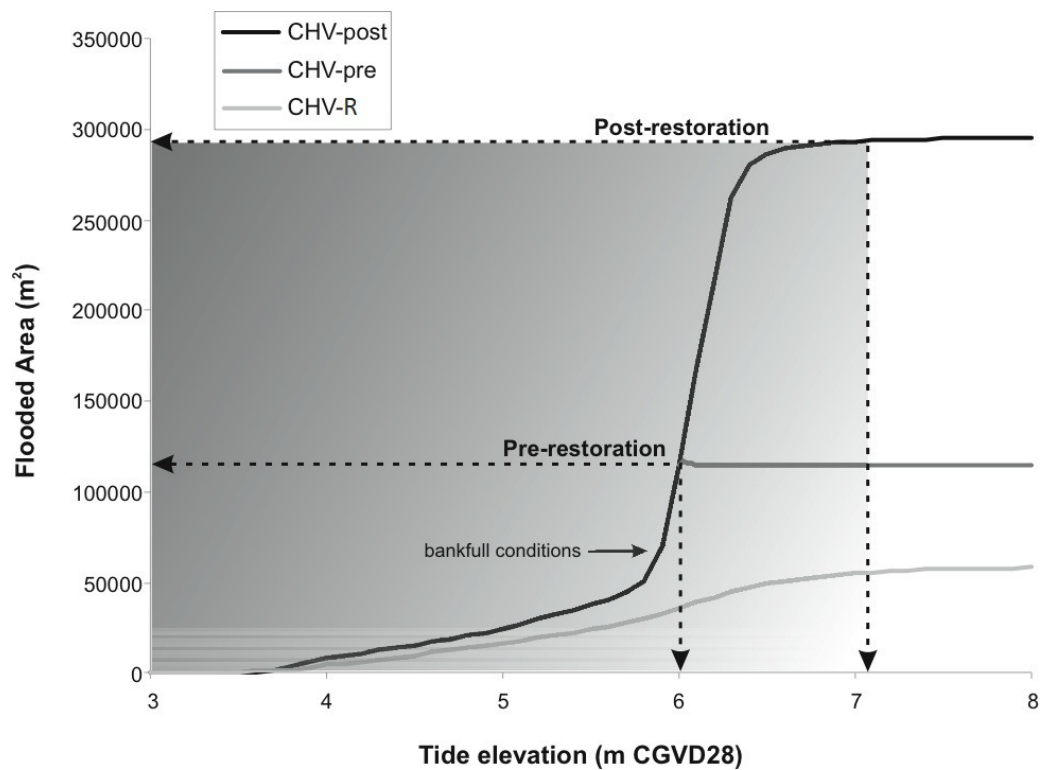
Figure 32 Hypsometric curve for CHV and CHV-R.

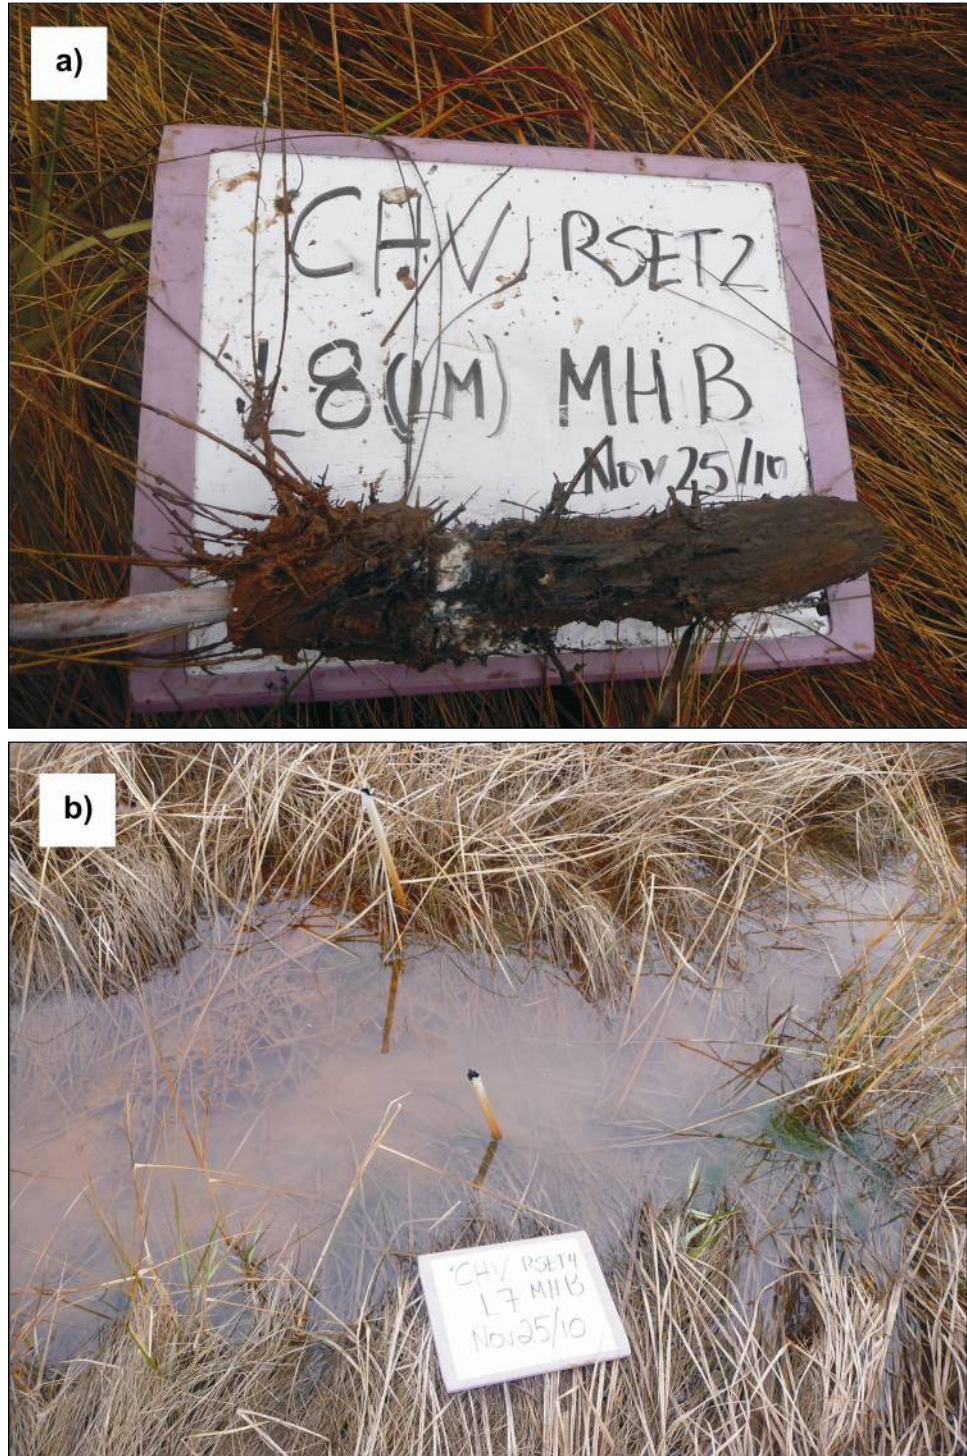
Figure 43 Marker horizon B at a) RSET-02 transect 8 in the low marsh on November 25, 2010 showing 5.48 cm of sediment accretion since 2006 and b) RSET-04 in water on November 25, 2010.

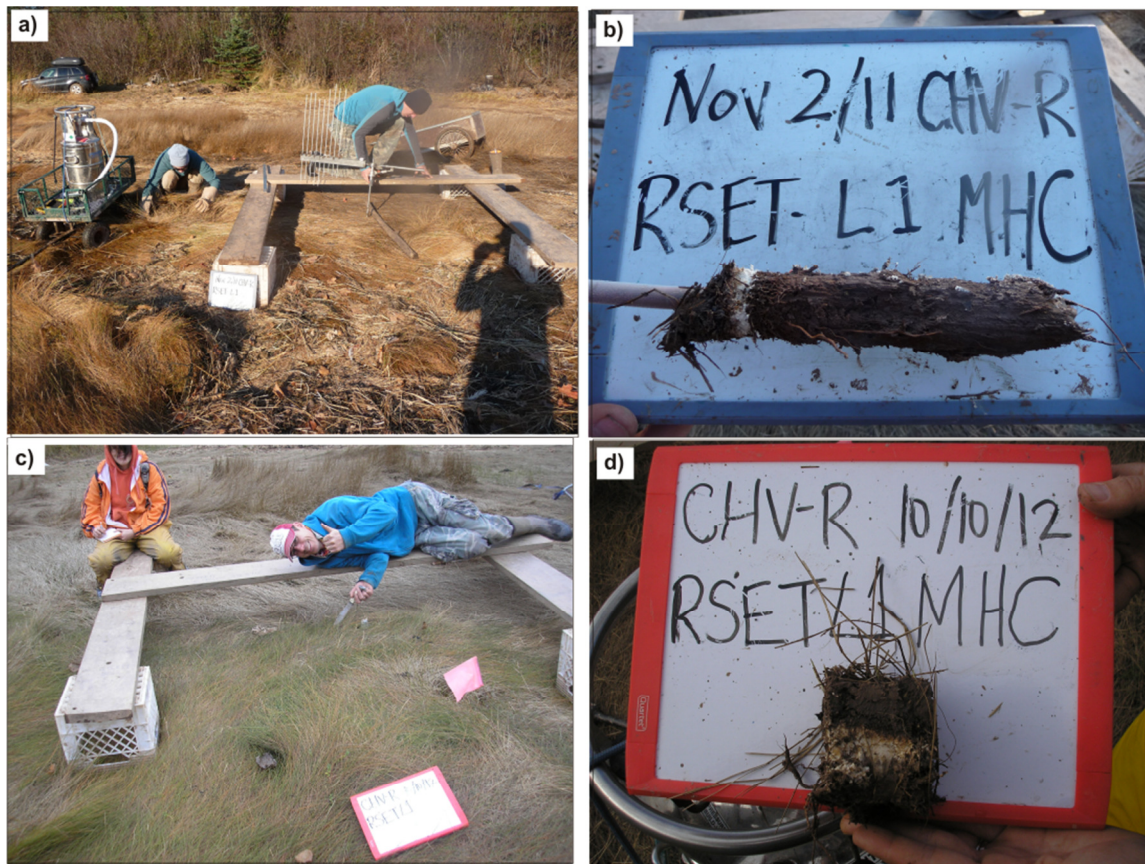
Figure 44 RSET-01 (LM) and associated marker horizon at CHV-R on a) Nov 2, 2011 and c) Oct 10, 2012. Note wrack material and debris in 2011.

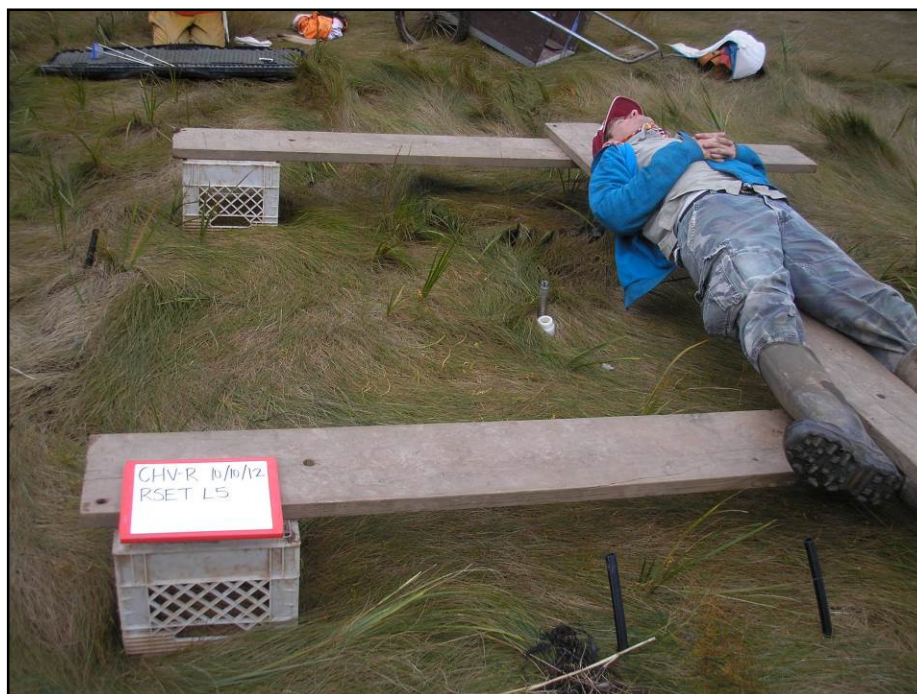
Figure 45 RSET-03 at CHV-R transect 5 in the mid marsh on 10 October 2012.

lowest at RSET-03 (1.55 cm) (Table 9; Figure 44). Both RSET-02 and 03 recorded decreases in elevation associated with subsurface processes, however, did maintain positive rates of change in surface elevation (Table 10).

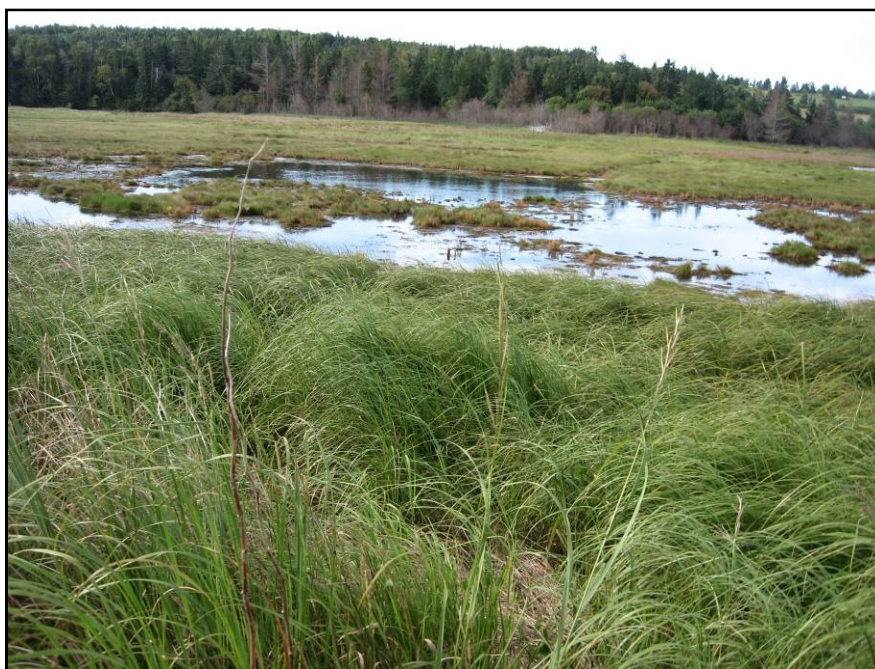
Figure 46 Enlargement of existing pannes at the upland edge of transects 3-5 after replacement of culvert in Dec 2005. Photograph taken on 14 August 2007.

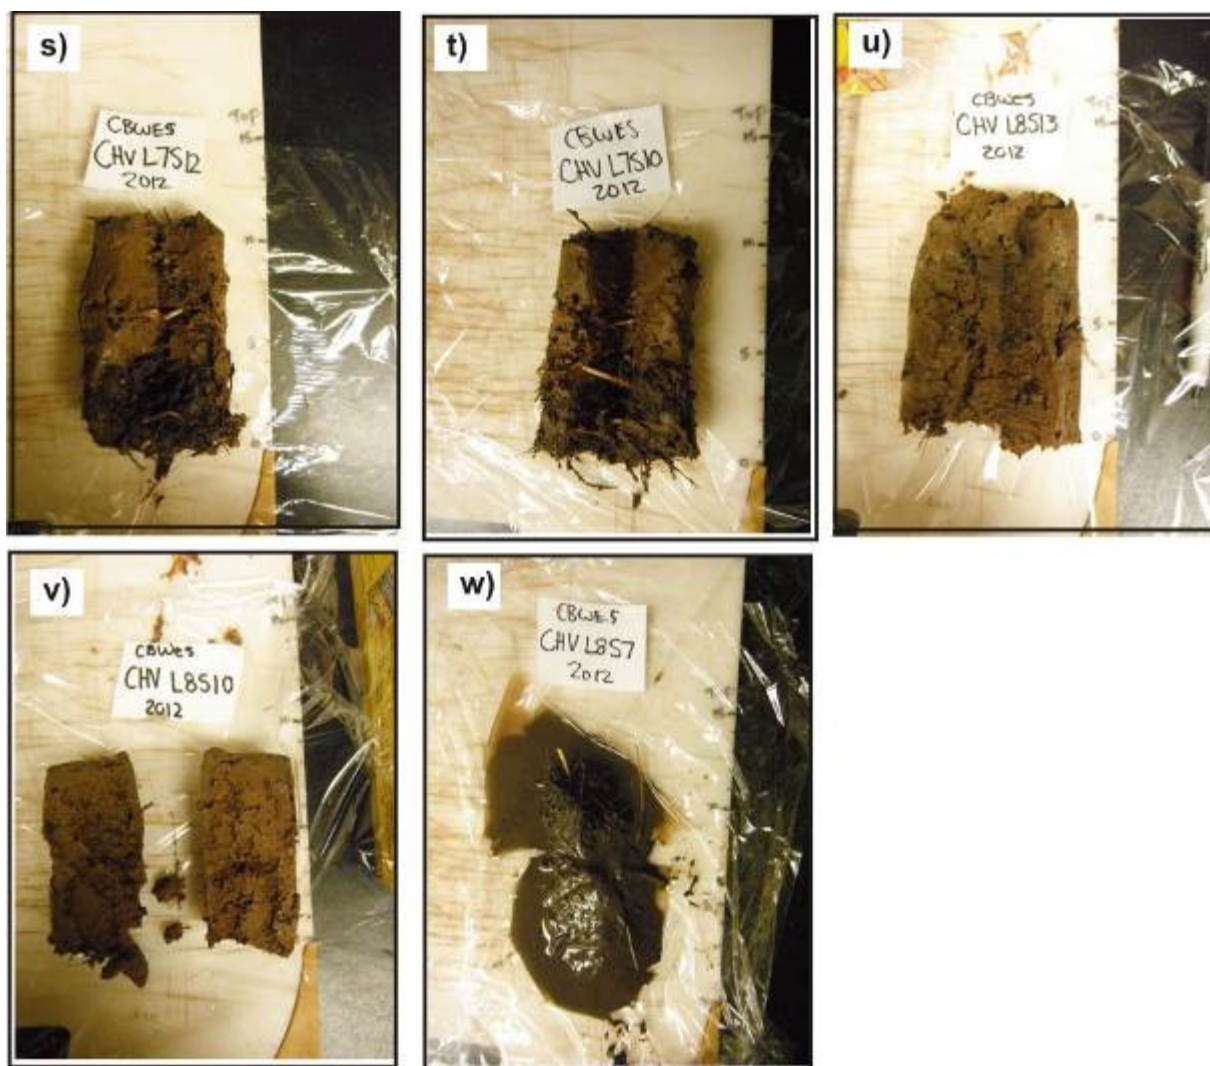
Figure 49 Split core sections for samples collected at CHV in fall 2012 at s) L7S3; t) L7S5; u) L8S2; v) L8S5; and w) L8S8 (note - ignore photo labels).

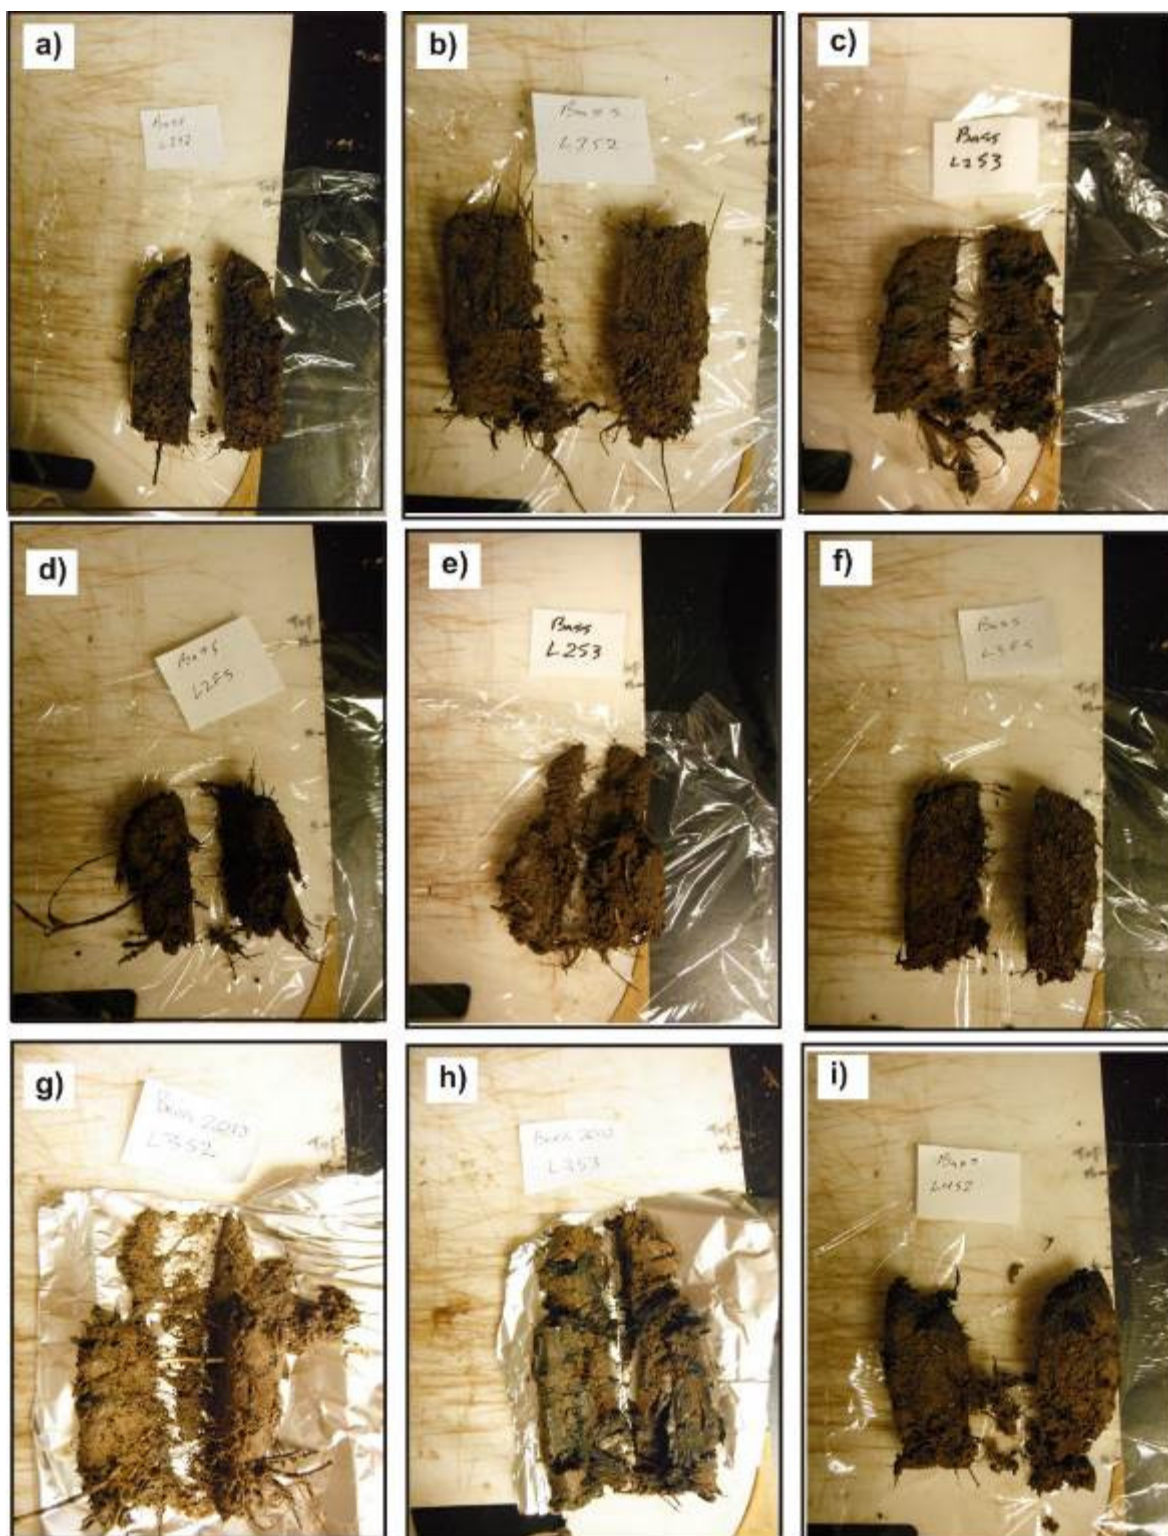
Figure 50 Split core sections for samples collected at CHV-R in fall 2012 at a) L1S1 or L1FS; b) L1S2; c) L1S3; d) L2S1 or L2FS; e) L2S3; f) L3FS; g) L3S2; h) L3S3 and i) L4S1 or L4FS.

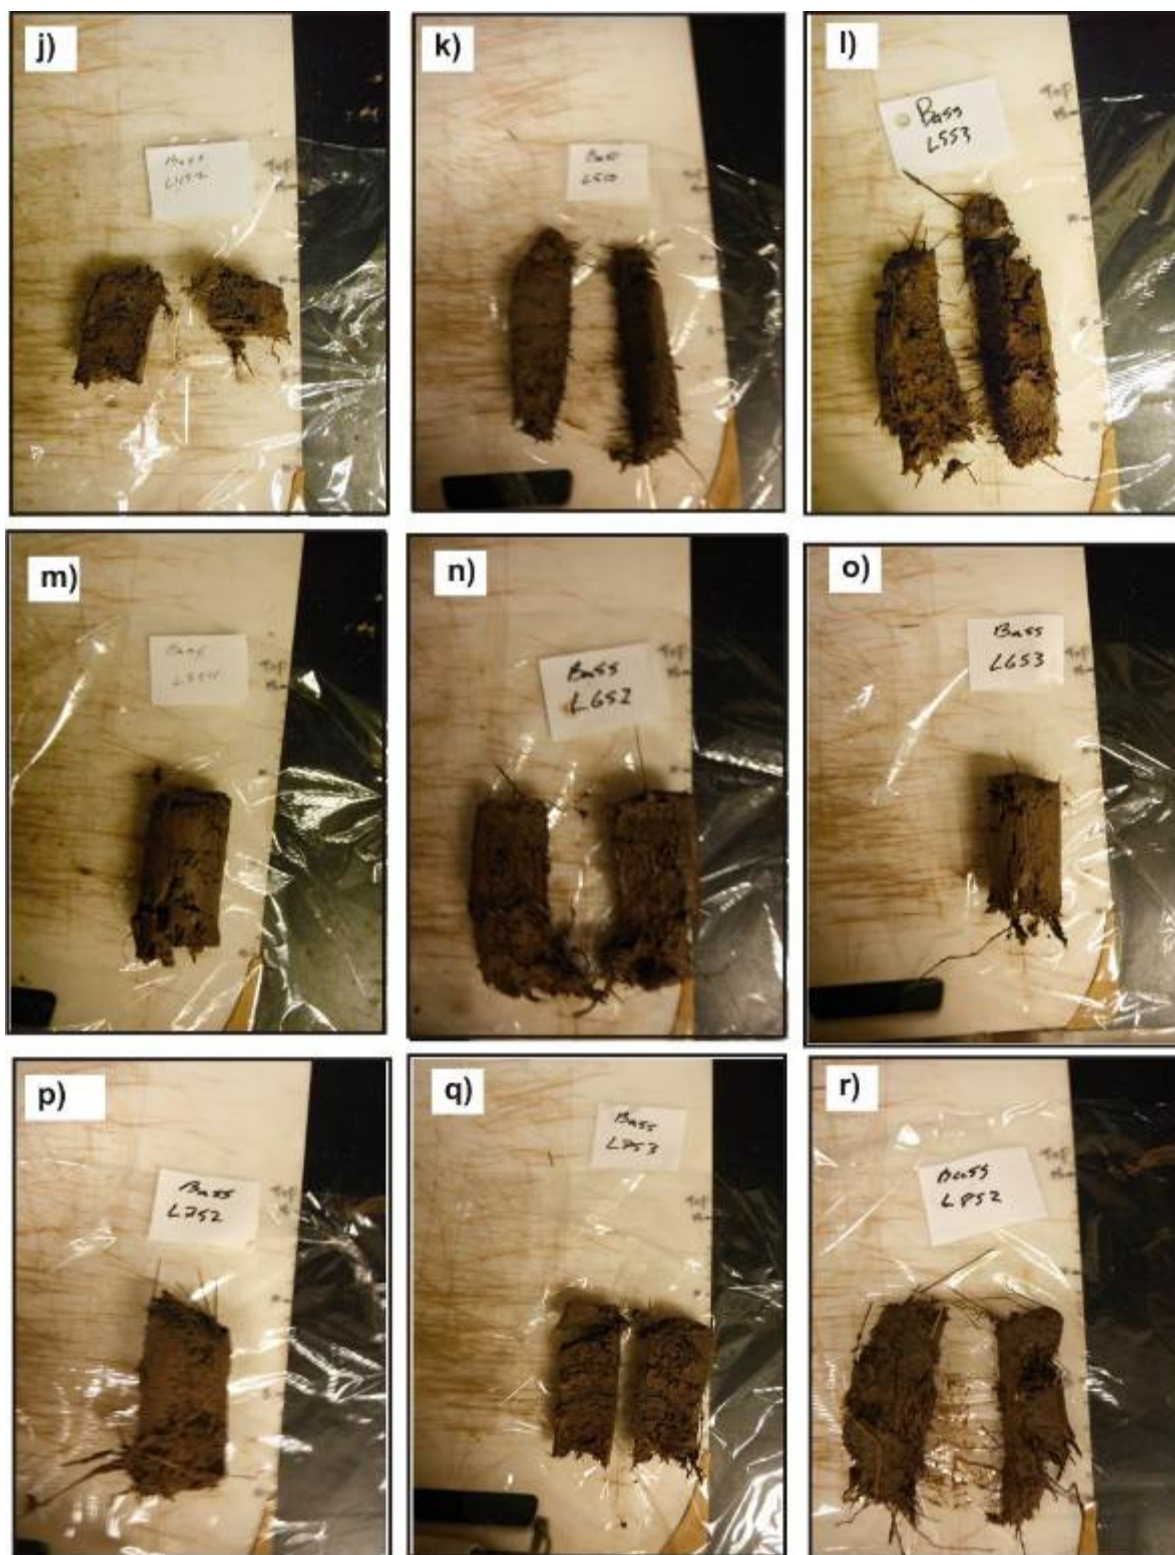
Figure 51 Split core sections for samples collected at CHV-R in fall 2012 at j) L4S2; k) L5S2; l) L5S3; m) L5S4; n) L6S1; o) L6S2; p) L7S2 q) L7S3 and r) L8S2.

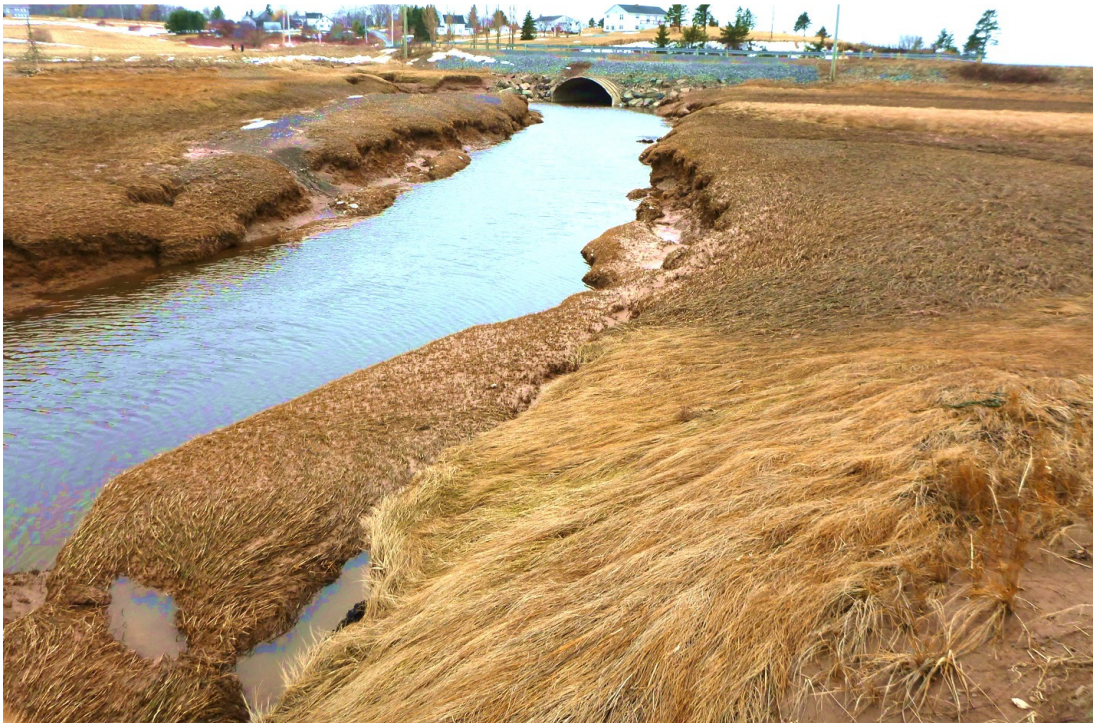
Figure 62 Bank slumping and erosion along the main channel at the toe of the dyke. Photograph by T. Bowron, 15 March 2011.

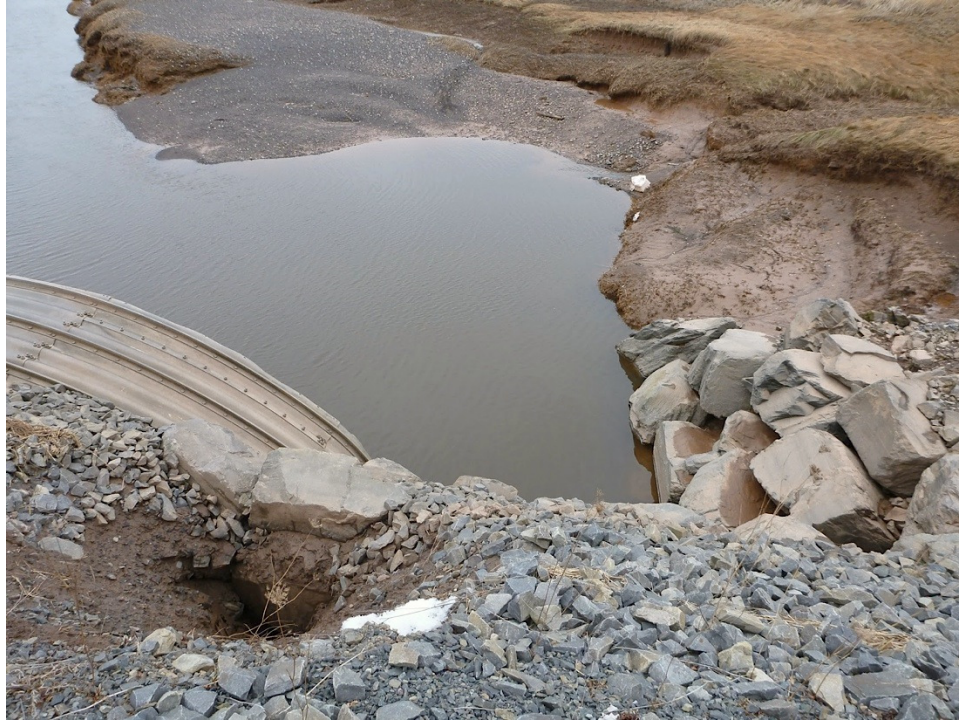
Following the warmer than normal winter of 2012, the winter of 2013 experienced an extended cold period that lasted much of January and February. Snow fall and ice development were high throughout much of the winter, but early March saw the onset of warmer conditions and rain, such that by mid-month both CHV and CHV-R were largely ice/snow free. As was observed over the past two years, winter saw more of the trees within the die-back zone broken and fallen. Erosion and bank slumping along the north side of the main river channel in the vicinity of the old dyke continued (Figure 62). There was also erosion occurring around the upstream end of the culvert that was not observed previously (Figure 63).

Figure 63 Erosion around the upstream end of the culvert. Photograph by T. Bowron, 6 March 2013 (NB: NSTIR added additional armour stone in Summer 2013).

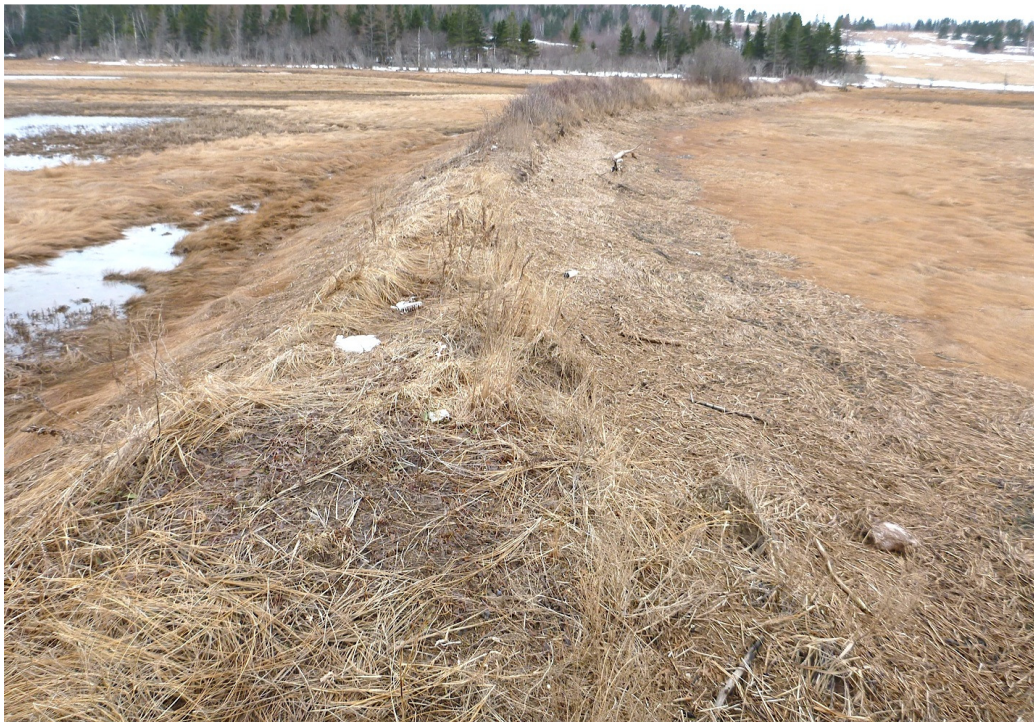
Figure 64 Vegetative material and large woody debris along downstream side of dyke at CHV. The dyke itself has suffered much erosion and subsidence over the past several years. Photograph by T. Bowron, 15 March 2011.

It was first noted during the 2009 field season (Bowron et al. 2010) that erosion was starting to occur along the seaward side of the causeway, particularly along the exposed parkway. The erosion of the causeway has continued, with more of the parkway being eroded (land under the

administration of the NS Department of Natural Resources). It was noted that armour stone around either end of the culvert was replaced by NSTIR staff between the period of 2010 and 2012. However, nothing was done to address the situation with the remainder of the causeway.

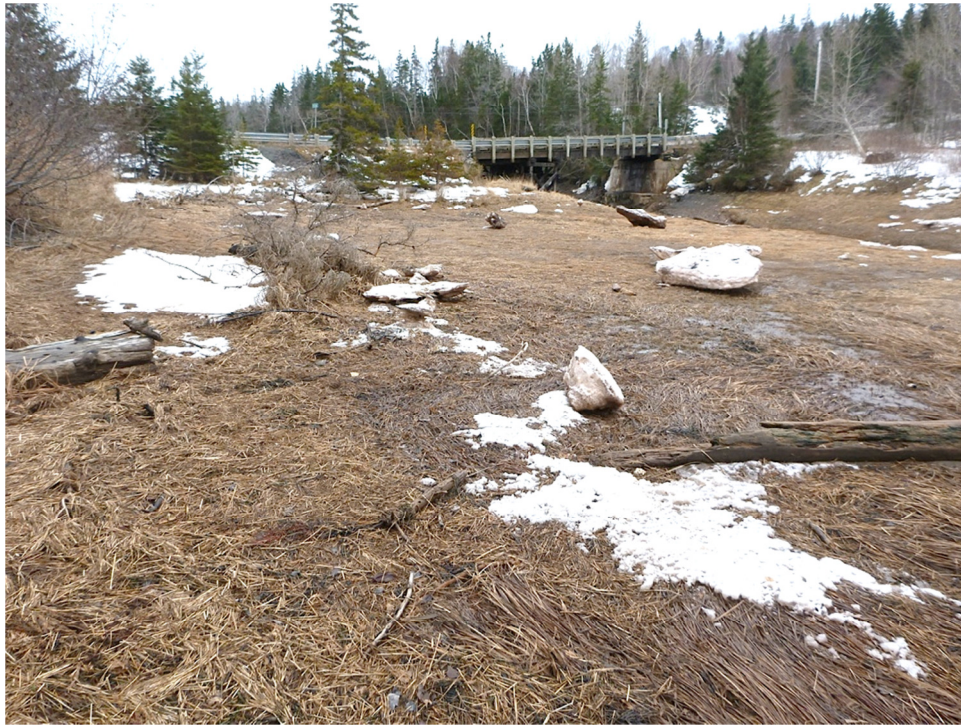
causeway-bridge and dispersed over a broader portion of the marsh surface (Figure 65). As in previous years, ice raft deposits at CHV-R were observed to contain more marine (mudflat) derived fine to coarse sediment (rocks) than CHV (Figure 66). This may be indicative of a difference in the origin and transport of ice between the two sites. Given that the culvert at CHV continued to present a barrier to tides larger than 7.1 m (CGVD28), it was likely that the culvert also represented a barrier to the import of the larger marine derived ice materials. Therefore it was likely that much of the ice material at CHV may be locally derived (developed on-site) and thus contained material that was also from within the site (salt marsh sediment and plant materials). The bridge at CHV-R did not represent a barrier to tidal flow, ice or the import/export of materials, and so more materials (estuarine sediment and rock material) from outside the site were able to reach and be deposited within.

Figure 65 Vegetative material, ice and large woody debris downstream of causeway-bridge at CHV-R. Photograph by T. Bowron, 6 March 2013.

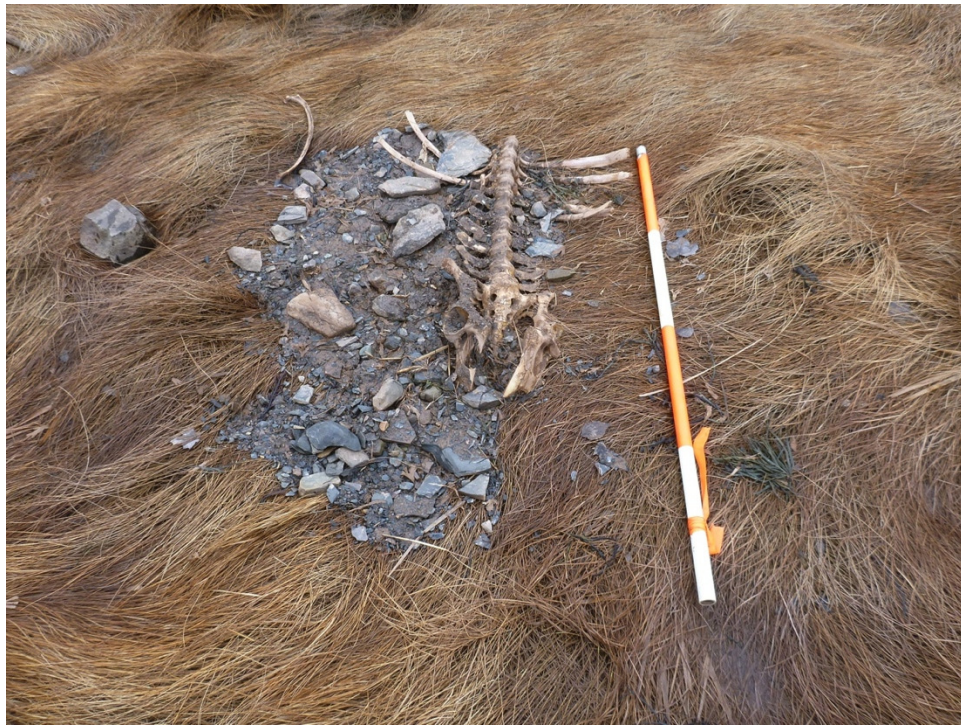
Figure 66 Suspected marine derived coarse material deposited on the marsh surface at CHV-R by winter ice. The skeleton was not part of the deposited material as it was present at this location in fall. Photograph by T. Bowron, 6 March 2013.

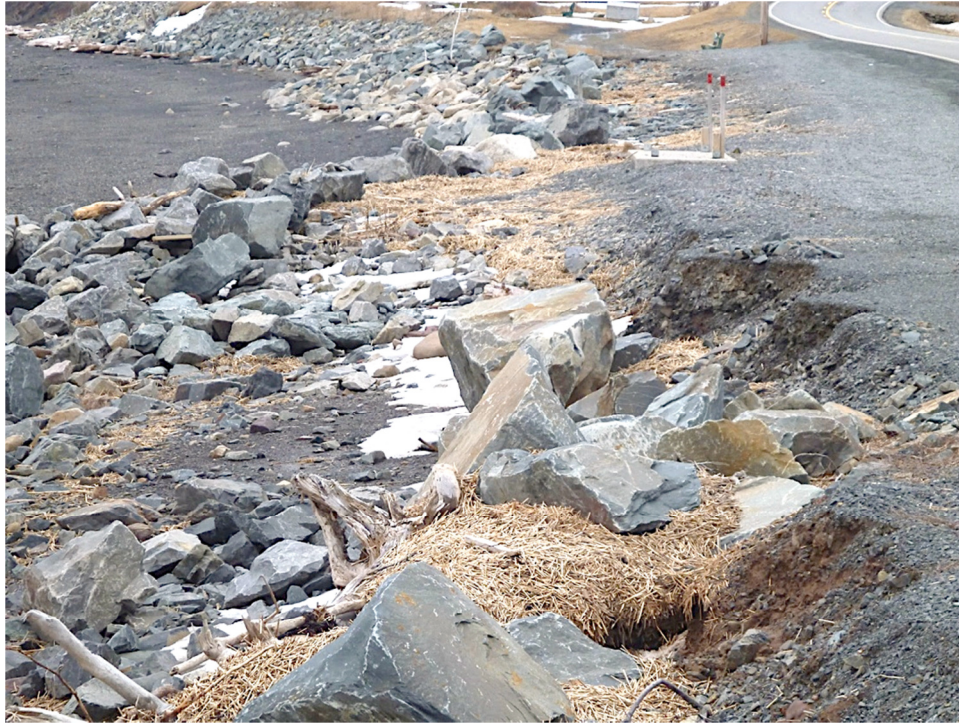
Figure 67 Loss of armour stone and erosion of fill along seaward side of causeway. Photograph taken at mid-causeway looking north away from culvert. Photograph by T. Bowron, 6 March 2013.

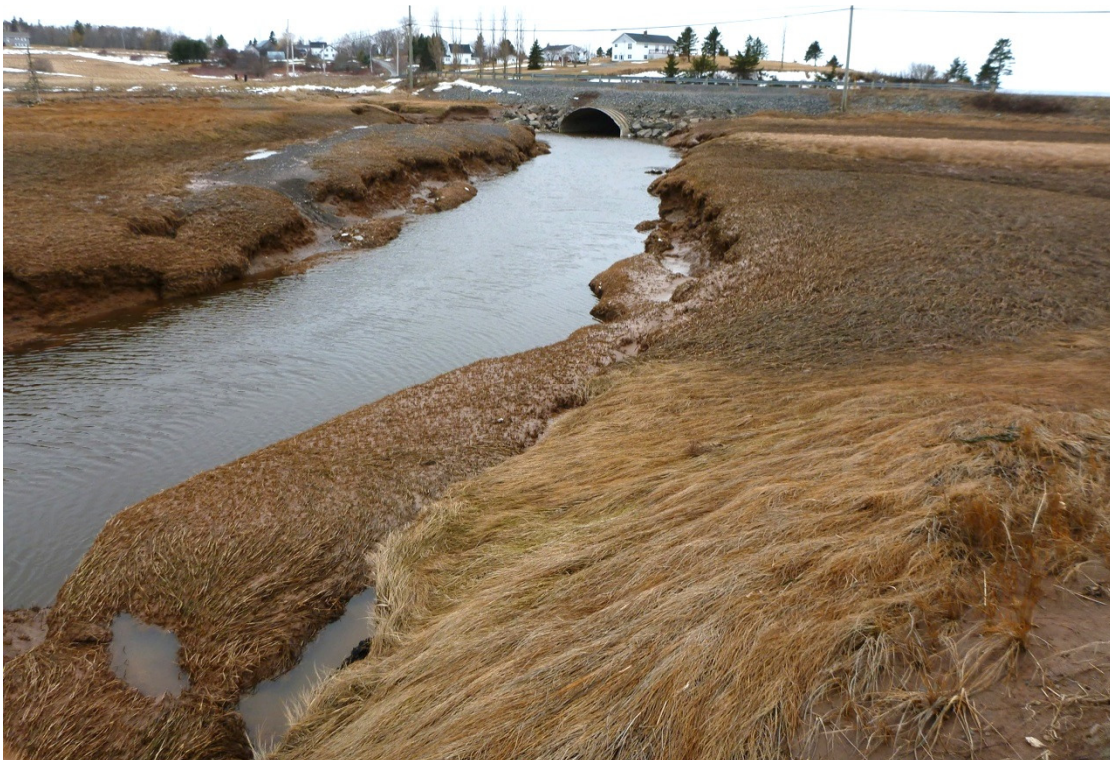
Figure 7 Cheverie Creek culvert, upstream end, as viewed from the dyke.
