A Report for:
Nova Scotia Department of
Transportation and Infrastructure Renewal

Post-Restoration Monitoring (Year 7) of the Cheverie Creek Salt Marsh Restoration Project

Prepared by:
Tony M. Bowron, Nancy C. Neatt, Jennifer M. Graham, Dr. Danika van Proosdij,
Dr. Jeremy Lundholm, and Ben Lemieux

March 2013
Publication No. 33

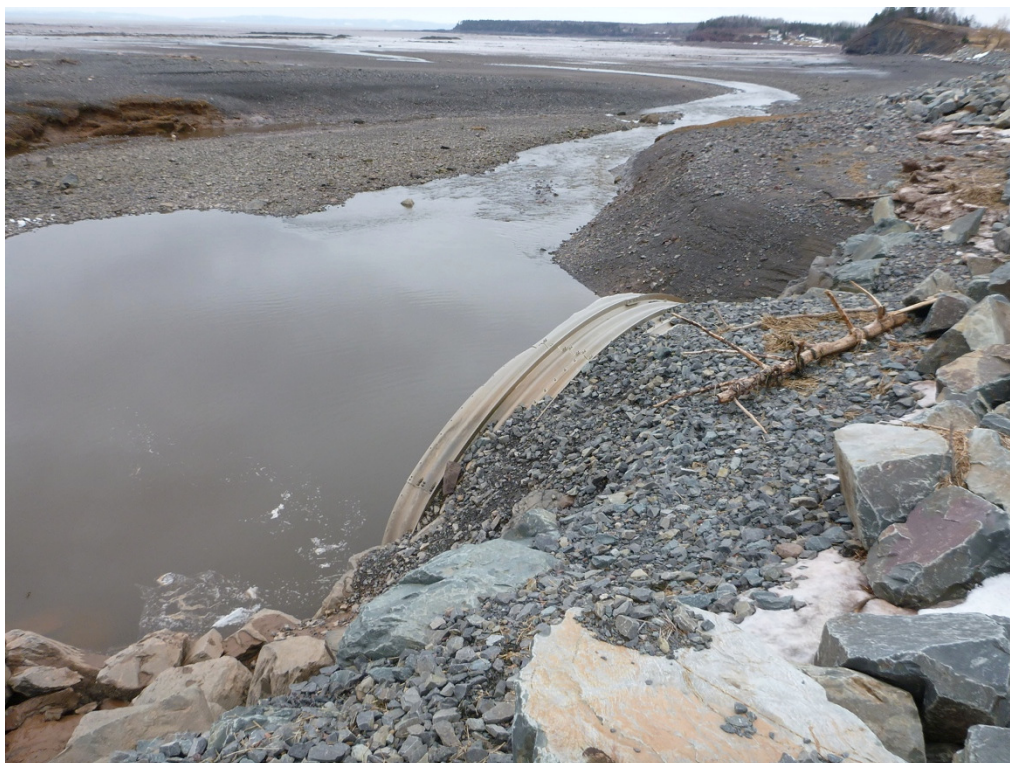
Figure 8 Downstream end of culvert, coastal berm and channel.

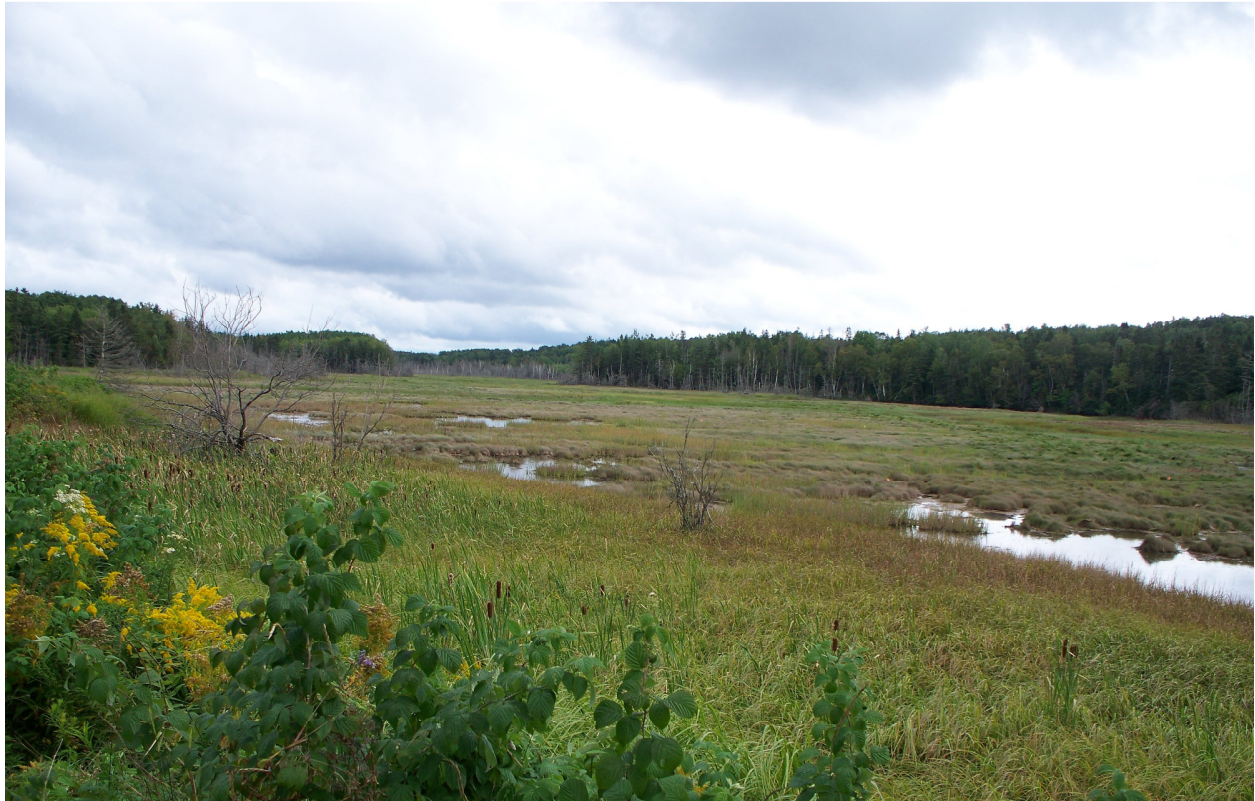
Direct observations (Figure 1) suggest that Cheverie was successfully reverted back to its historical salt marsh state. This is most evident by the re-establishment of salt marsh vegetation (*Spartina sp.*) and the creation of salt pannes. The monitoring results suggest that there has been an increase in waterfowl use both for breeding and staging habitat since the salt marsh

Figure 1 – Cheverie Creek salt marsh August, 2010.
