Post-Restoration Monitoring (Year 1) of the Three Fathom Harbour Tidal Wetland Restoration Project

Prepared for:
Nova Scotia Department of Transportation and Infrastructure
Renewal

Prepared by:
Bowron, T.M., Graham, J., van Proosdij, D., Porter, C. and
Lundholm, J.
CBWES Inc.

March 2017
Publication No. 44

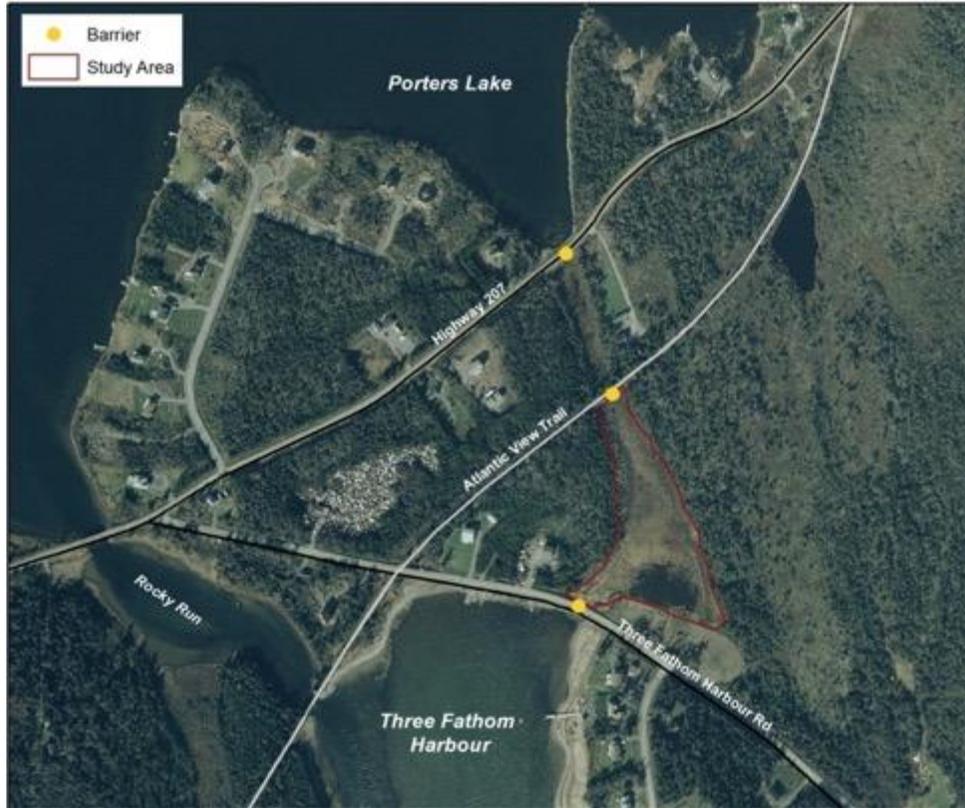
Figure 2 Three transportation routes separating the study site from Three Fathom Harbour and Porters Lake.

Prior to the construction of the former Musquodoboit Railway (now the Trans Canada Trail), Route 207 and the Three Fathom Harbour Road, TFH acted as a wetland corridor connecting Porters Lake to Three Fathom Harbour (Figure 2). The sequential construction of the three transportation routes resulted in the isolation of the wetland from both Porters Lake and Three Fathom Harbour and its conversion from a tidal wetland system to a brackish-freshwater system (Figure 3). Each of the transportation causeways was constructed with extremely undersized culverts in order to facilitate freshwater drainage. The culvert within the Three Fathom Harbour Causeway originally allowed limited hydrological exchange with the Three Fathom Harbour tidal system (Figure 4). However, subsequent rock armouring of the seaward side of the causeway and the deposition of sand, flotsam and seaweed detritus (wrack) resulted in the blockage of the downstream end of the culvert and further restriction (approaching complete) of the hydrological exchange.

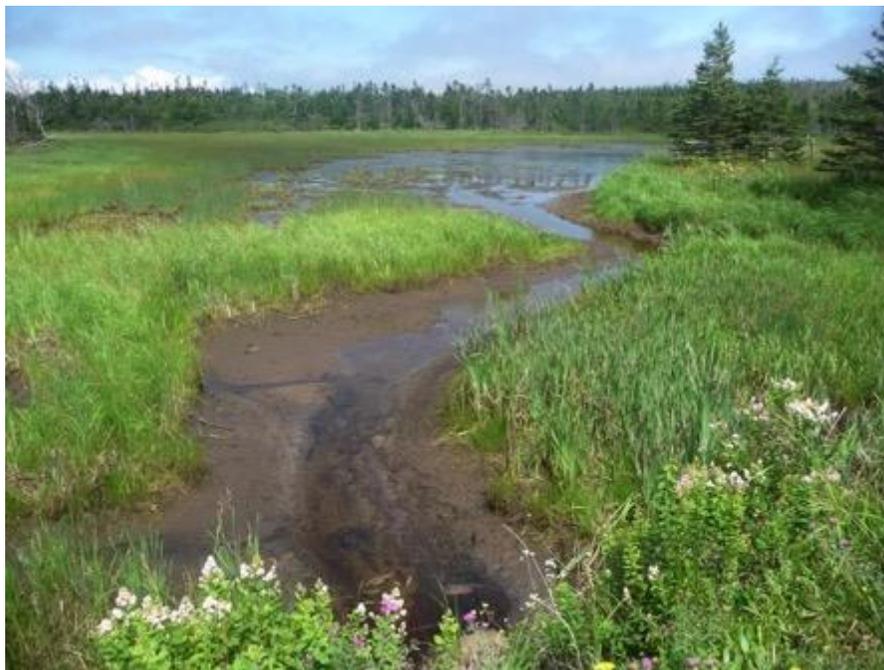
Figure 3 Landscape photograph of TFH from roadway above crossing. Photograph by T. Bowron, 12/8/11.

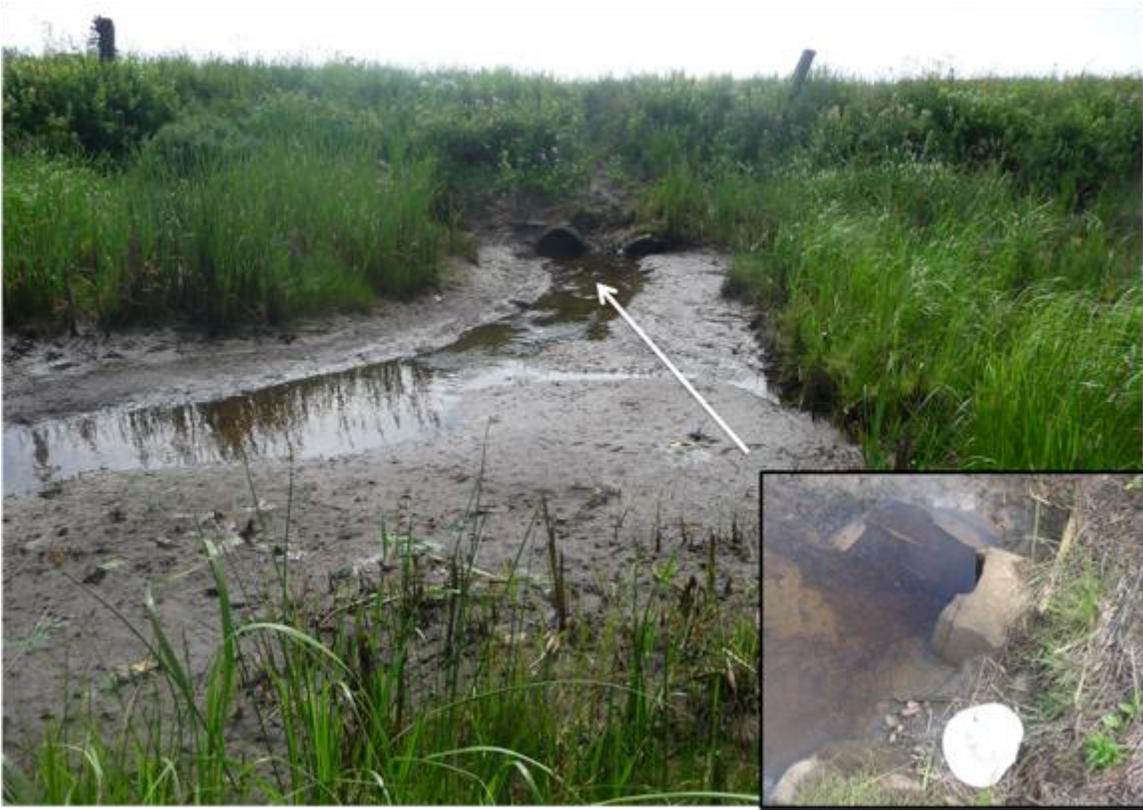
Figure 4 Upstream side of Three Fathom Harbour causeway and culvert shortly after a natural, storm blowout of the buried/plugged culvert. Photographs by T. Bowron, 12/8/11.

Communication with local residents prior to restoration indicated that drainage rarely occurred and typically would only occur following a major rain event causing enough hydrologic pressure to partially clear the downstream blockage (sand) (Figure 5).

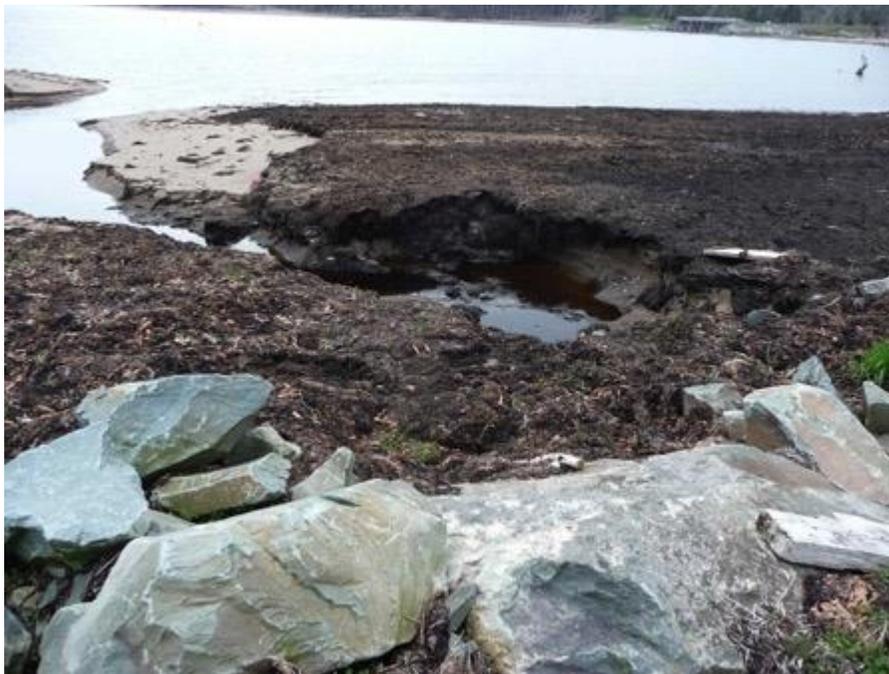
Figure 5 Adjacent beach with accumulated seaweed wrack downstream of the buried culvert. A temporary enlarged channel was created by a rainfall event shortly before the June 25, 2011 photograph.

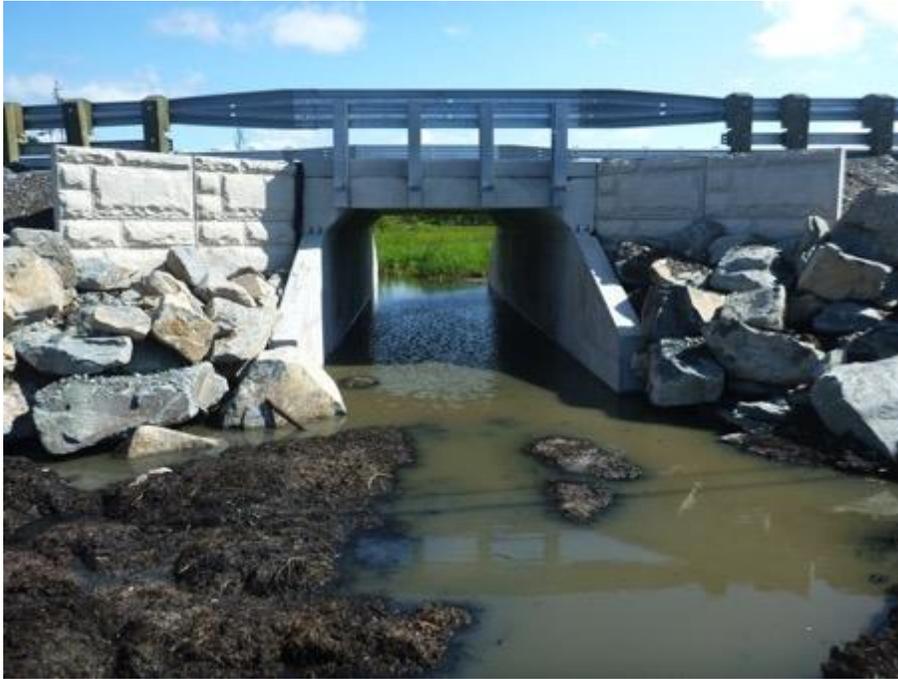
Figure 6 New tidal crossing installed July 2015. Photography by CBWES, July 16, 2015.

The new tidal crossing structure and upgrades to the causeway (increased elevation of the road, new guard rails and armour stone) were completed in July 2015 (Figure 6; Figure 7). The installation of the new crossing had the immediate effect of improving the hydrology of the site by draining the head pond, enabling the unrestricted flow of tidal waters into and out of the site, and over the subsequent year the re-activation of the primary tide channel and remnant creek network within the site (Figure 7).

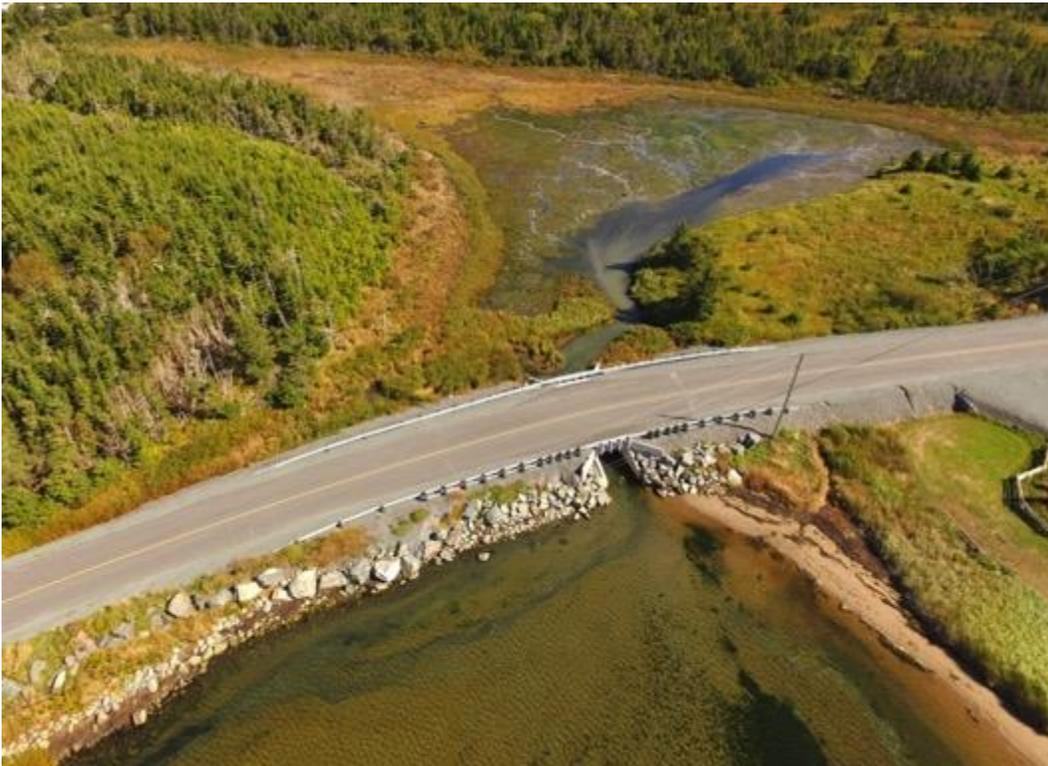
Figure 7 New tidal crossing, causeway upgrades and incoming tide flowing into the site via the re-established primary channel. Water can be seen in the re-activated network or smaller channels within the site. Aerial image by CBWES, September 22, 2016.

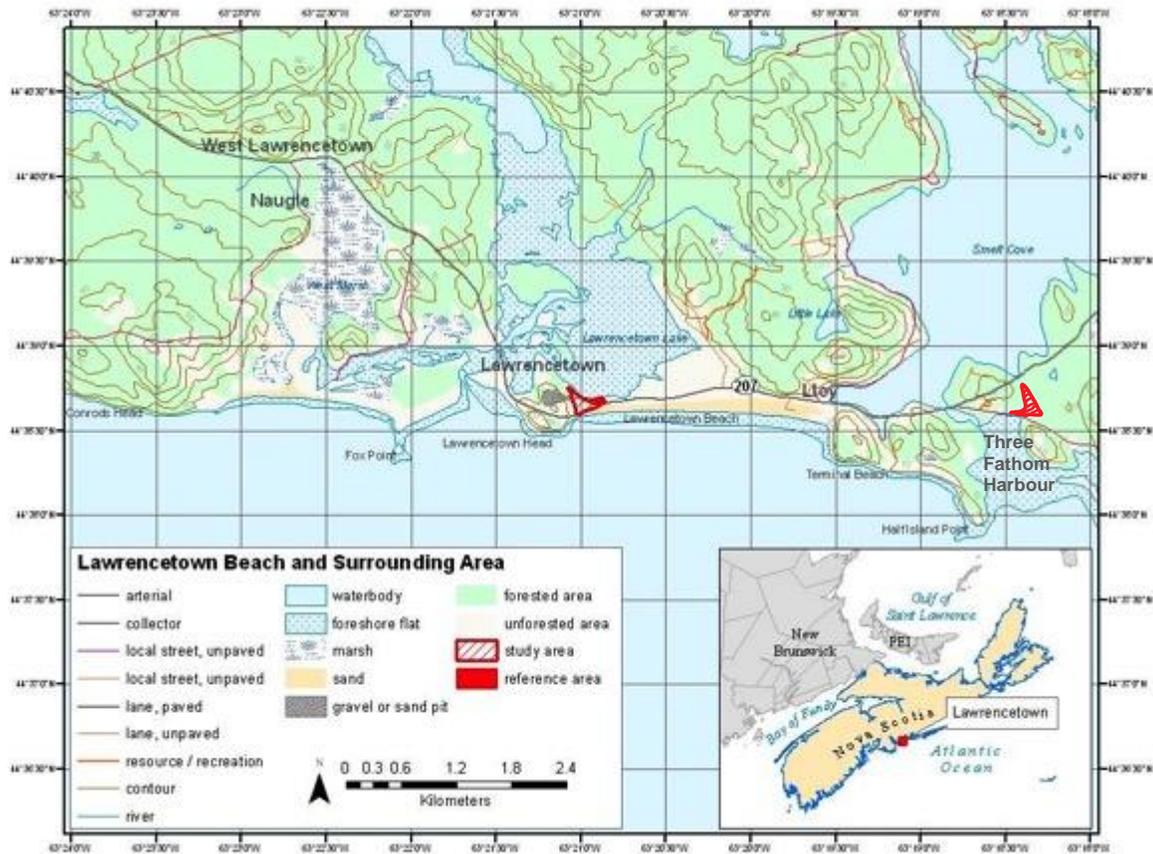
Figure 9 Location of Lawrencetown Lake restoration and reference sites, Halifax County, NS relative to Three Fathom Harbour (TFH) (base map downloaded from: www.geogratis.ca/geogratis/en/product/search.do?id=28954).

The Lawrencetown Lake Salt Marsh Restoration (LT) and Reference (LTR) sites are located approximately 4 km west of TFH along NS Route 207 (Marine Drive) in Lawrencetown (Halifax County), and are part of the Lawrencetown Lake tidal wetland system (Figure 9). The restoration site is a 26,354 m² (6.51 acres, 2.6 ha) tidal wetland that was restored (culvert installation) in 2007, and has been extensively monitored between 2006 and 2011. The reference site, located on the lake side of the Trans Canada Trail, is an 8,305 m² (2.0 acres; 0.8 ha) unrestricted tidal wetland (Figure 8). Both of these sites are part of a tidal marsh system extending around much of the perimeter of the Lawrencetown Lake tidal system. Although both sites were used in the comparison to TFH, the Lawrencetown Lake Reference site (LTR) in particular was the focus of the comparison for this report. Both LT and LTR follow a typical zonation pattern, hydrology and species composition expected of a salt marsh with low, mid and high marsh zones.

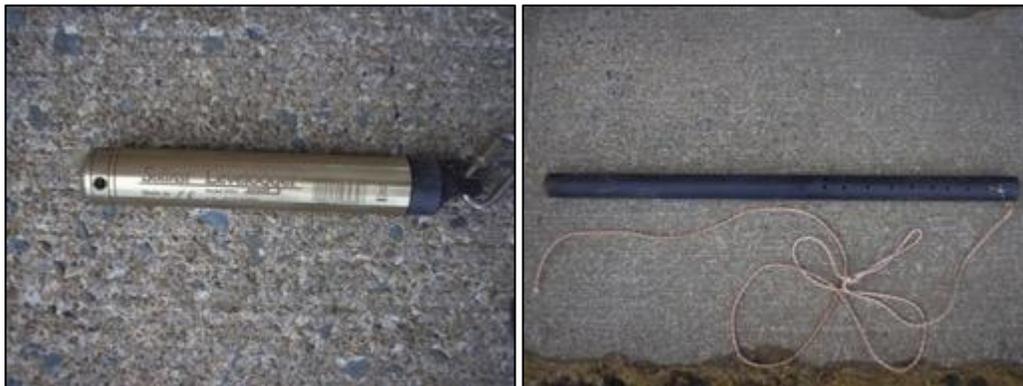
Figure 12 Solinst Model 3001 Levelogger Gold and still well. Photographs by N. Neatt, 2008.

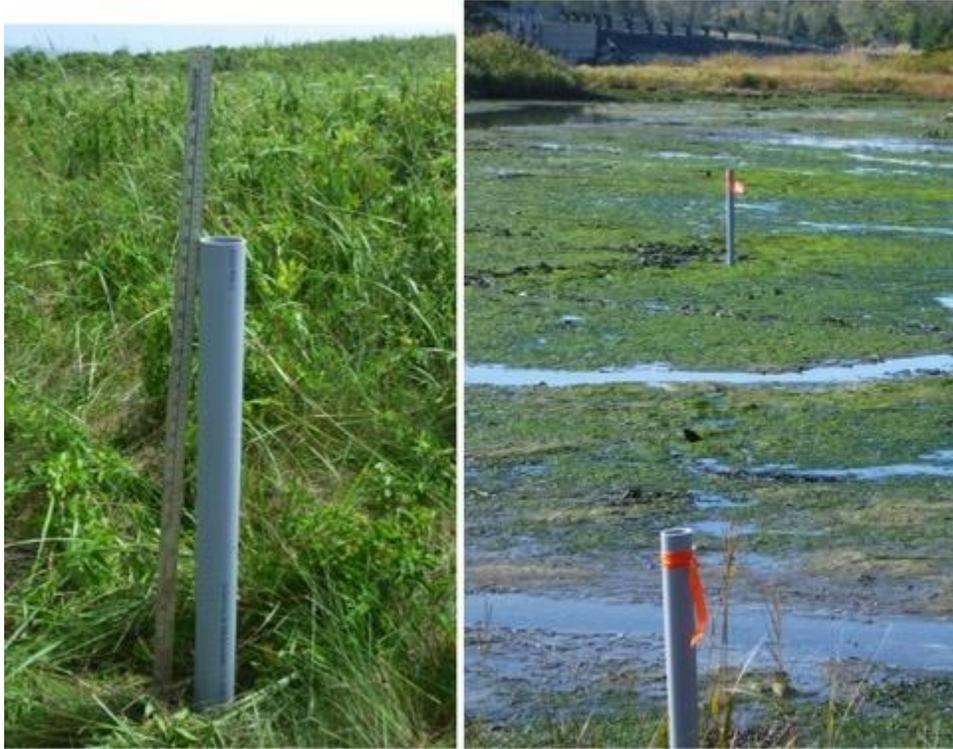
Figure 13 Example of a sediment pin installed at the Mavillette Tidal Wetland Restoration site (left image) in 2015, and two sediment pins installed along TFH's transect 2 (right image). Photographs by T. Bowron.

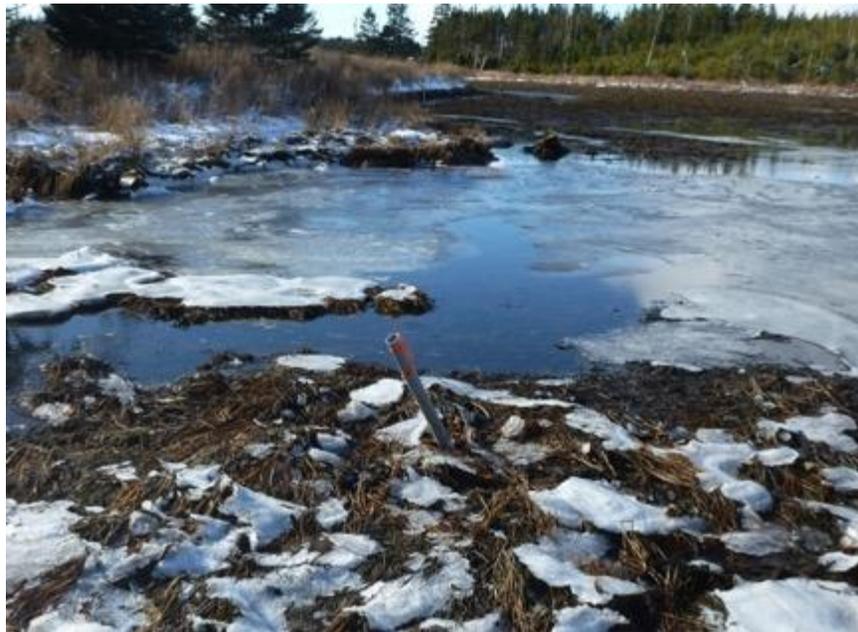
Figure 14 Sediment pin T1S2 compromised by winter conditions. Photograph by CBWES February 2017.

One immediate shortcoming of the sediment pin methodology was the inability to install a number of the pins to the desired 1.5 m depth due to the shallow nature of the marsh soils and the underlying geology of the site. Unlike tidal marshes in the Bay of Fundy in which wetland soils can be in greater than 10 m in depth, the underlying rock throughout much of the TFH site was around 0.5 m below the surface. It was noted during the structured winter walk in February that two of the pins had already been compromised (pins T1S2 and T2S2) (Figure 14).

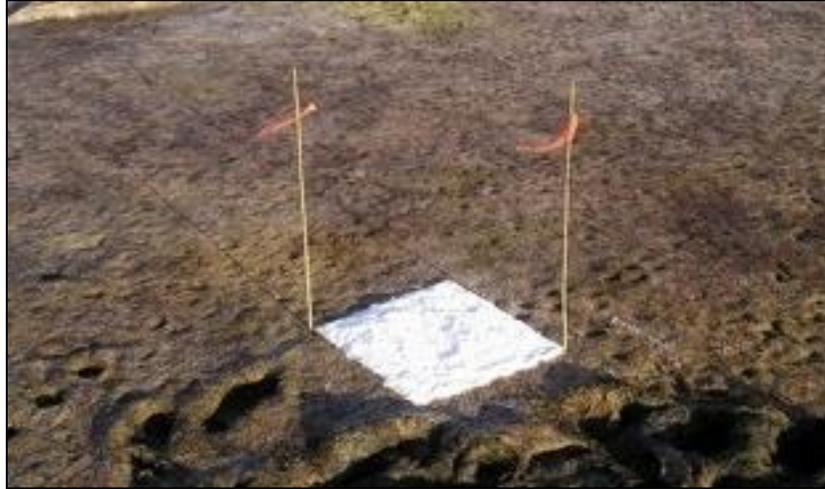
Figure 15 Example of a feldspar clay marker horizon. This is one of the markers established in 2005 at the Walton River Salt Marsh Restoration site. Photograph by T. Bowron, 2005.

Eight marker horizons were established at points throughout TFH that represent the different potential habitat zones (low, mid, high marsh) (Figure 15). The marker horizons were established according to the methods developed by Cahoon and Lynch (USGS 2005). Marker horizons were installed at TFH in October 2011. The marker horizons were measured approximately 15 months (13 October 2016) after tidal exchange was restored, using a cryogenic corer (Figure 16) and methods as described by Cahoon et al. (1996) on 13 October 2016. These were compared to the rates of accretion observed at LT(R). Seven markers were installed at LT and six markers at LTR. The markers at LT(R) were originally installed in November 2006 and measured annually for 5 years (2007-2012).

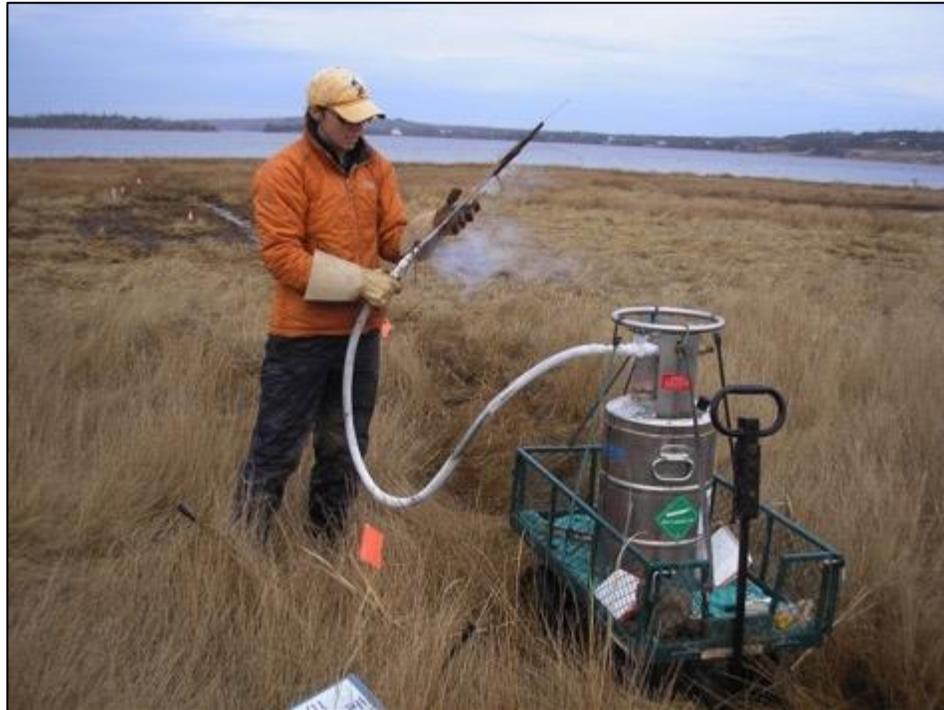
Figure 16 Marker horizon sampling with the cryogenic corer at LT-R. Photograph taken by B. Lemieux, December 2011.

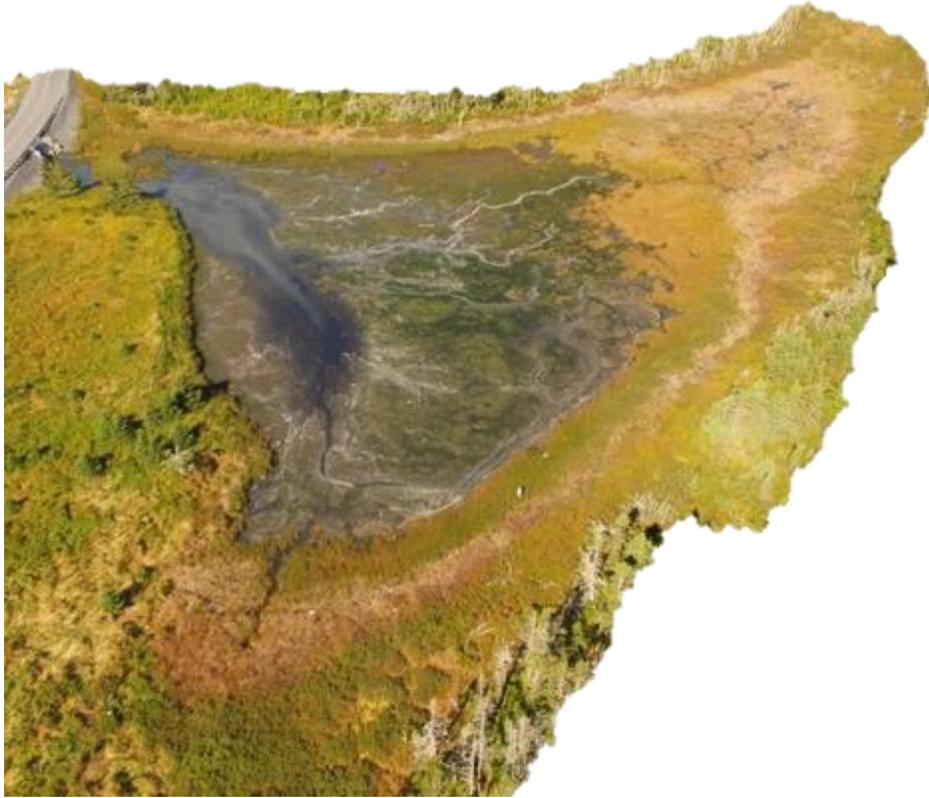
Figure 29 Aerial view of TFH at low tide showing the mudflat and dieback zone around much of the perimeter of the former pond. Photography by CBWES 2016.

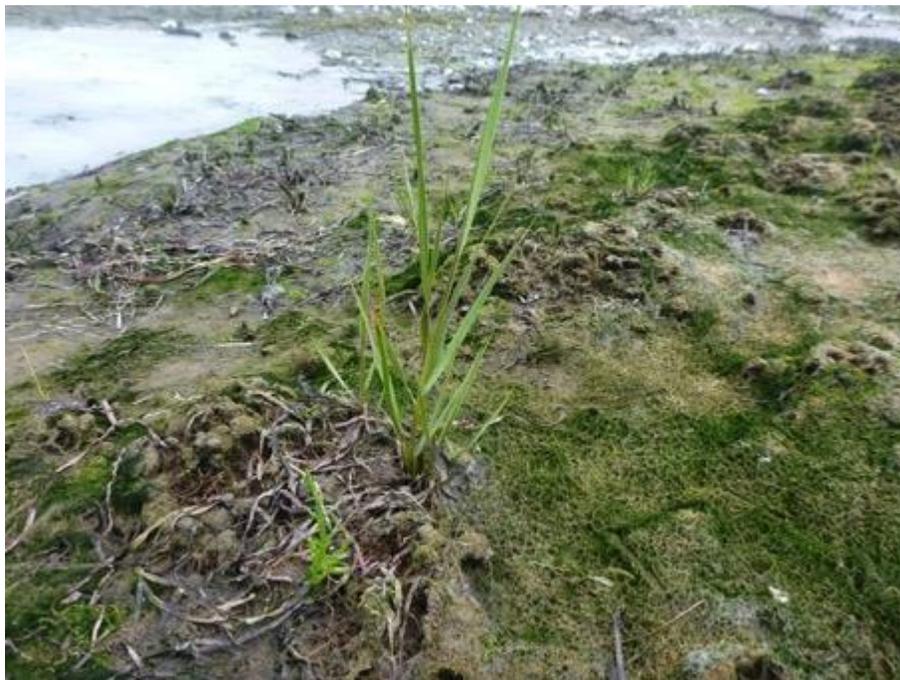
Figure 30 Colonization of the die-back zone and mudflat of the former central pond by salt marsh species (pictured *S. alterniflora* and *Salicornia europaea*). Photography by CBWES 2016.

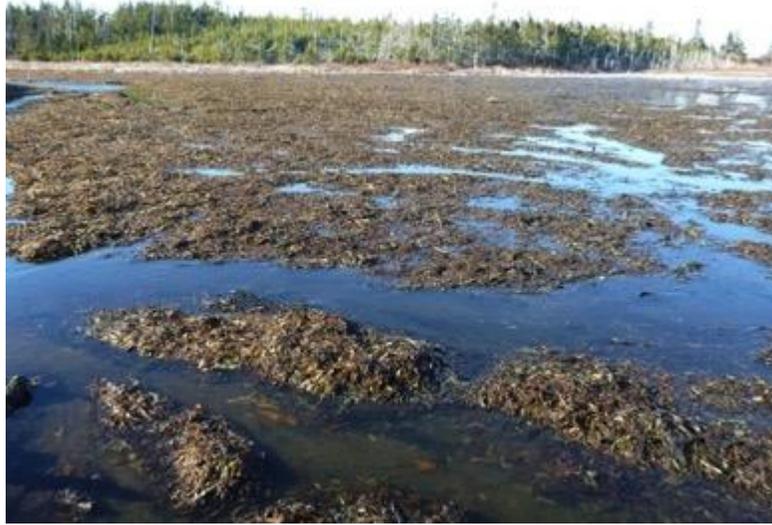
In large amounts however, the deposition and decomposition of seaweed can repress plant cover and biomass, and in the case of a restoration site such as TFH, has the potential to hinder the rate of vegetation recovery. Large amounts of decomposing seaweed can also have a strong aroma, which was something also reported by local residents during construction and the spring of 2016.

Figure 31 Seaweed wrack deposition within the restoration site. View is east to west across the site. Photography by CBWES Inc. 3 February 2016.

Monthly site visits into spring and early summer of 2017 are recommended in order to determine if this cycle of winter deposition and spring/early summer re-suspension and export is a pattern for the site.

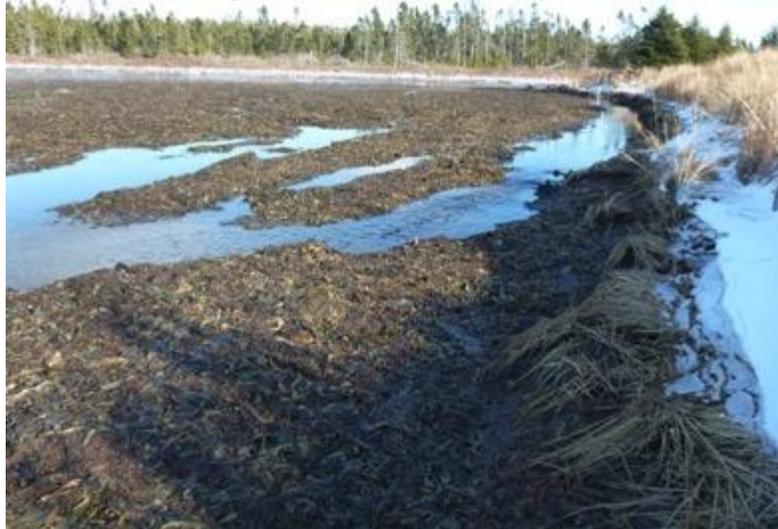
Figure 32 Seaweed wrack deposition within the restoration site. View is along the eastern edge of the site looking north across the site. Photography by CBWES Inc. 3 February 2016.

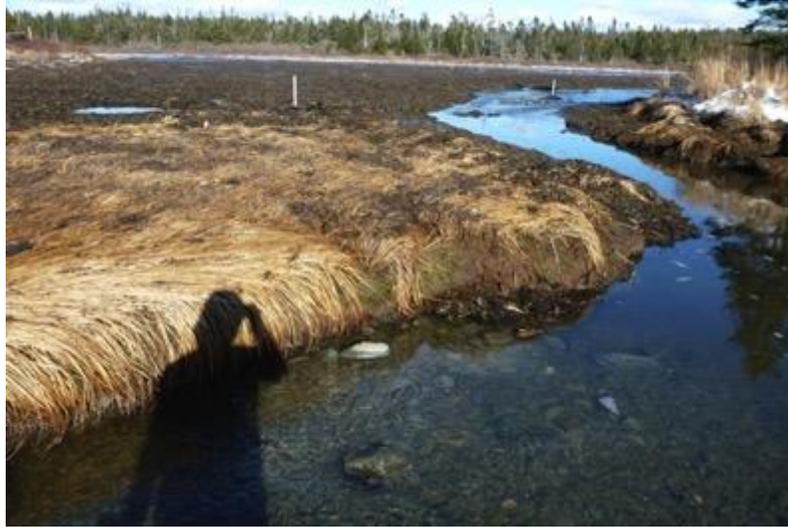
Figure 33 Primary tide channel with vegetated marsh surface in the foreground and wrack on the central mudflat within the site. View is from the upstream end of the tidal crossing looking north across the site. Photography by CBWES Inc. 3 February 2016.

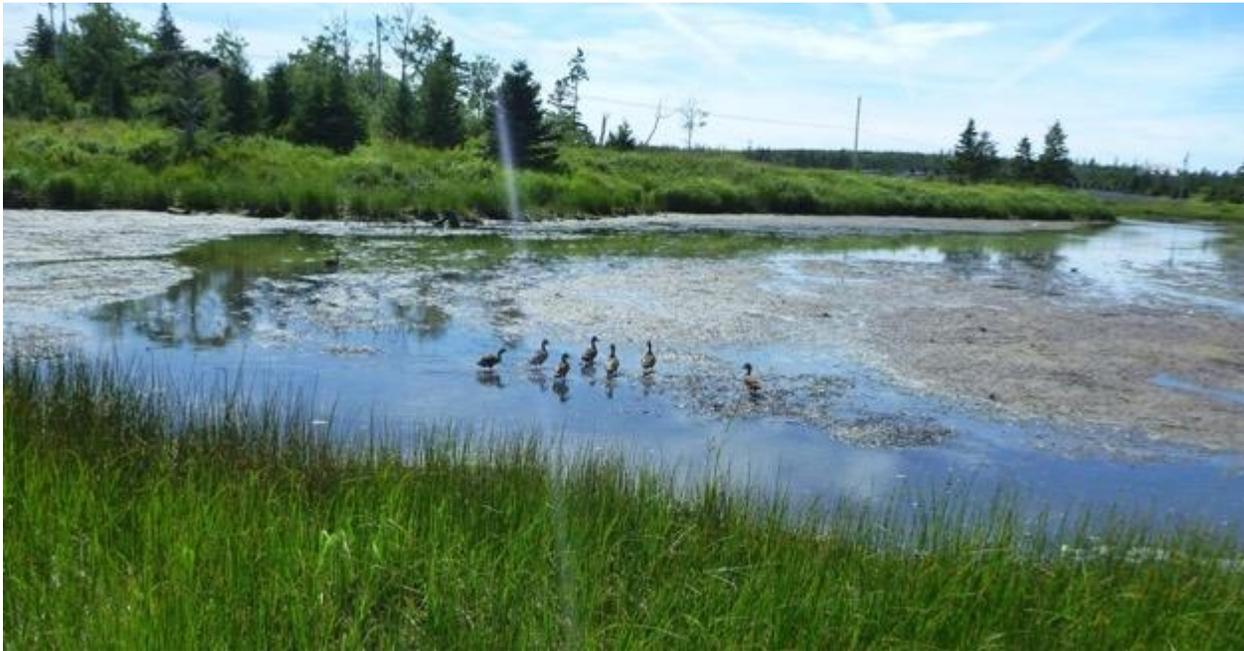
Figure 34 One of the three families of ducks that were regularly seen at the site during the summer months. Photograph by CBWES, 10 August 2016.

The results of the 2016 year one post-restoration monitoring, as presented in this report, revealed that site is behaving hydrologically as the original modeling and design predicted and that a corresponding shift in habitat conditions, particularly in the front/main portion of the site, has been initiated. The vegetation community assemblage has begun the process of transitioning to a more halophytic species dominated one. A decrease in water and organic matter content and a corresponding increased bulk density were recorded for a majority of the soil cores and are consistent with improved drainage and regular tidal flow. That the sediment cores taken within the main tidally influenced portion of the site, which is also the part of the site where seaweed would have been most heavily deposited during the 2016 winter months, did not exhibit an increase in organic matter content suggests that much of the seaweed was transported out of the site rather than fully decomposing in-situ and incorporated into the site. As the soils within and immediately surrounding the former central pond continue to dewater and consolidate, it is expected that the colonization of these areas by halophytic plant species will increase. In the interim, the exposed mudflat is serving as valuable forage habitat for shorebirds and waterfowl (at least six different species were observed feeding within the site; three families of ducks were present at the site during the summer months) (Figure 34).

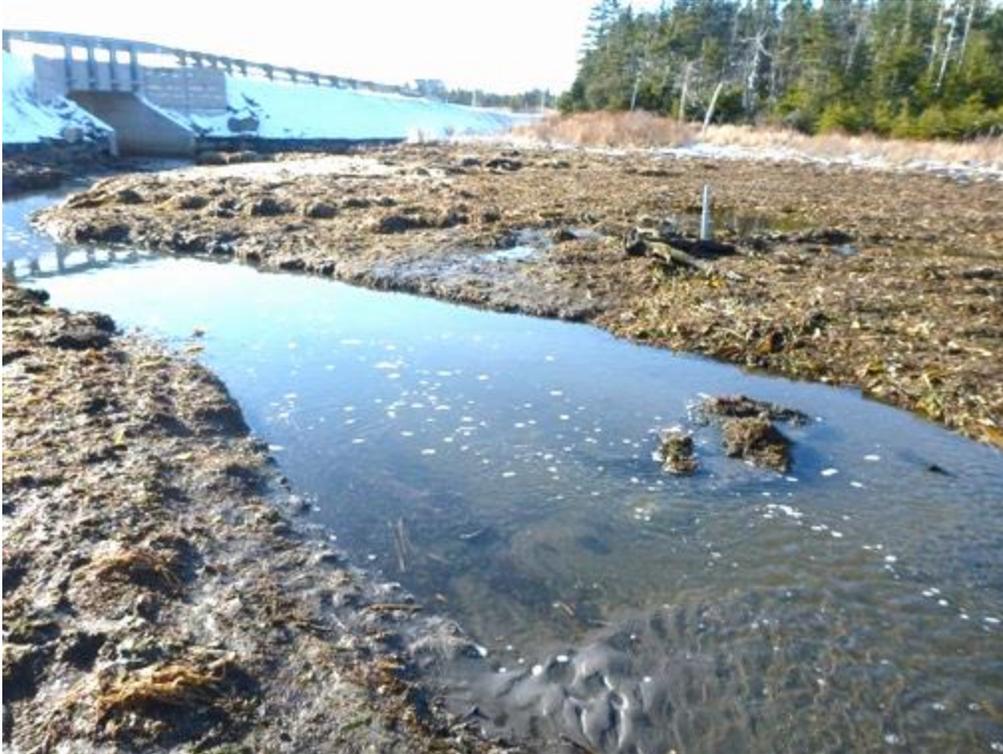
Figure 6 Upstream end of new tidal crossing and main tidal channel leading into site.
