Condition Assessment and Recapitalization Plan

Job No. F01-25-01-23
Joseph Howe Building
Hollis Street, Halifax, NS

Final Report

October 31, 2007

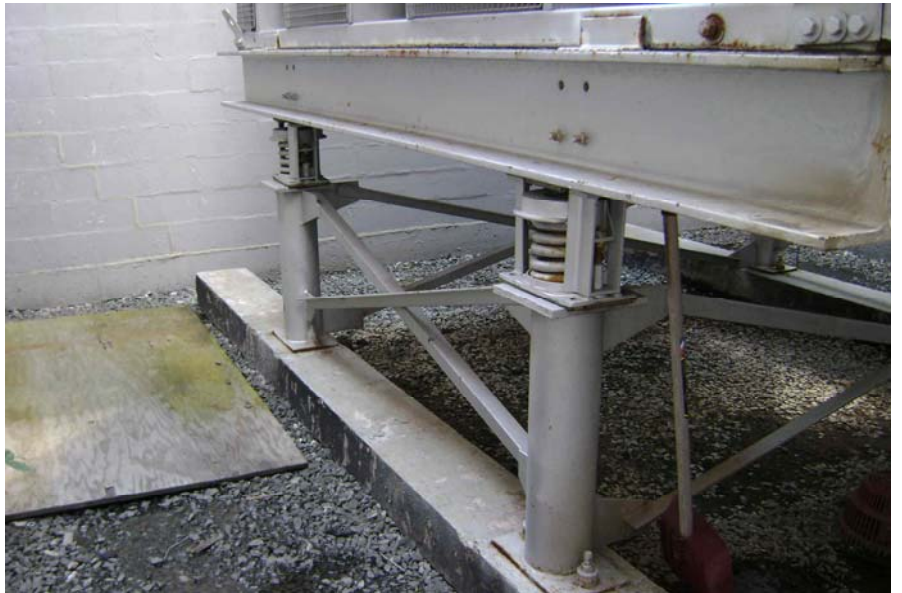
Figure S2: Existing cooling tower support framing. Note unbolted spring isolators.

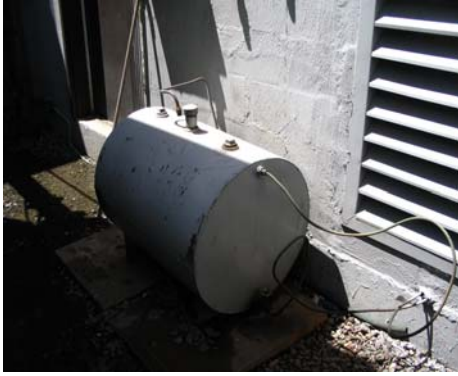
The existing emergency power system consists of a Detroit Diesel 88kW, 600/347V three-phase genset (Refer to *Photo 1.1*) and a Kohler 100A automatic transfer switch (Refer to *Photo 1.2*) installed in the generator room located on the 12th floor. The fuel for the genset is from a 25 gallon tank located on the exterior wall of generator room (Refer to *Photo 1.3*). This tank is kept full from the main diesel tank on the lower level which supplies fuel mainly for the building's boiler plant. The fuel is delivered from the main tank through a fuel pump.

Photo 1.3; 25gal day-tank

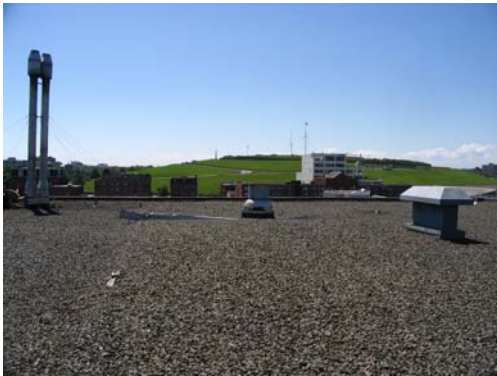
Photo 2.2; View to Citadel Hill from Joe Howe Building

The second option for a location is the roof. This location involves structural reinforcement of the roof and view plane considerations from Citadel Hill. Refer to *photo 2.2*. This would need to be explored further and is outside the scope of this report.
