Reclamation of the Irish Cove Limestone Quarry (NTS 11F/15), Richmond County

D. B. Hopper and F. J. Bonner

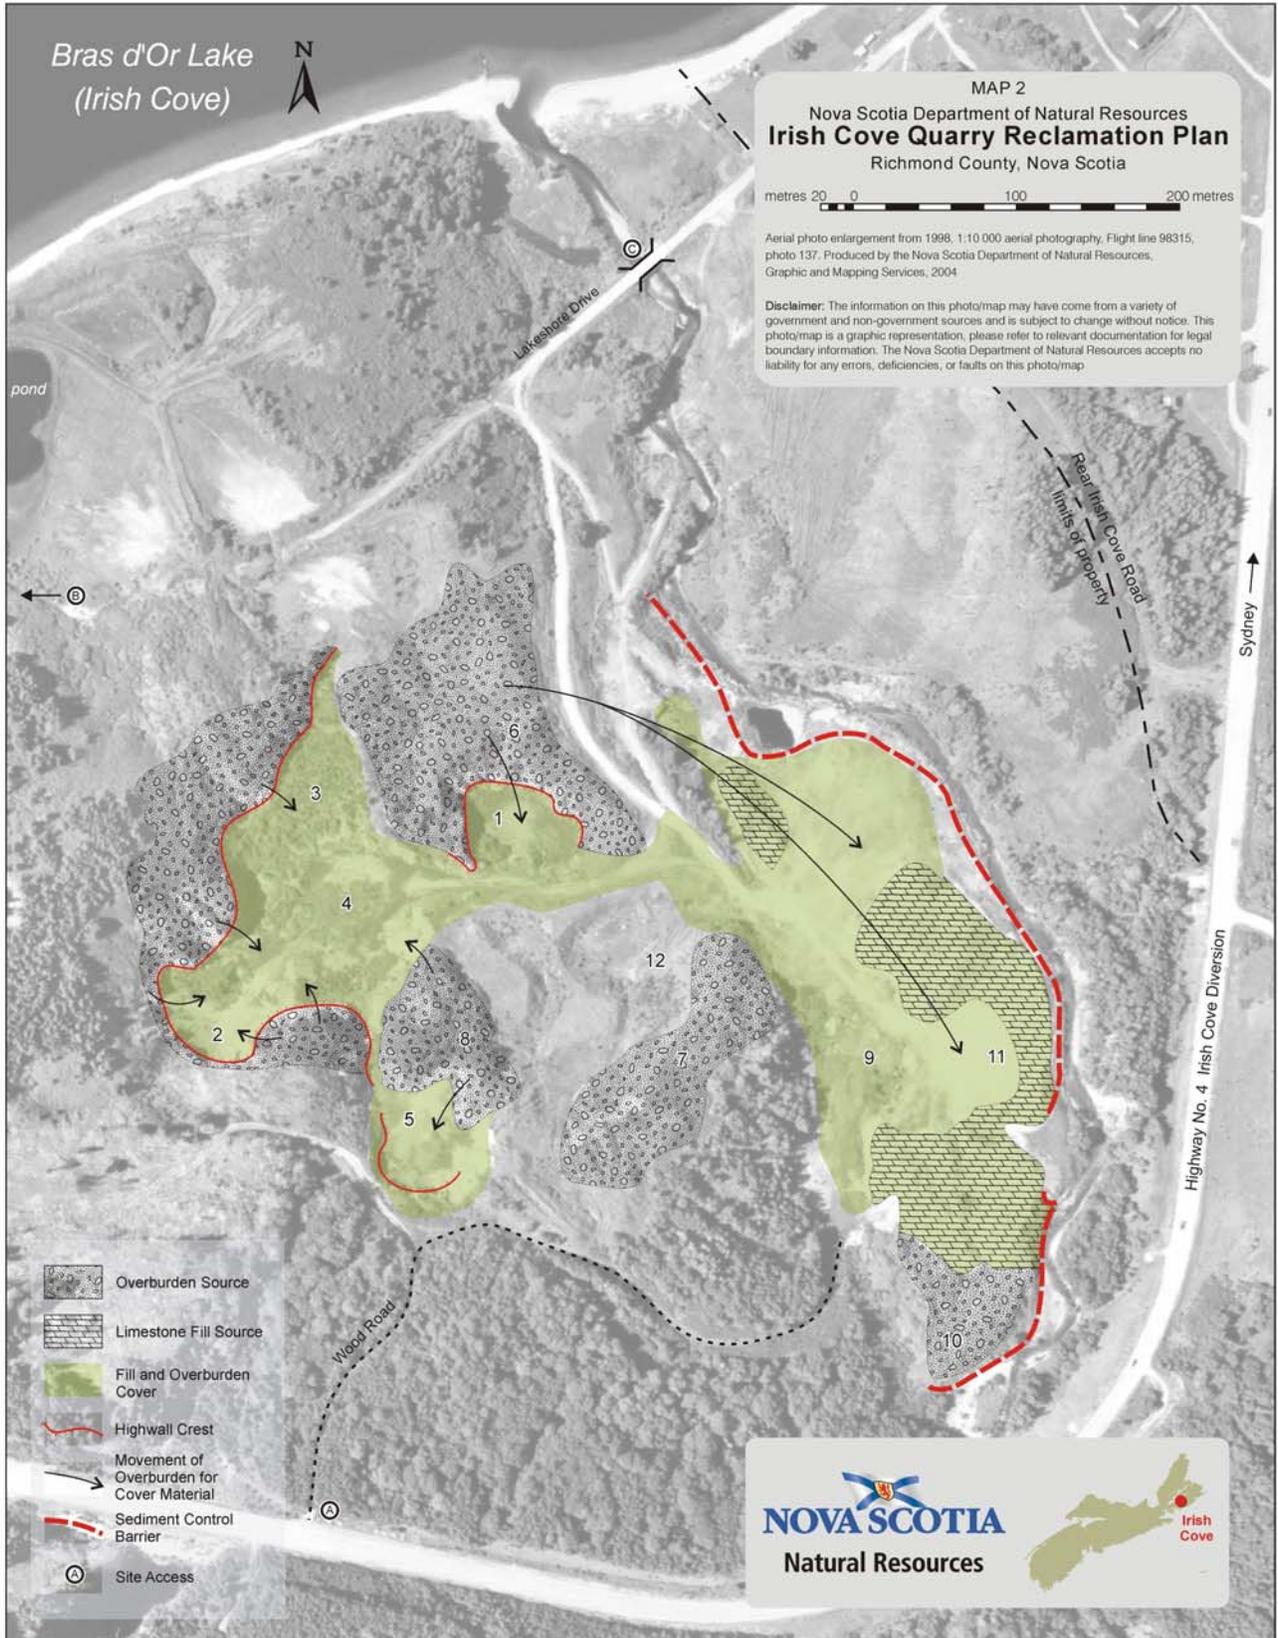
Figure 3. Reclamation plan for the Irish Cove Quarry.

The quarry walls and steep overburden (areas 1, 2, 3 and 5 as shown on Fig. 3) lying above the crests of the walls were public safety hazards. The quarry walls located in Areas 1 and 2 were, by far, the

Safety objectives aim to reduce the severity of all slopes and high walls to an average grade ratio of 1:3. This is to reduce the hazards of steep terrain and provide adequate slopes for revegetation. The piles are relatively high and steep, and tend to attract ATV and motorcycle riders. During winter the snow-covered slopes are popular for tobogganing, which has resulted in at least one known injury. One of the most important safety measures in this reclamation project is to move most (90%) of the stockpiled material back into the quarry for backfilling against highwalls. The remaining material will be used to cover and landscape the riparian zone. A former truck-loading ramp and drop-off presents a public hazard. The structure will be dismantled and disposed of with the other quarry debris. The remaining embankment is to be smoothed down and incorporated into the new landscaping.
