Factors Affecting Coastal Armour Stability along the Amherst Shore, Northern Nova Scotia

P. W. Finck

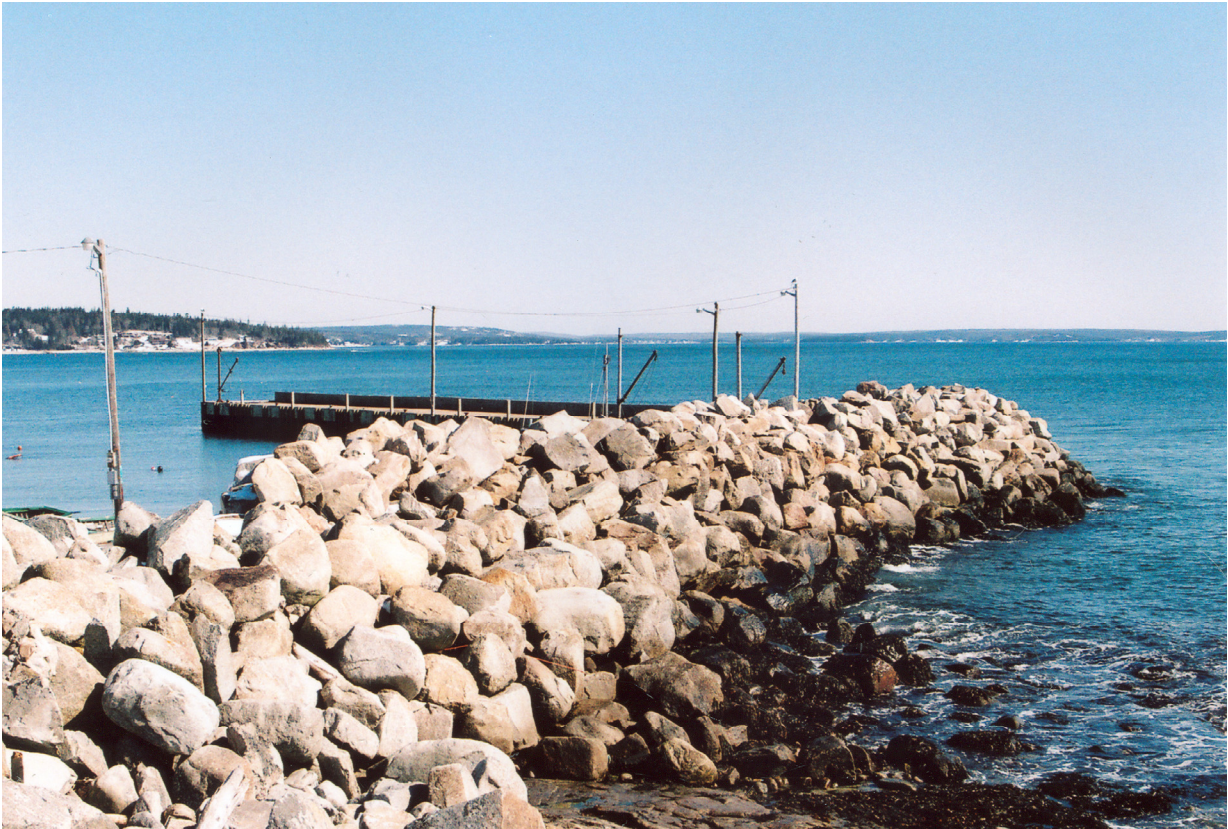
Figure 5. Examples of common breakwater construction methods; large armour stone breakwater protecting an older creosote-framed, interlocking bay and stone ballast breakwater located at Fox Point, St. Margarets Bay.

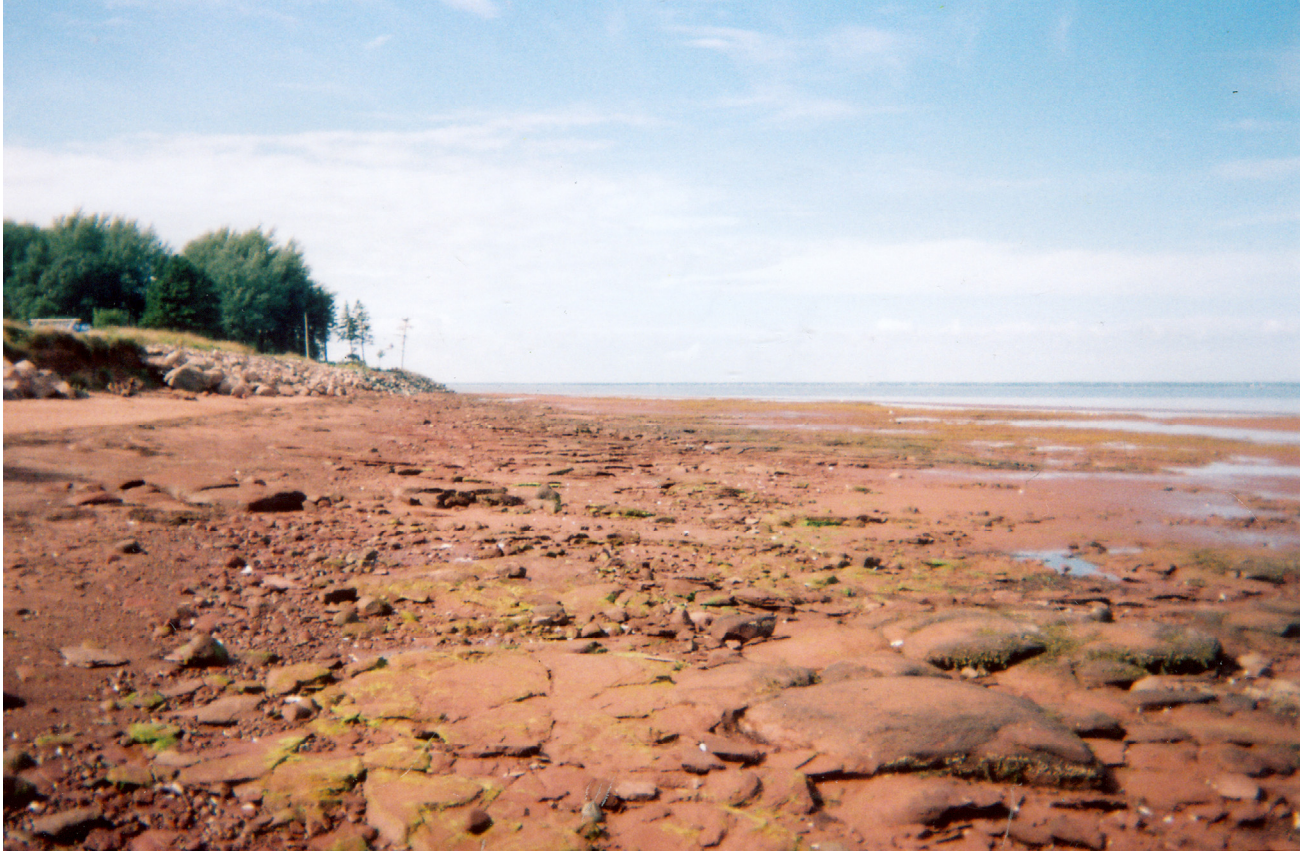
Within the study area the coastline has a wide wave cut platform and a low-angle to almost flat foreshore (Fig. 13). An abrupt change in slope occurs near the top of the foreshore where there may be a narrow sandy beach ridge about 1 m high.

This indicates that for much of the tidal cycle waves must cross the wide, low-angle foreshore (relatively resistant to erosion due to rock outcrop) prior to striking the unconsolidated banks or low beach ridge. This situation suggests that the larger destructive waves break or otherwise lose significant amounts of energy prior to reaching the shore face. If the foreshore was somewhat steeper, shore front properties would probably take a much more severe beating from plunging and collapsing waves. This may be why many cottages are not simply swept away in storms, given the low elevations and proximity of the structures to the shore face.

Figure 13. View of the wide, flat foreshore with rock outcrop.
