# Coastal Hazard Assessment Along the Blue Beach Fossil Cliffs, Kings County

*P. W. Finck and D. J. Utting*

## Background and Scope of Report

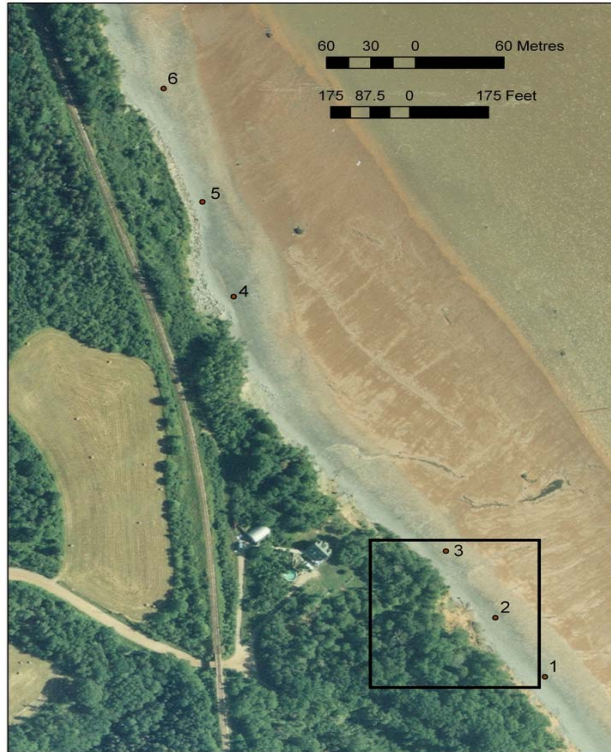
**Figure 2.** Air photo showing locations of the photographs referred to in this report. The square outline shows the location of a close-up view of the shoreline where there is a large rotational slump (Fig. 3).

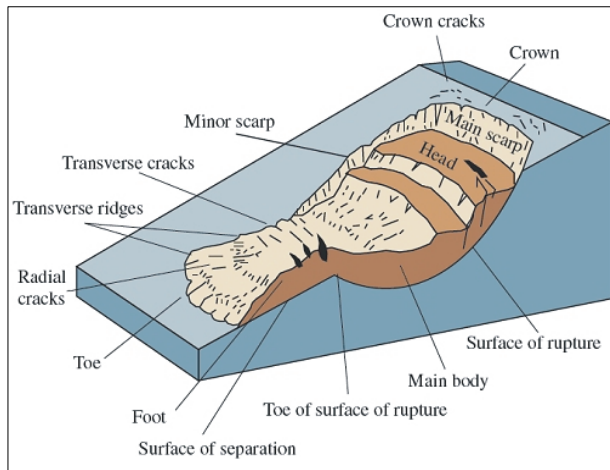
Rotational slumps along the shoreface likely fail along main internal plains of weakness in the bedrock, or at the overburden - weakened rock interface, producing a main scarp (Fig. 4), and in some areas multiple secondary slumps internal to the main rotational slump. The result is a series of systematic ridges, tilted landward and decreasing in elevation toward the shoreface. At Blue Beach observed slumps are in excess of 10 m in width, though significant amounts of material were previously eroded and washed away. Thus 10 m is

the shoreline is caused by slumps of material falling and sliding down and out over the beach, giving the appearance of seaward movement of the shoreline. The debris was subsequently eroded. The debris comes from the outer edge of a large slump block at the top of the cliff near site 2 (Fig. 2). These slumps are classic examples of rotational slumps (Fig. 4).

**Figure 4.** Diagram showing typical rotational slump and its various components (Geological Survey of Canada web site).
