Coastal Process, Geohazard, Erosion and Infrastructure Sustainability Studies at Cabots Landing Provincial Park, Port Shoreham Beach Provincial Park, and the Proposed Replacement for Plaster Provincial Park, Nova Scotia

P. W. Finck

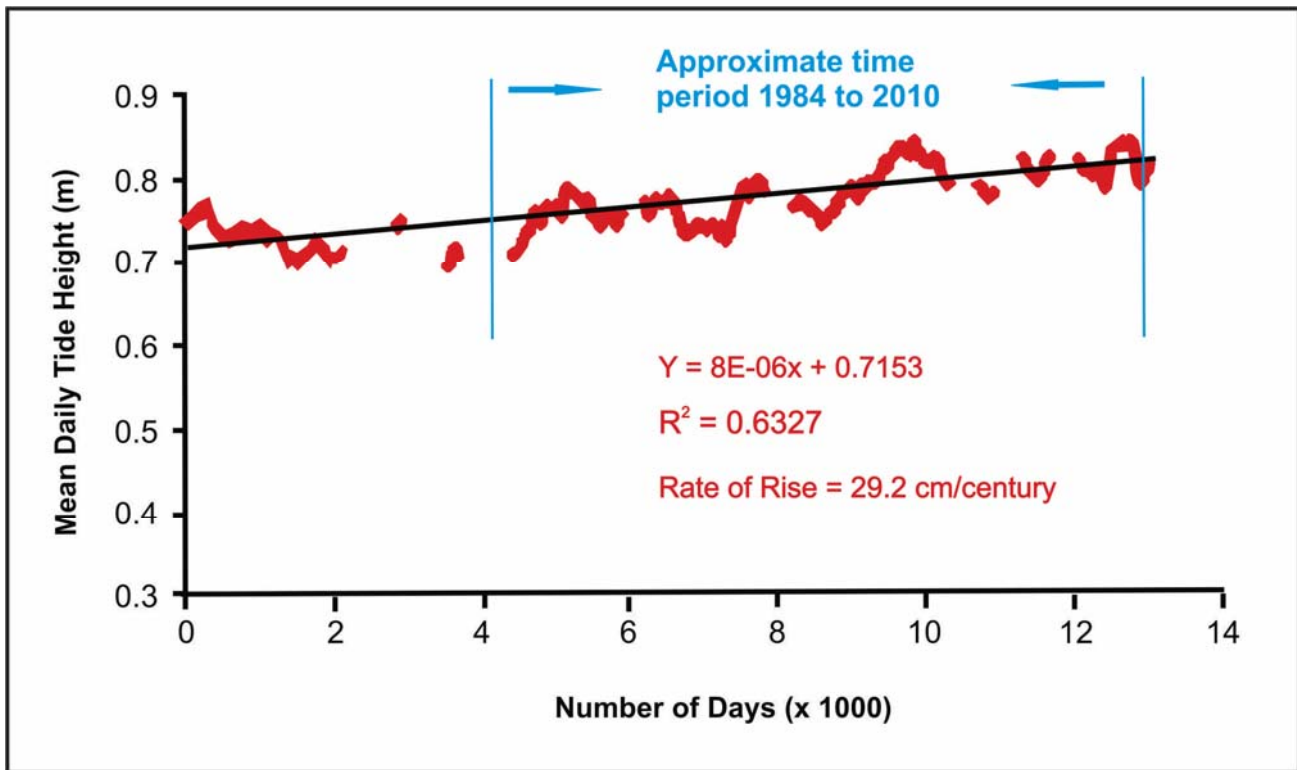
The time period from 1984 to 2010 is approximately equivalent to days 3650 and 13000 in Figure 5, which shows data from the North Sydney tidal gauge. It is clear that sea level is rising with respect to the shoreline and that this will drive erosion. However, there is no obvious increase in the rate of sea-level rise between 1984 and 2010 compared to the trend from 1975 to 2010. This suggests that an increase in the rate of sea-level rise isn’t a primary driver of the apparent increase in the rate of erosion at Cabots Landing. At the same time, this doesn’t imply that any future increase in the rate of sea-level rise won’t result in a further increase in the rate of erosion at the park.

Figure 5. Tide data (daily mean water level) for the North Sydney tide gauge from Fisheries and Oceans Canada (n.d.), 1975 through 2010.

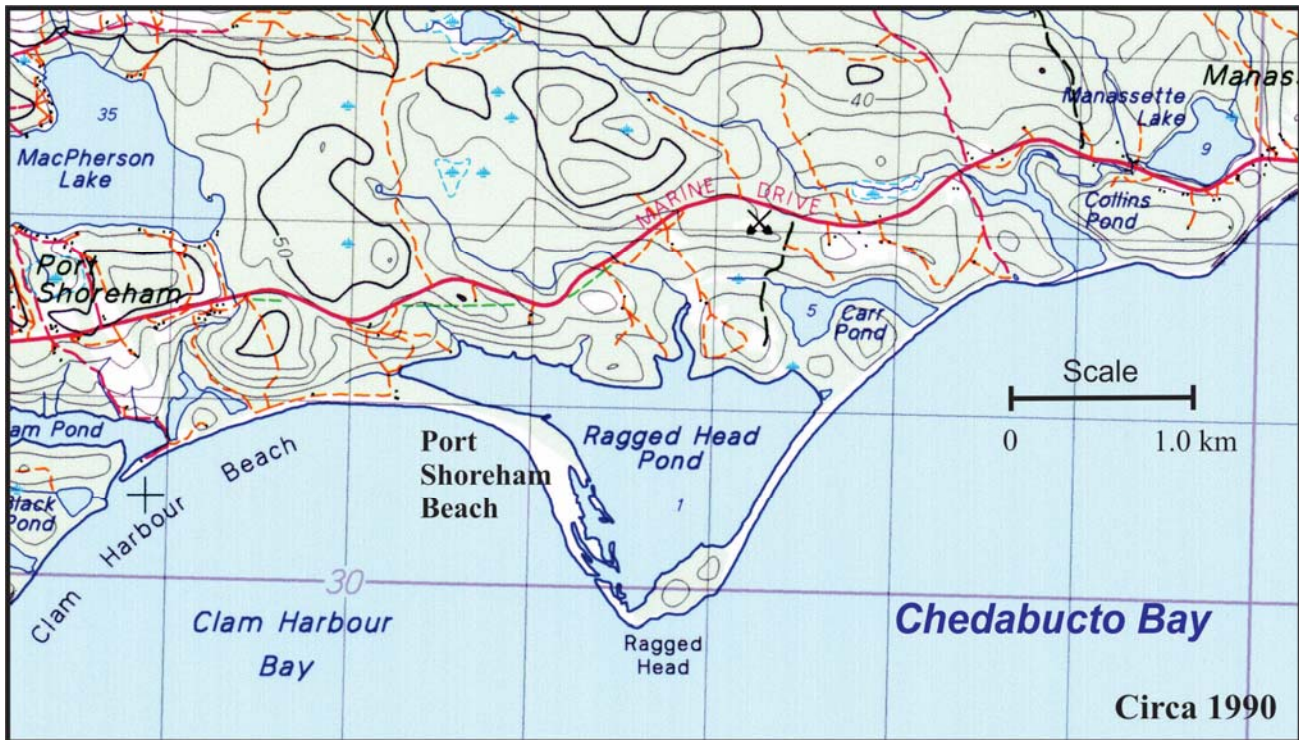
Port Shoreham Beach is located on the north side of the western extension of Chedabucto Bay, Guysborough County, Nova Scotia. The beach is on the west side of Ragged Head (Fig. 6). It consists of a series of spits that have built seaward in a southeast direction from the mainland, ultimately joining to the west side of Ragged Head. An unnamed, stable barrier beach or bar extends from the east side of Ragged Head to the mainland in the vicinity of Carr Pond. The two beaches are distinct in that the beach on the east side of Ragged Head shows no signs of breaching or channel development and further shows no indication of historical spit development. This beach probably formed as a bar deposit that moved progressively landward in response to a gradual rise in sea level. In contrast, Port Shoreham Beach formed from the progressive southeastward extension of spit development and shows clear signs of historic breaching and tidal channel formation. Historic southeastward growth is evident from the geomorphological expression of numerous coalescent spits that show sequences of growth,

Figure 6. Overview of the Port Shoreham Beach study area.

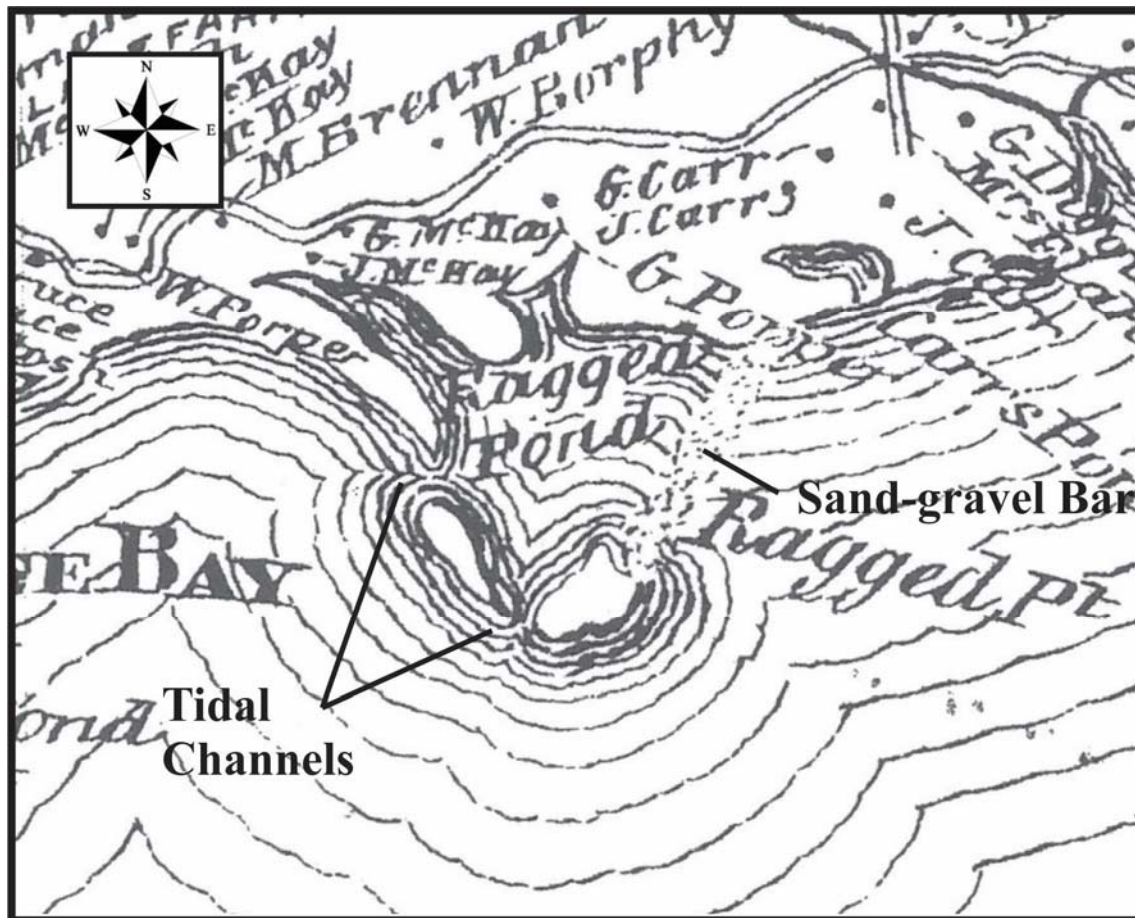
erosion and truncation, and subsequent regrowth. The growth of the spit complex is further evident when one examines the 1864 map of the area by Church (Fig. 7). Church shows two well formed breaches in Port Shoreham Beach. The westernmost breach is two contours deep while the eastern breach is one contour deep. I wasn't able to locate information on the Church map stating what the contour interval represented. It may in fact be qualitative rather than quantitative. Regardless, I interpret the western breach as being an open channel even at low tide. The eastern breach may have been an intertidal channel. In the 1864 map, I interpret Ragged Pond as being an intertidal lagoon.

Figure 7. Map of the Port Shoreham study area by Church (1864).
