Open File Report ME 1996-016

**Spillway Design/Construction Report
Stirling Mine Site
Richmond County, Nova Scotia**

File No. 24-3594-008-1

March 1996

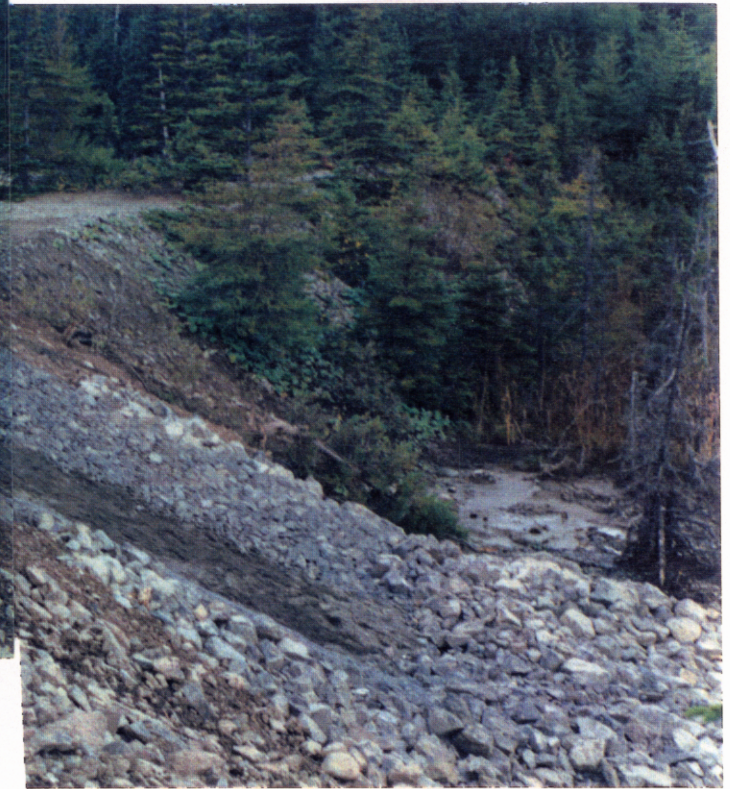
The completed spillway structure is shown in figures 5 and 6. The photographs show the rip rap material that was placed at the intake structure and the discharge outlet to prevent scour.

Photo #5 (above): Completed Spillway. Note ponding of water in tailings basin.
