Evaluation CBNS Sydney Subdivision

**Preliminary REVIEW of OPERATING, COSTS,
GEOTECHNICAL and INFRASTRUCTURE IMPROVEMENTS
RAIL LINE – Subsidized Portion of Sydney subdivision
MP 20.0 to 113.8 Nova Scotia**

CANARAIL Consultants Inc.

Date : August 31, 2015

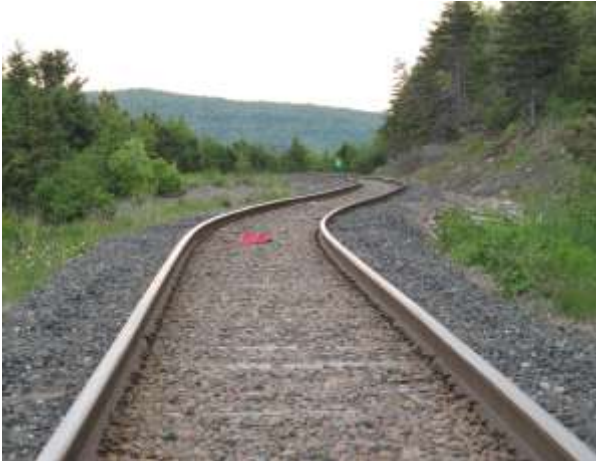
**Photo 7 – Mile 2.9: Non Subsidized Line
Westerly Looking Easterly: Line Realignment**
June 18, 2014

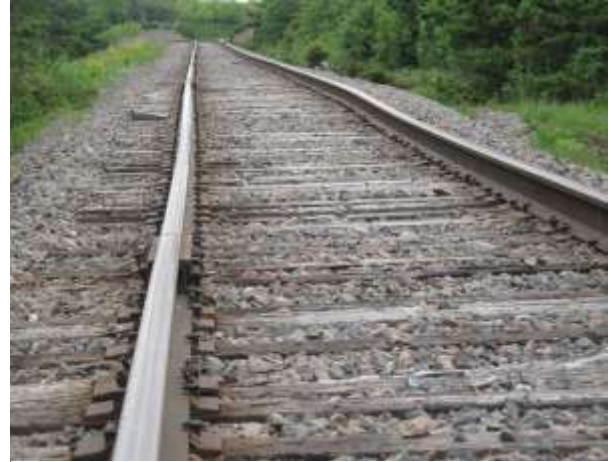
**Photo 8 – Mile 2.9: Non Subsidized Line
Line Settlements**
June 18, 2014

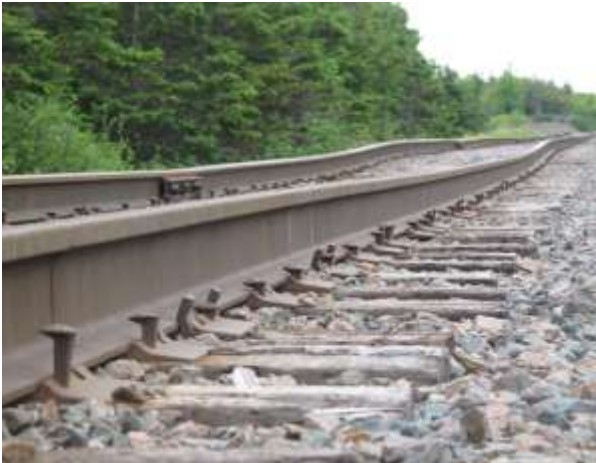
**Photo 9 – Mile 2.9: Non Subsidized Line
Side View Showing Line Settlements**
June 18, 2014

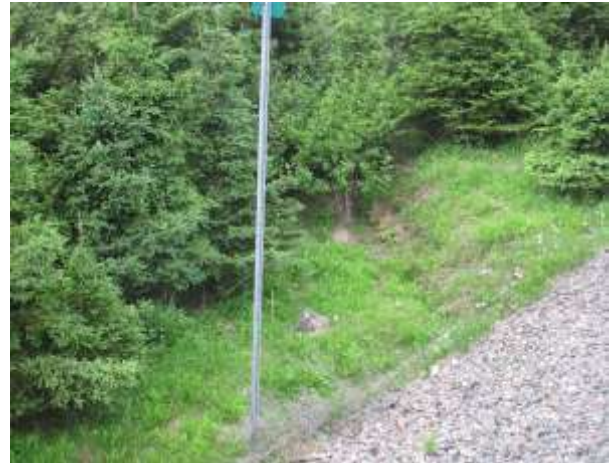
**Photo 10 – Mile 2.9: Non Subsidized Line
Crest of Slope: Sloughing**
June 18, 2014

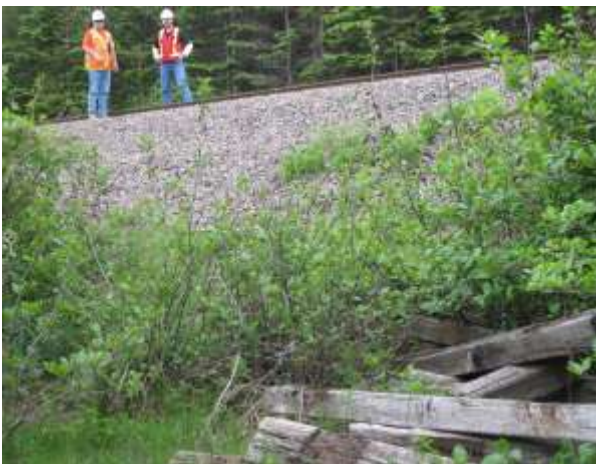
**Photo 11 – Mile 2.9: Non Subsidized Line
Toe of Slope: Bulging**
June 18, 2014

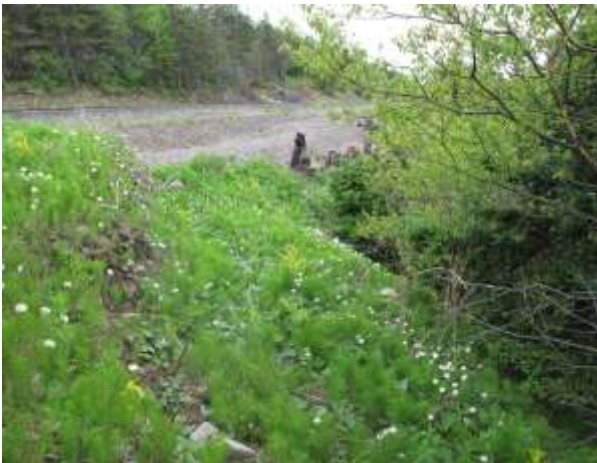
**Photo 14 – Mile 3.0: Non Subsidized Line
Crest of Slope (East Side): Sloughing**
June 18, 2014

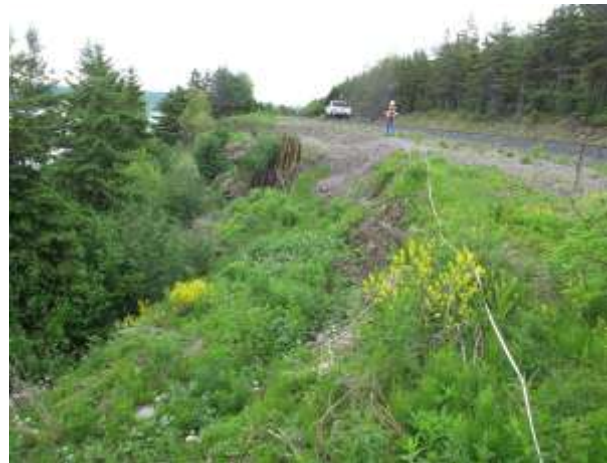
**Photo 15 – Mile 3.0: Non Subsidized Line
Crest of Slope (West Side): Sloughing**
June 18, 2014

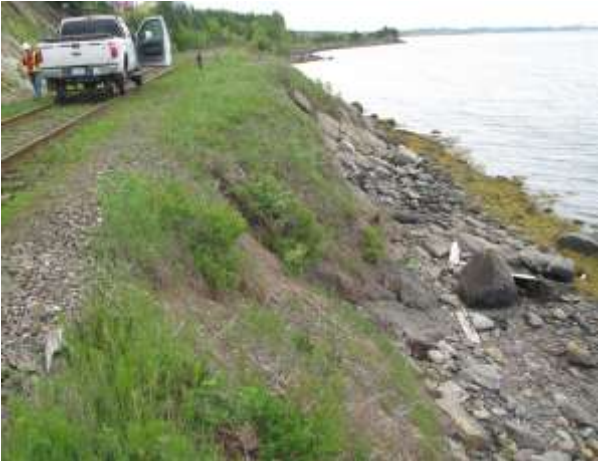
**Photo 18 – Mile 8.5: Non Subsidized Line
Westerly Looking Easterly: Sloughing**

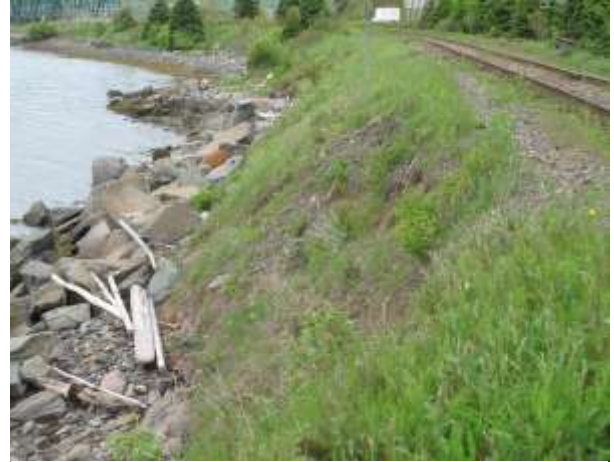
**Photo 19 – Mile 8.5: Non Subsidized Line
Easterly Looking Westerly: Sloughing**

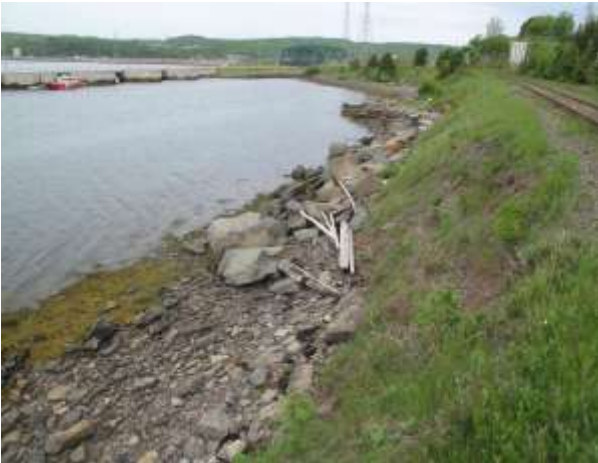
**Photo 20 – Mile 8.5: Non Subsidized Line
South Side of Line: Toe of Slope**

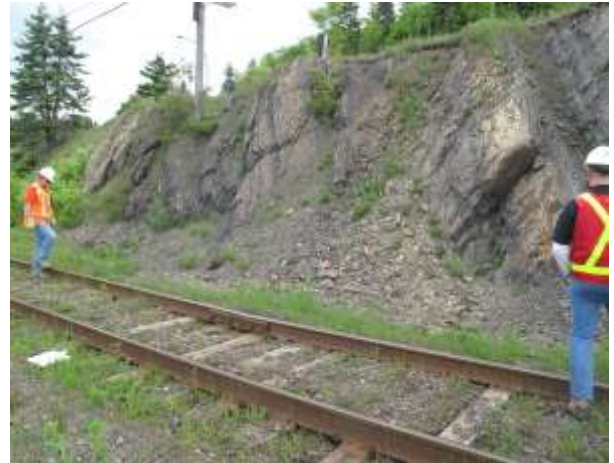
**Photo 21 – Mile 8.5: Non Subsidized Line
North Side of Line: Bedrock Outcrop**

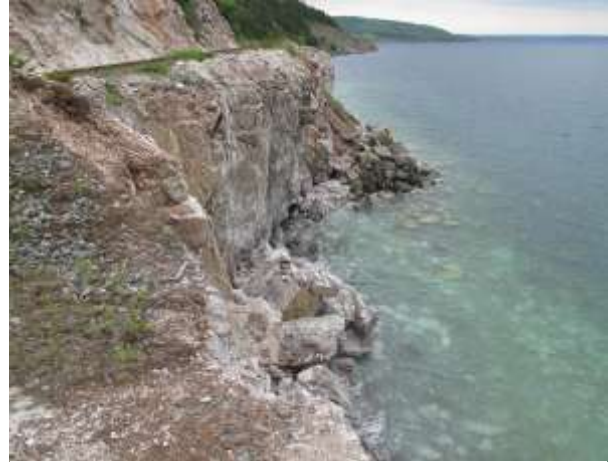
**Photo 24 – Mile 54.6: Subsidized Line
Undermining at Toe of Cliff**
June 18, 2014

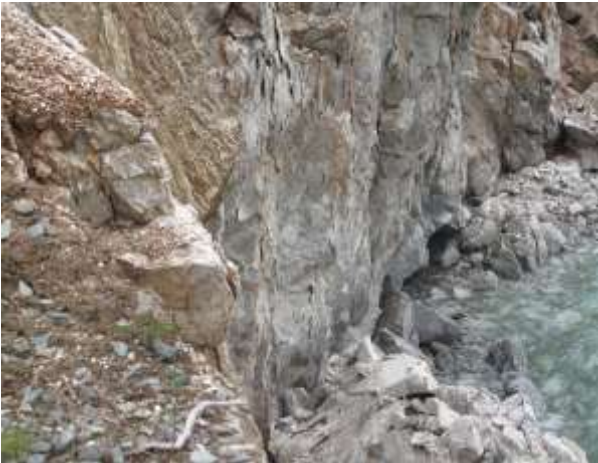
**Photo 25 – Mile 54.6: Subsidized Line
Close Up of Toe of Cliff**
June 18, 2014

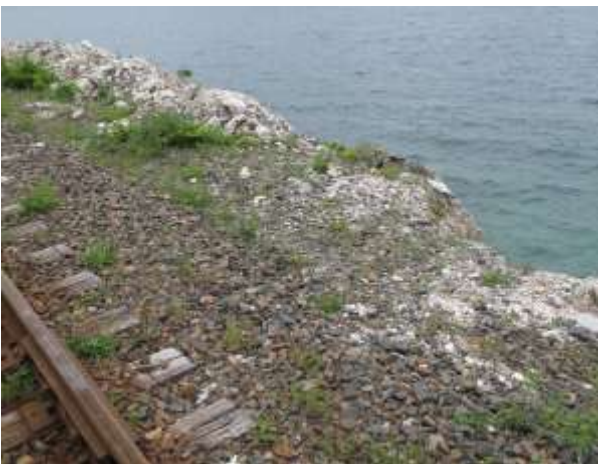
**Photo 27 – Mile 54.6: Subsidized Line
Area Between Line and Cliff**
June 18, 2014

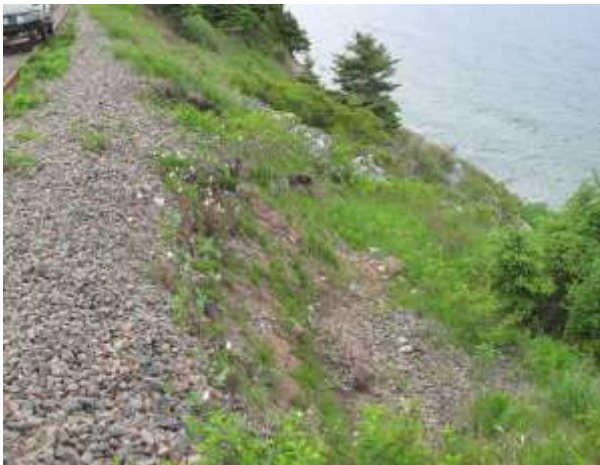
**Photo 31 – Mile 55.1: Subsidized Line
Sloughing Near East End of Slope**

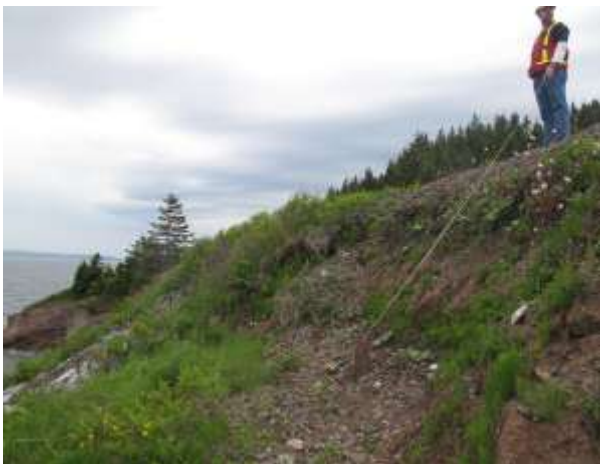
**Photo 33 – Mile 55.1: Subsidized Line
Vertical Displacement at Crest of Slope**

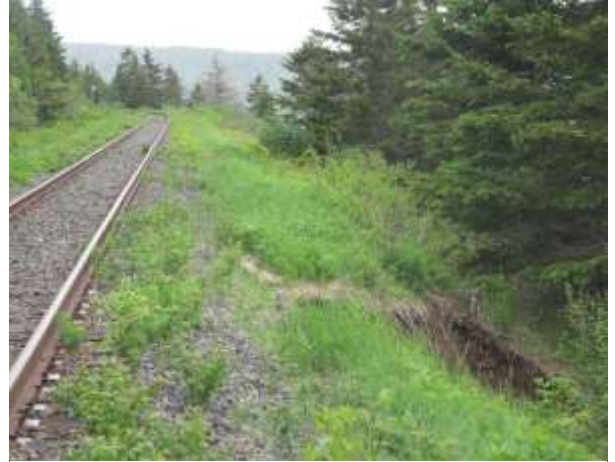
**Photo 36 – Mile 60.1: Subsidized Line
North Side of Line: Sloughing at Crest**
June 18, 2014

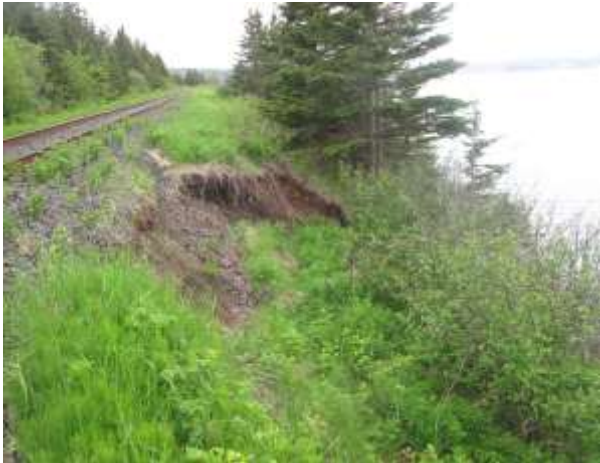
**Photo 37 – Mile 60.1: Subsidized Line
Vertical Displacement at Crest of Slope**
June 18, 2014

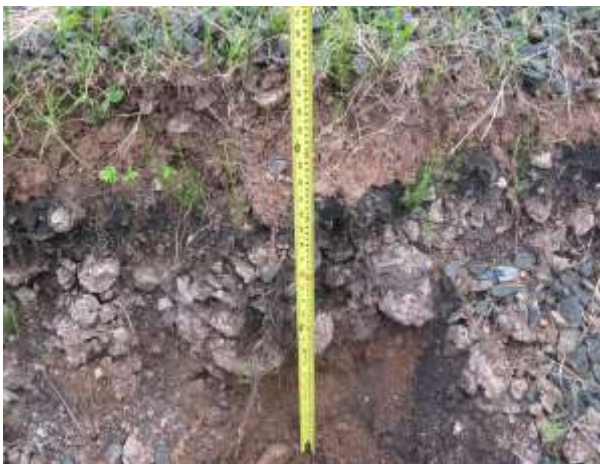
**Photo 39 – Mile 60.1: Subsidized Line
Crest of Slope Consisting of Fill**
June 18, 2014

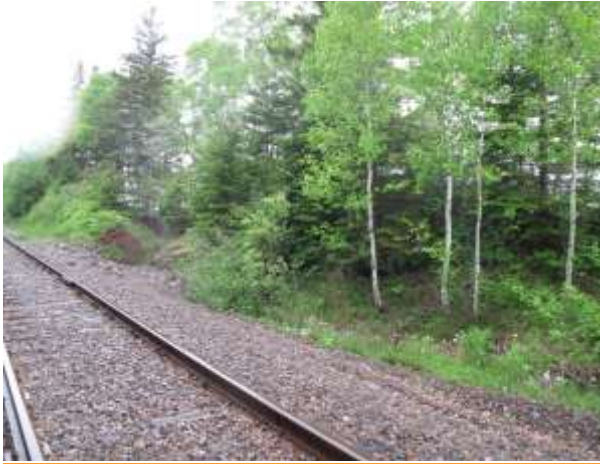
**Photo 41 – Mile 68.3: Subsidized Line
North Side of Line**

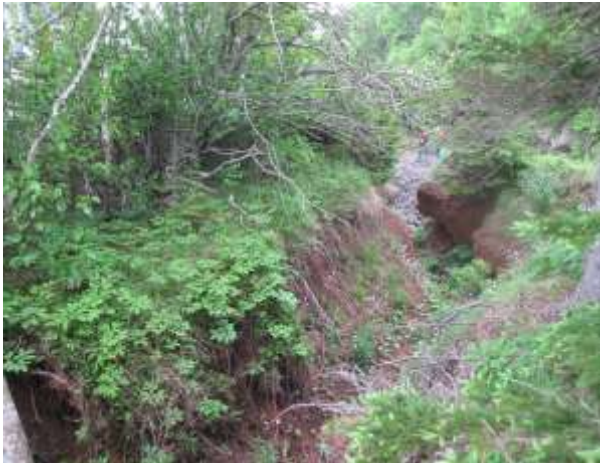
**Photo 43 – Mile 68.3: Subsidized Line
North Looking South: Slope Movement**

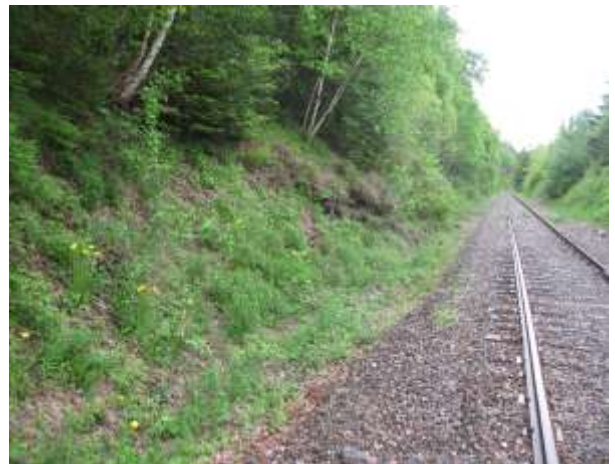
**Photo 46 – Mile 68.3: Subsidized Line
South Side of Line**

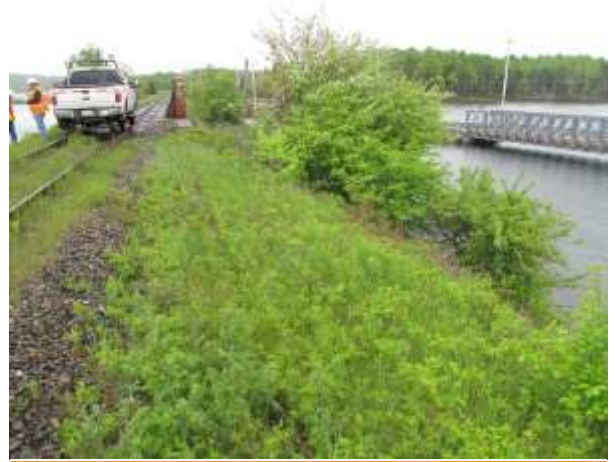
**Photo 48 – Mile 103.3: Subsidized Line
North Looking Southerly: West Side of Line**
June 18, 2014

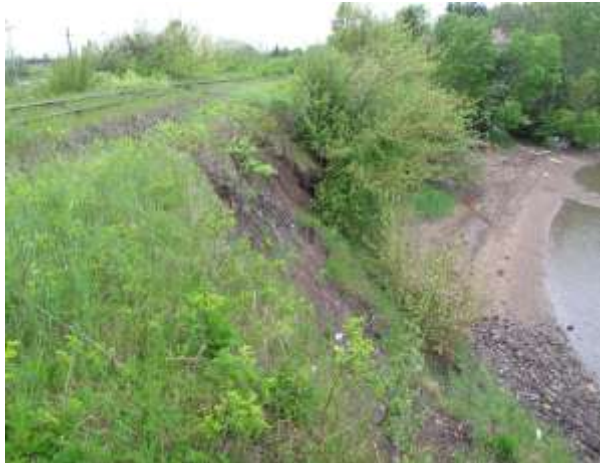
**Photo 49 – Mile 103.3: Subsidized Line
North Looking South: East Side of Line:**
June 18, 2014

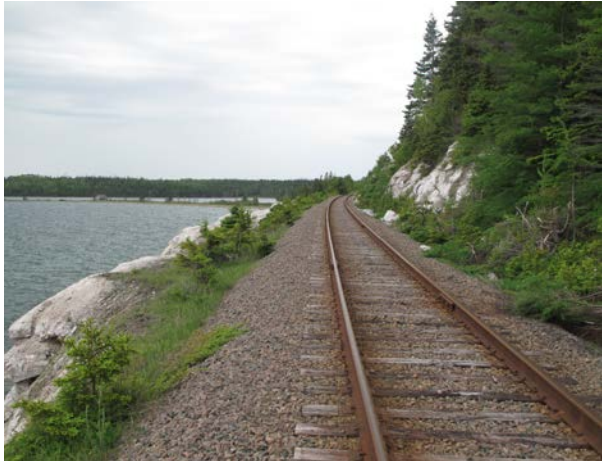
Photo #53 - Mile 53.8: Subsidized Line East looking West - Crest of Embankment

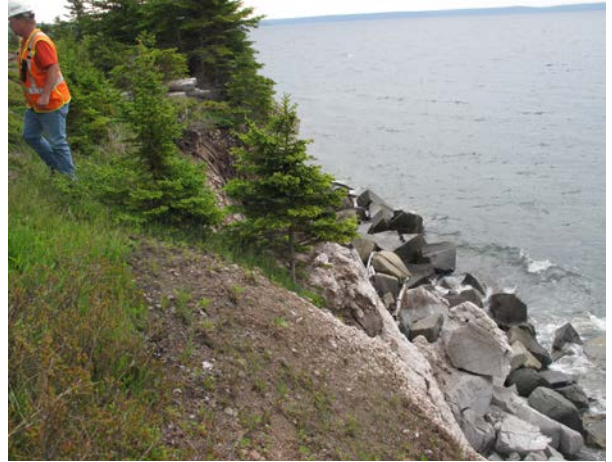
Photo #54 - Mile 53.8: Subsidized Line Local Sloughing Near Crest

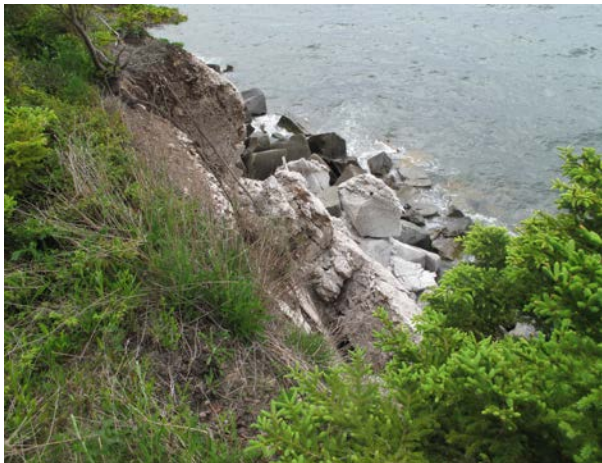
Photo #55 - Mile 53.8: Subsidized Line Toe of Embankment

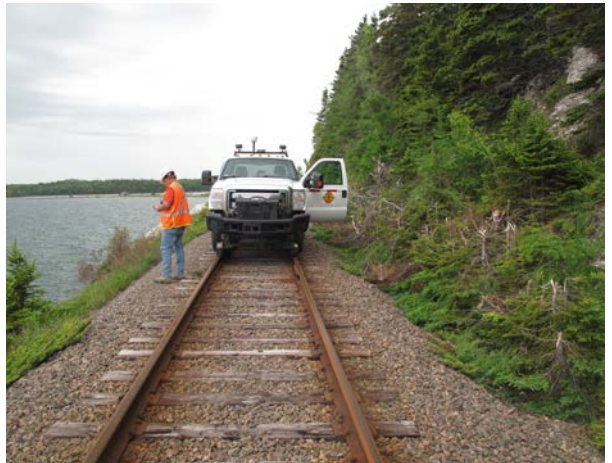
Photo #56 - Mile 53.8: Subsidized Line East Looking Westerly

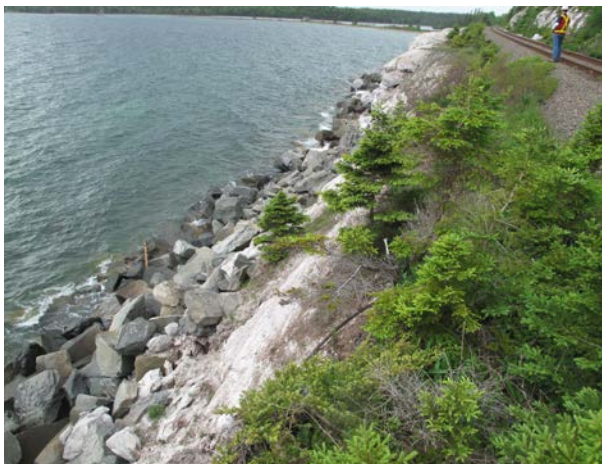
Photo #57 - Mile 53.8: Subsidized Line Toe of Embankment

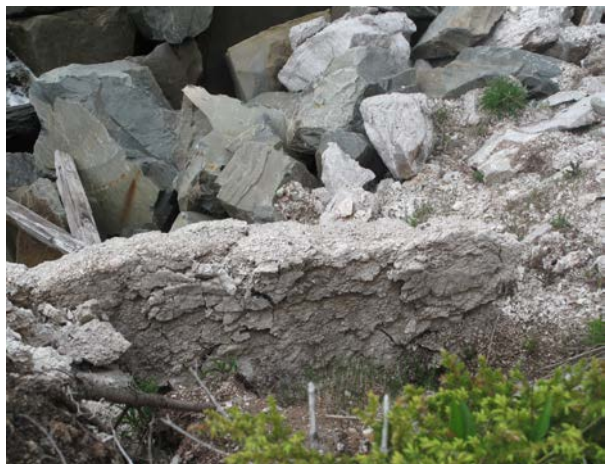
Photo #58 - Mile 53.8: Subsidized Line Soughed Material at Toe

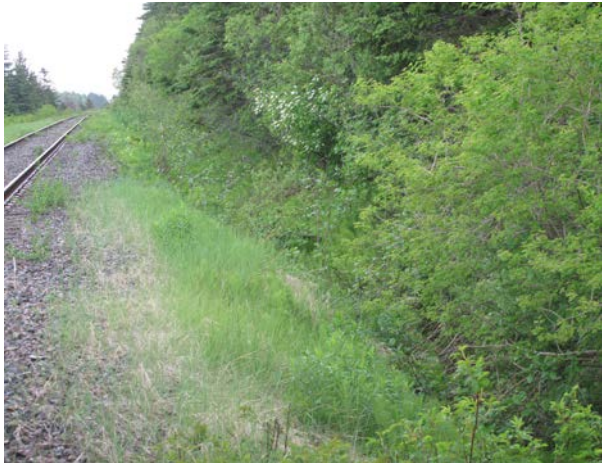
Photo #59 - Mile 57.0: Subsidized Line West Looking Easterly, South Side of Rail

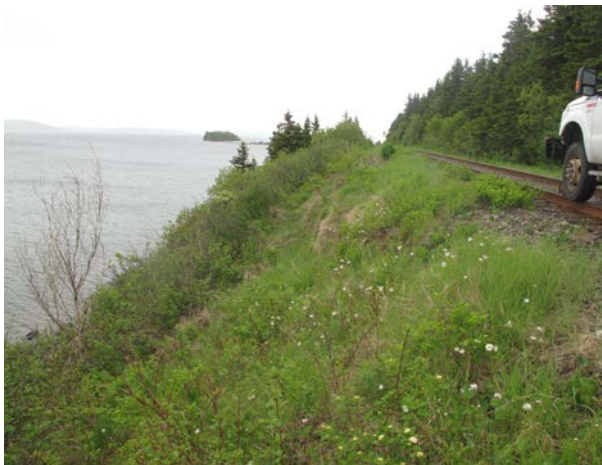
Photo #61 - Mile 58.8: Subsidized Line West Looking Easterly; North Side of Rail - Localized Sloughing

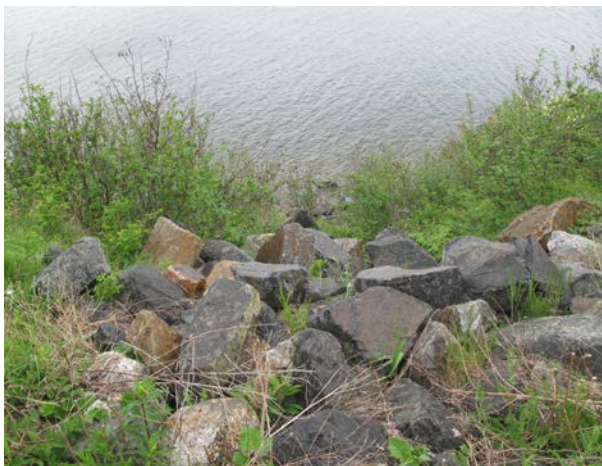
Photo #63 - Mile 57.0: Subsidized Line Location Remediated West of Subject Slope

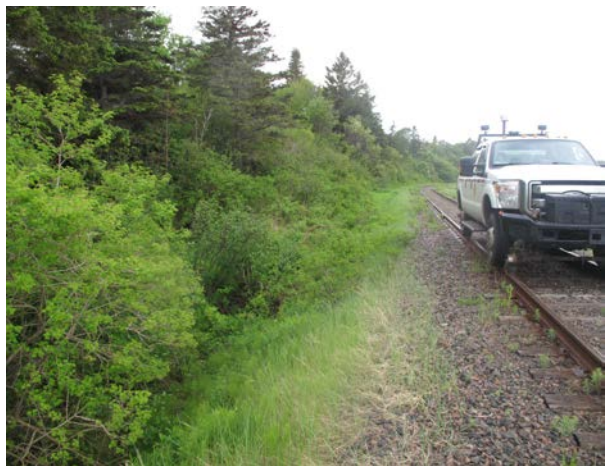
Photo #64 - Mile 58.8: Subsidized Line East Looking Westerly, South Side of Rail
