APPENDIX 6.8-A

**Fish Habitat Compensation Plan for the Proposed Work
by Melford International Terminal Inc.**

Project Name: Container Terminal Facilities, Melford Nova Scotia

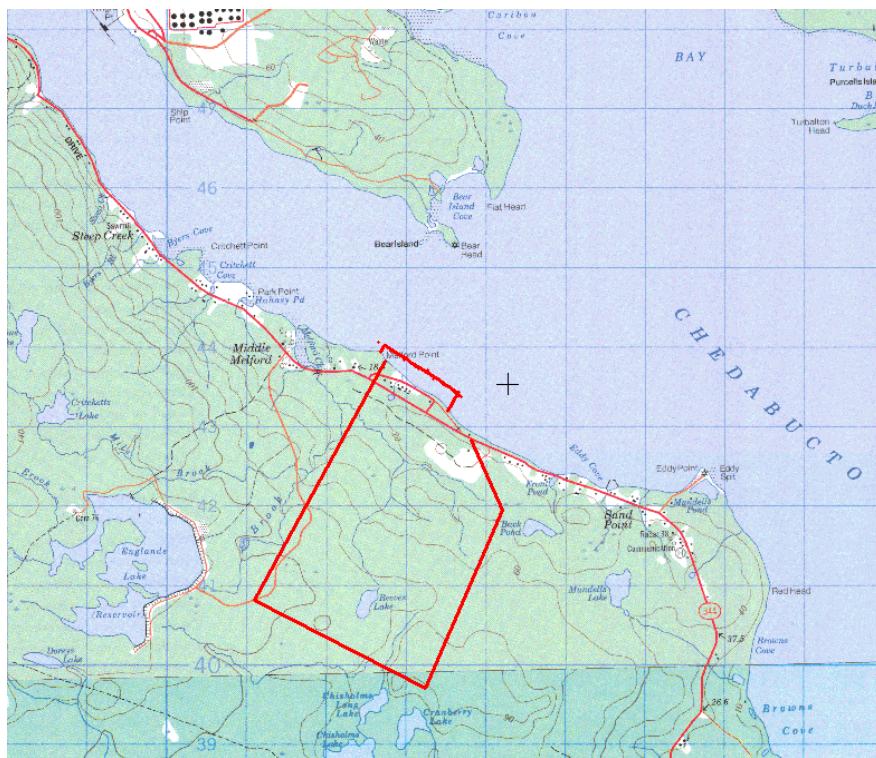
Fig 1 Project location: showing the marine infill area and the logistics park area.
Topo map 11F11

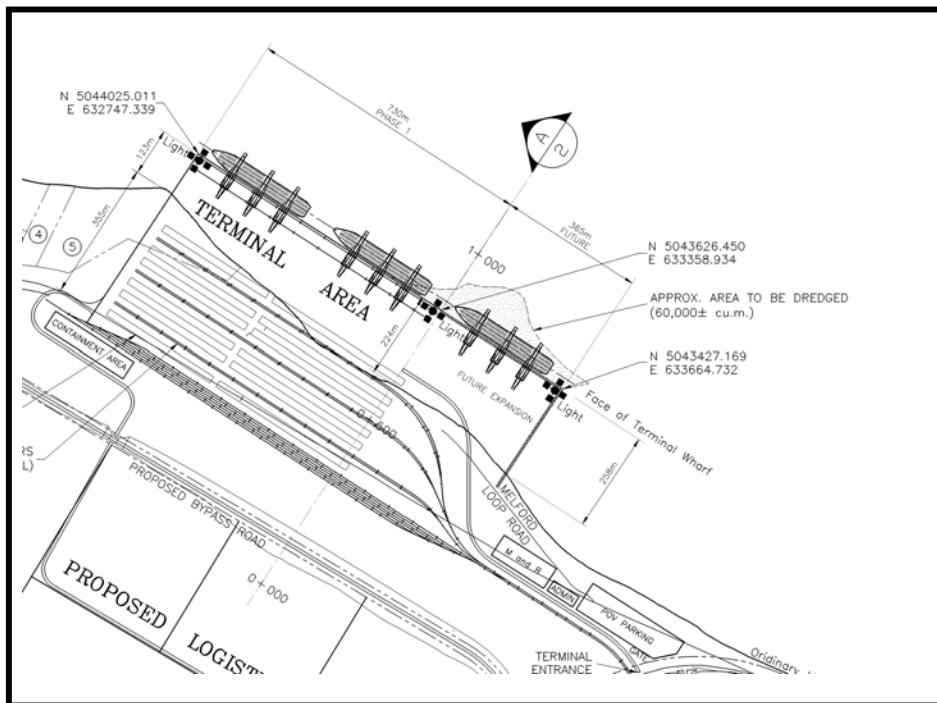
Fig 2 Marine terminal detail: showing the infill and dredged areas.

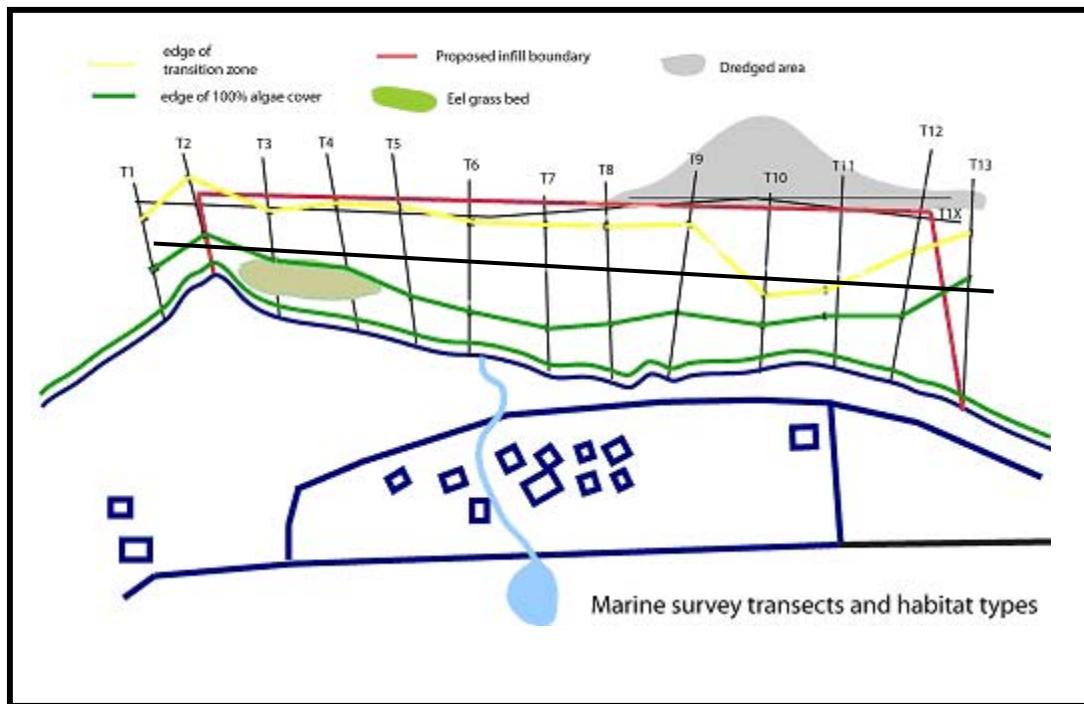
Fig 3. Location of spring 2008 video transects and habitat types

The area in which the HADD will occur has been surveyed using underwater video along the transects shown on fig 3 and locations in table 1.

In the near shore area the substrate is clean cobble/gravel and does not support very much life because of its’ wave exposure and related high mobility. This area is a small narrow band along the shore as shown in fig 3 between the green and blue lines.

There is very high primary productivity in this area but unexpectedly low secondary productivity. This may be due to the fact that water temperatures were 0⁰ C to 2⁰ C during the 2008 sampling. Transects collected in June 2007 show the presence of lobster and crab in very low numbers but the other species mentioned above were still absent or in very low numbers. This is true for all of the habitat types in the development area and there is no clear answer as to why this might be the case. This area is shown in fig 3 between the two green lines.

Only one eelgrass bed (*Zostrea marina*) was found in the surveyed area. The substrate in this area is composed of coarse sand, likely superimposed over a gravel/cobble base. If the prevailing coastal current is from the northwest to southeast as would be expected then the eelgrass bed is on a depositional area in the lee of the point. This isolated oasis of sand is a substrate type that is more conducive to eelgrass establishment, propagation and production than coarse gravel and cobble found in adjacent areas. The bed is on the edge of the dense macrophytic algal community in water depths between 3m to 5 m. The eelgrass is shown in fig 3 as a green polygon.

This is a broad zone exhibiting a complex gradient of substrate types ranging from a coarse gravel/cobble matrix to increasingly fine sand to silt/clay fraction that covers the underlying coarse gravel/cobble matrix. Associated with this increasing amount of a silt/clay veneer deposit is a filamentous algal growth. Dense mussel shell debris beds begin to dominate the surface as Area “E” is approached. The silt/algae veneer covers this shell material. This band of dead horse mussel (*Modiolus modiolus*) shells is clearly seen in all transects and follows the yellow line on fig 3 ranging in depth from 10 to 15m but usually between 14 and 14.5m deep. Area ‘D’ is shown on fig 3 between the green line and yellow line.

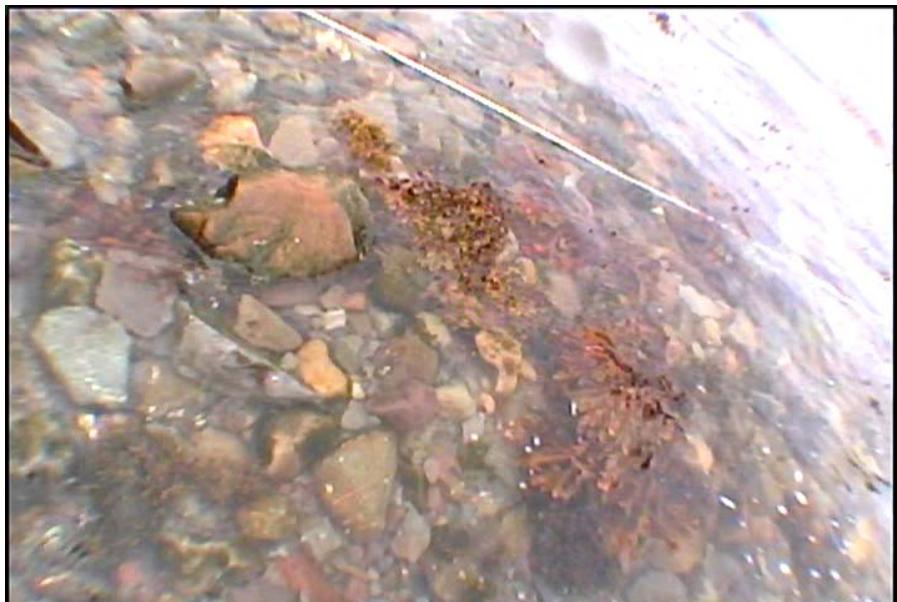
Pic 1 Inshore substrate on transect 11

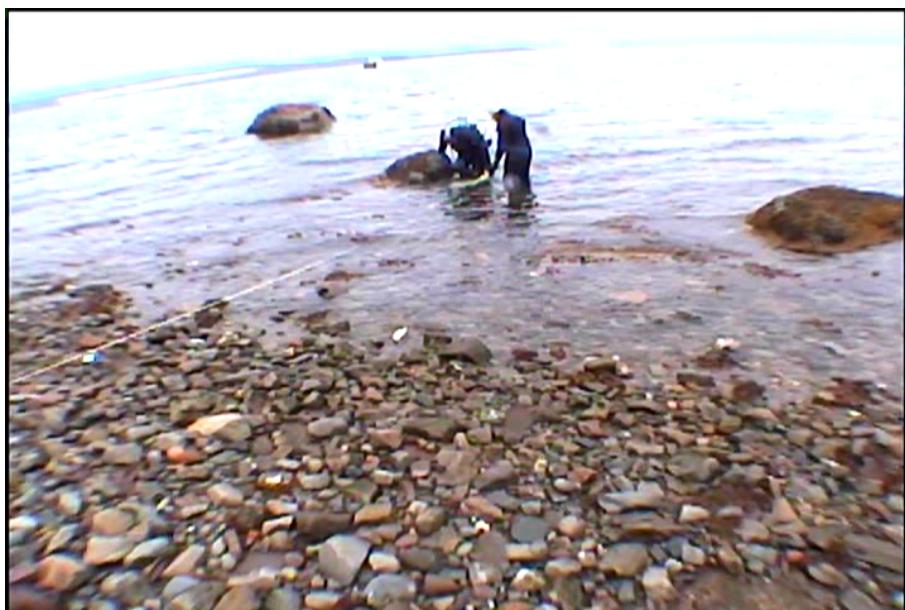
Pic 2 Shore substrate on transect 11

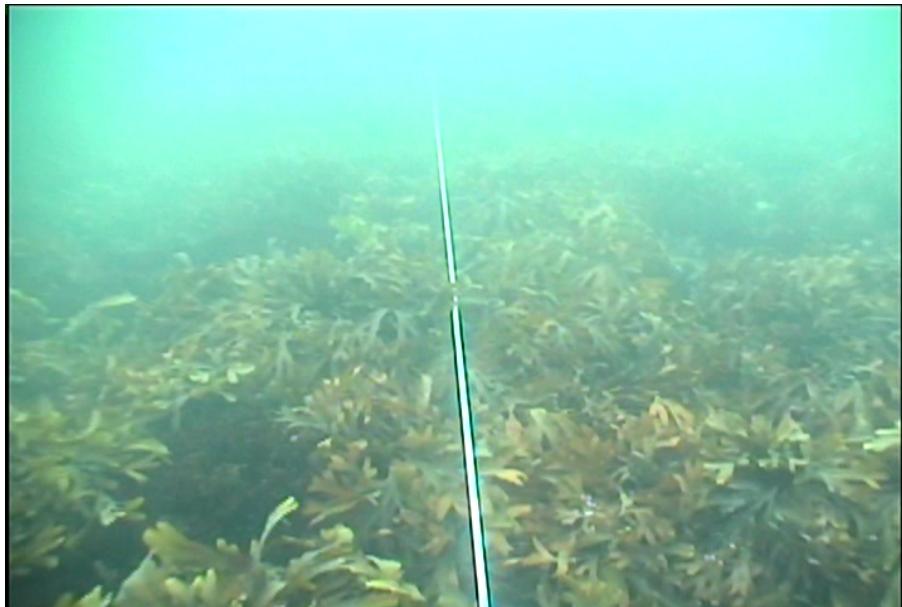
Pic. 3 Typical algae cover on transect 4 at the 15 m mark, depth 2 m

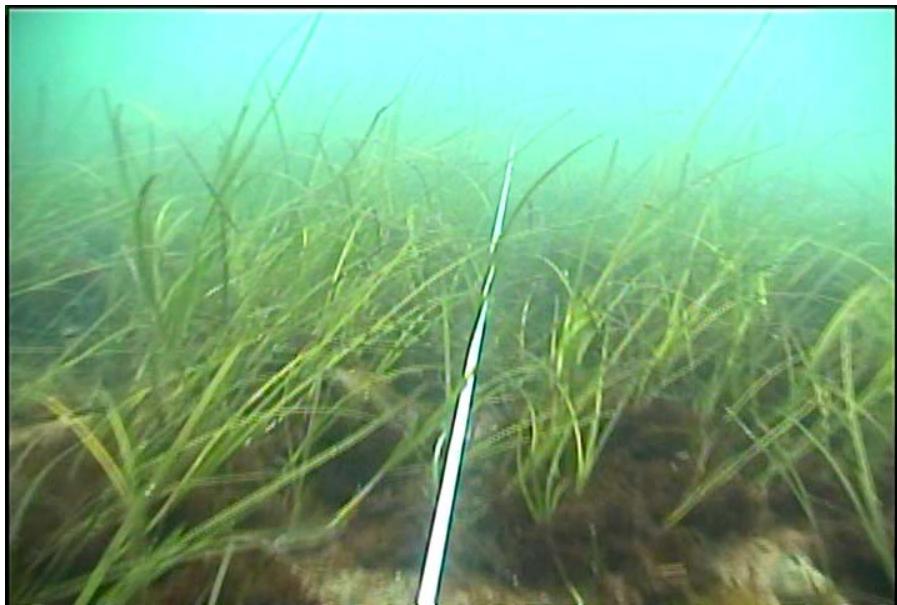
Pic. 4. Typical eelgrass bed on transect 3 at the 35 m mark, depth 3 m

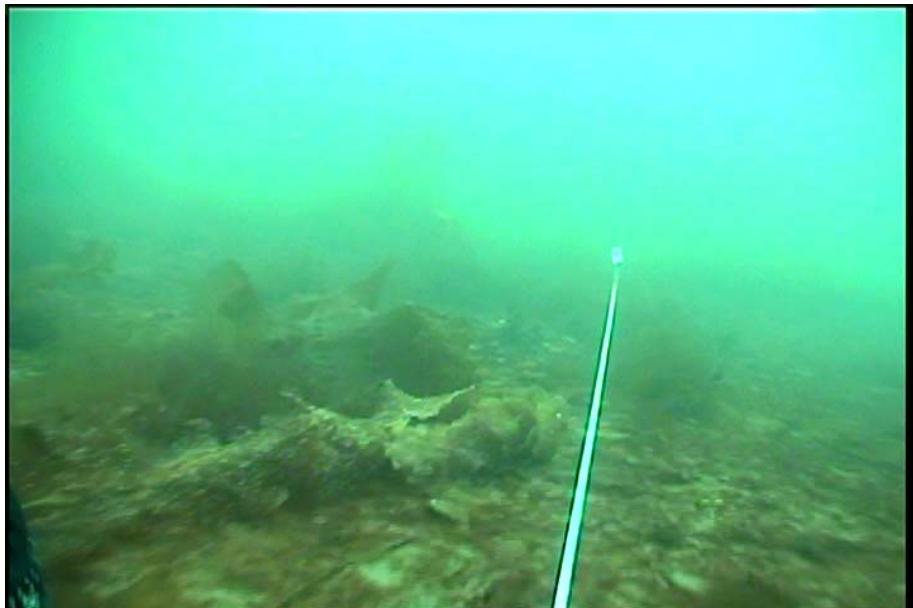
Pic 5 Typical transition zone habitat transect 3 at the 75 m mark, depth 8 m

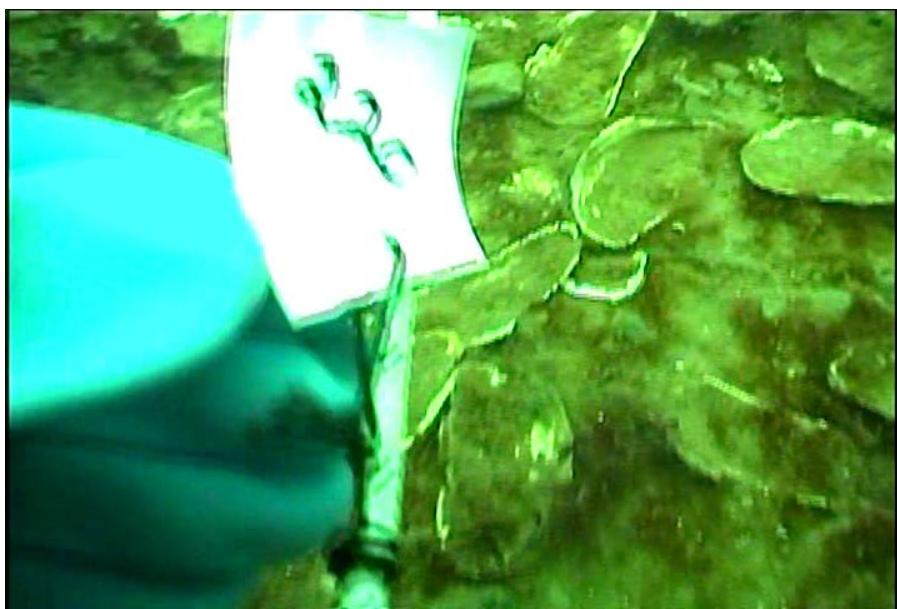
Pic 6 Shell debris line on transect 9 at the 230 meter mark, depth 15 m

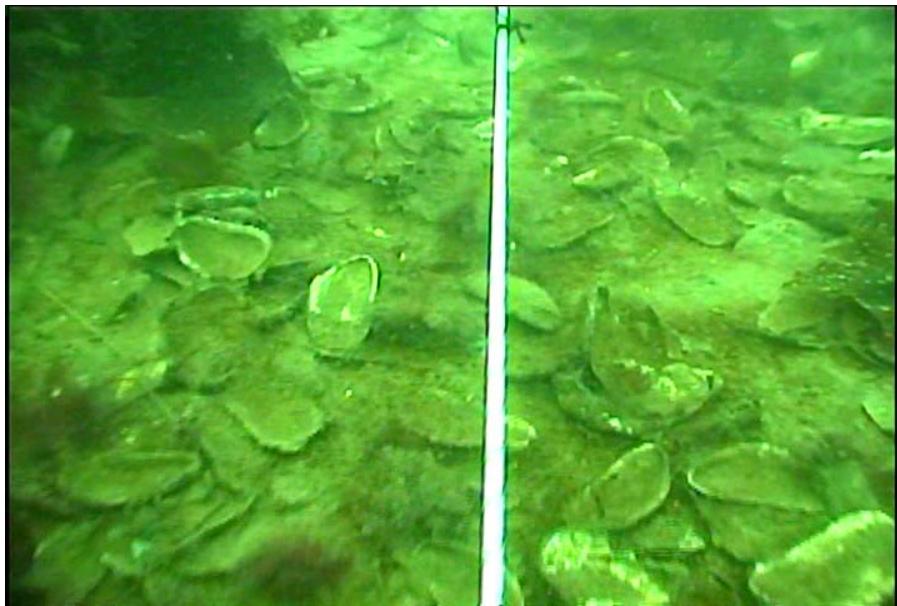
Pic 7 Shell debris line on transect 10, at the 230 m mark, depth 14.5 m

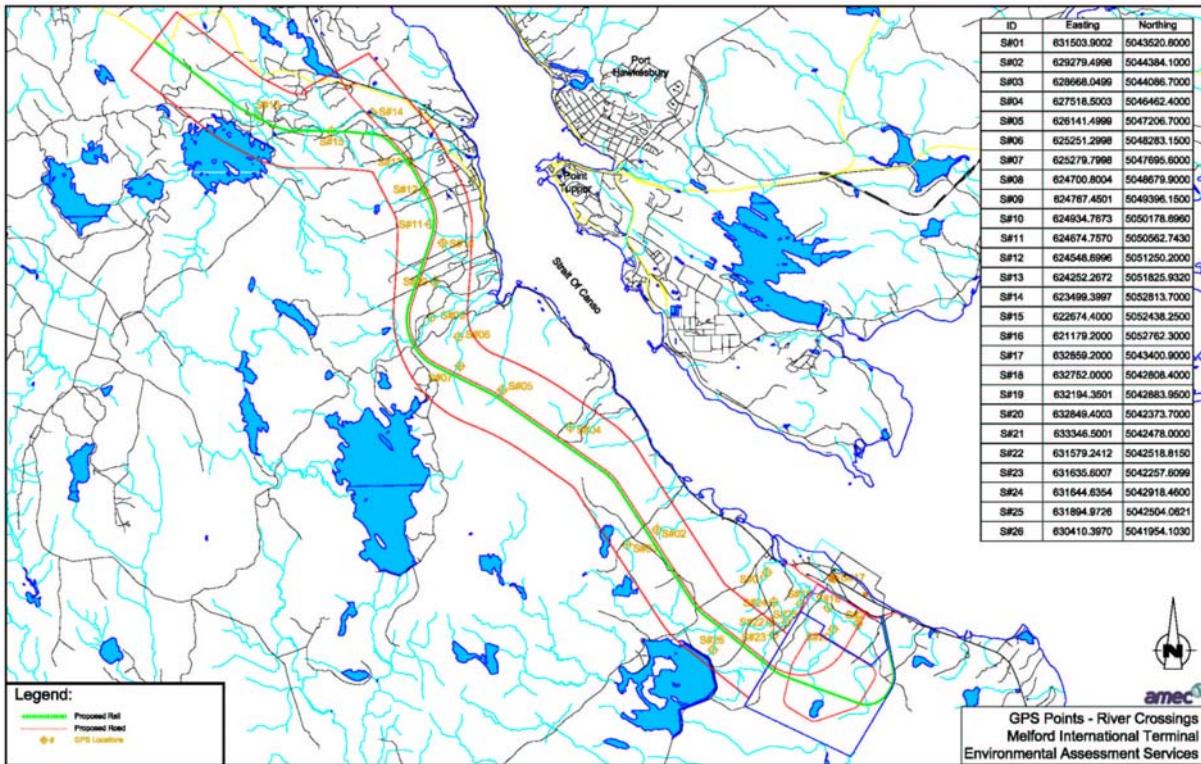
Fig 6 Map of the rail corridor and identified stream crossings

All stream crossings will be open box culverts until the rail line reaches the logistics area then it will begin to descend through an open cut. Open box culverts are effective at protecting fish habitat in areas where the footings can be placed near the ground surface. In areas that require a lot of overburden excavation for the footings the work may encroach on the stream habitats. Detailed geo-technical surveys for the crossings have not been done. However, if it is found that the habitats will be impacted by the culvert installation the on site habitats will be restored in a way to create equal or better Brook trout habitat. There will be no net loss of habitat from these stream crossings.

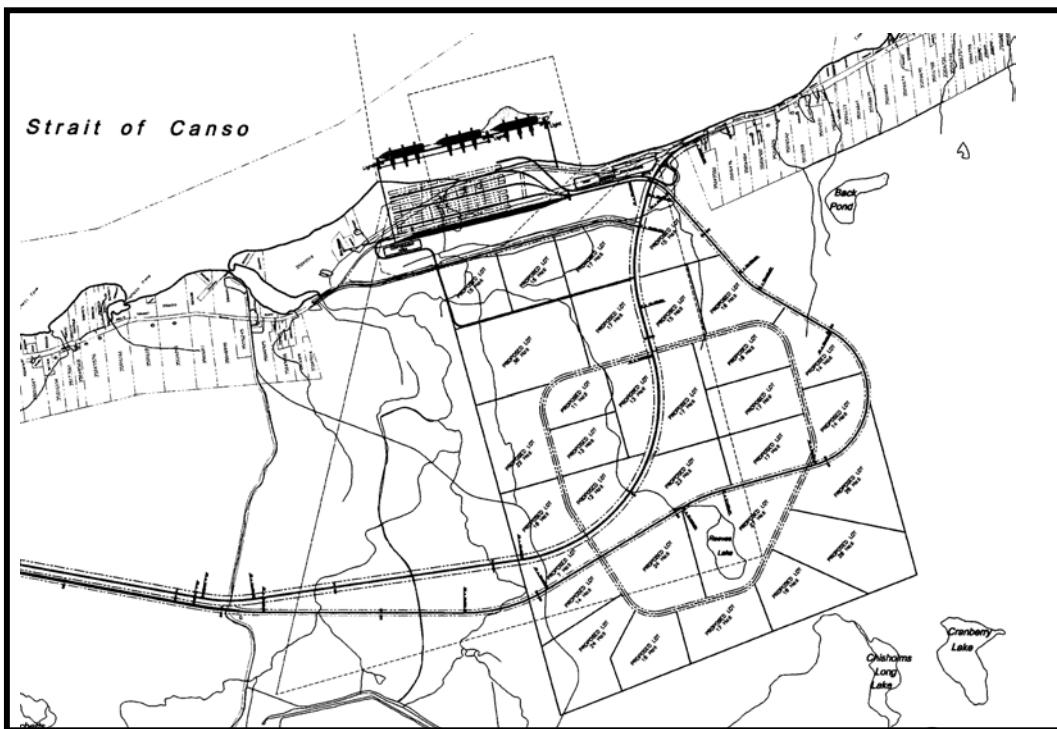
The logistics area will be developed over the next 10 years. The figure below shows the rail cuts that will intercept the flow from the streams and direct the flow along the deep cut to the ocean at the east end of the development. All the streams are Brook trout habitat and support all life stages.

Fig 7 Location of rail cuts in the logistics park area.

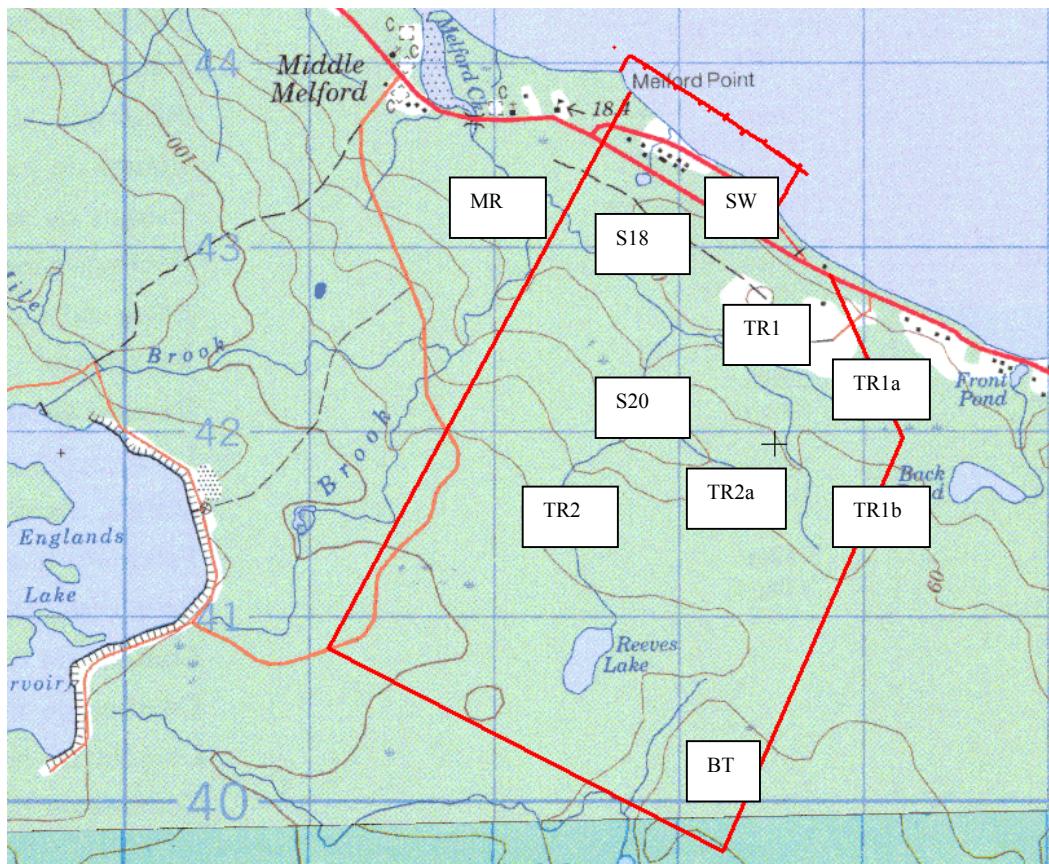
Fig 8 Stream reaches impacted by the development of the logistics park

The fish habitat areas have been estimated by calculating the stream size expected for the watershed area of each reach listed in table 5 and the length of the streams calculated from the topo map. These were crosschecked against field measurements done by AMEC at some of the sites. More field investigation may be required for the final compensation agreement. Water flow in the main river will be reduced by a portion equal to the size of the watershed lost, which is 14%. The water from the back tributary will still flow to King Brook.

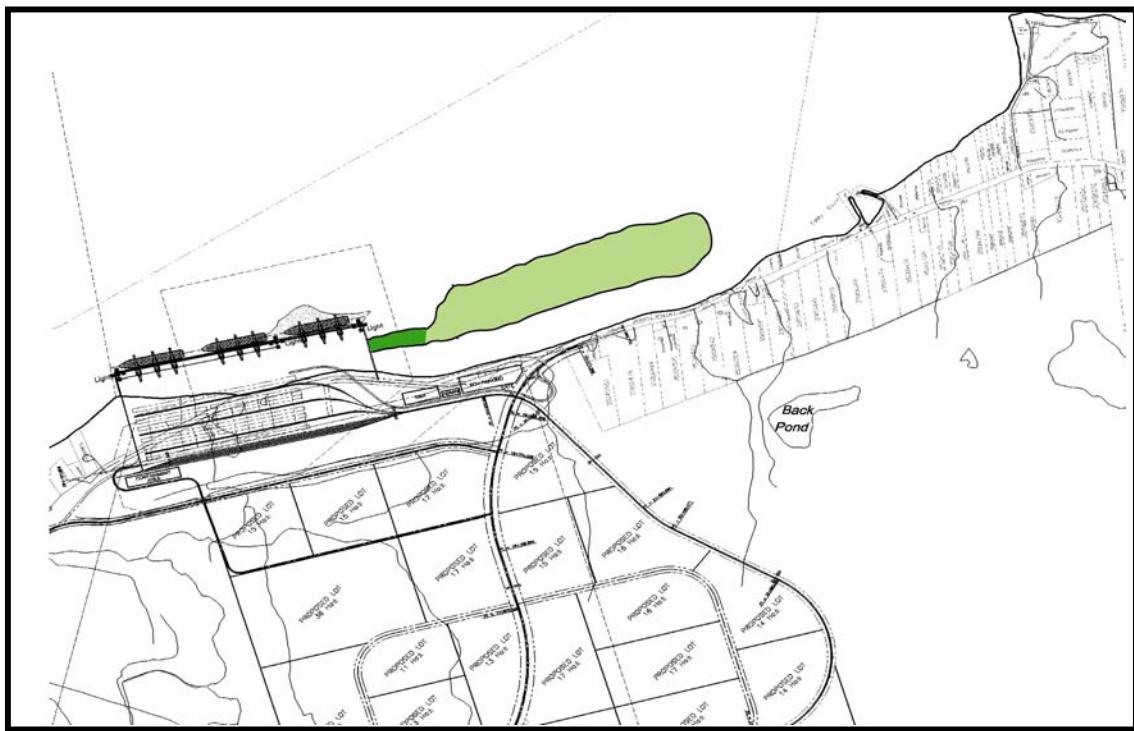
Fig 4 Location of marine compensation project 1. The eel grass bed in dark green and the algae bed in light green.

To do this we propose that habitat development work be undertaken to the southeast of the infill site toward Eddy Cove and in the outer 50m of the transition area and approximately 250m seaward staying in less than 20m of water along the coast to the east of the terminal infill for approximately 1.6 km. Video transects in this area during the summer of 2007 and a circle transect 60m in diameter 500m east of the site in the spring of 2008 indicate that the habitat zones in this area are the same as in the impacted area and available for compensation work.

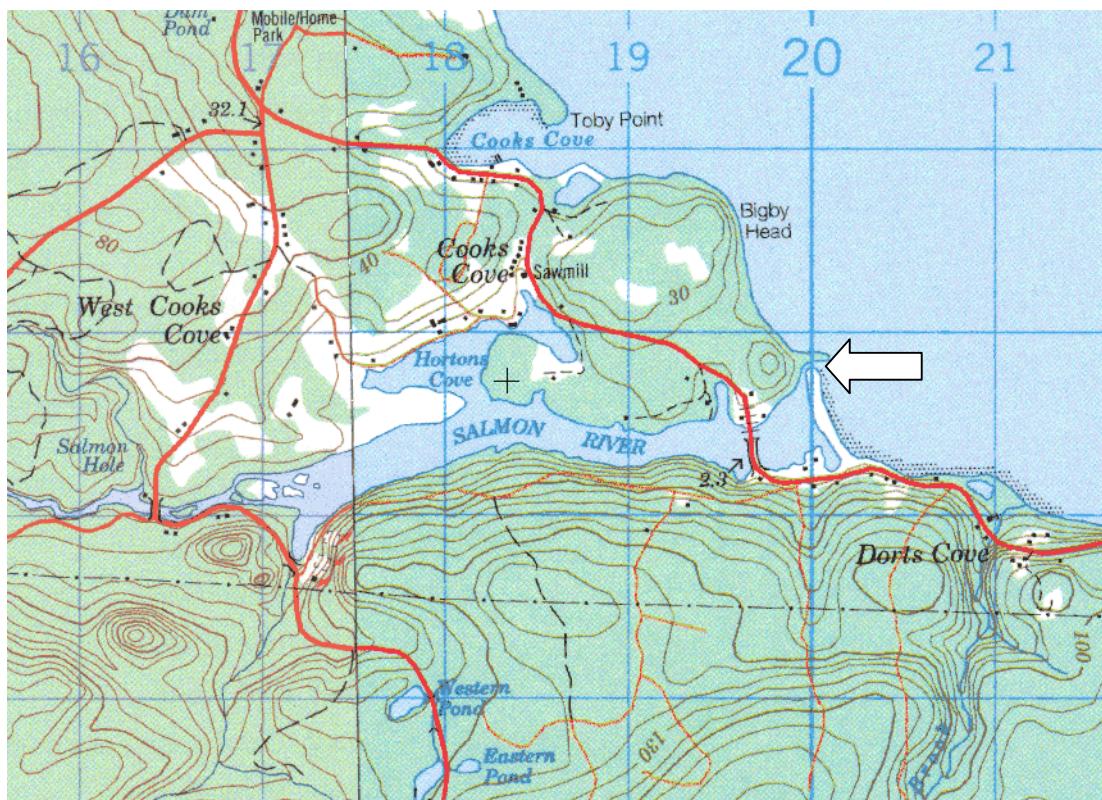
Fig 5 Location of Salmon River estuary work.

The estuary of Salmon River Guysborough, tributary to Chedabucto Bay, is restricted by a barrier beach that has a small opening at the north end (45 21.440N 61 28.080W topo 11 F6). This opening restricts the tide so that the estuary does not fill on a high tide and the estuary does not fully empty on a low tide. The lack of a full tidal flow in the estuary limits the productivity of marine plants in the lower estuary including the eelgrass beds and fucoid growth. This limit on primary productivity also limits secondary productivity, physical habitat structure provided by the macrophytes, and food for fish living in the estuary. Fish passage in and out of the estuary is also restricted at times of low river flow and low tide heights.

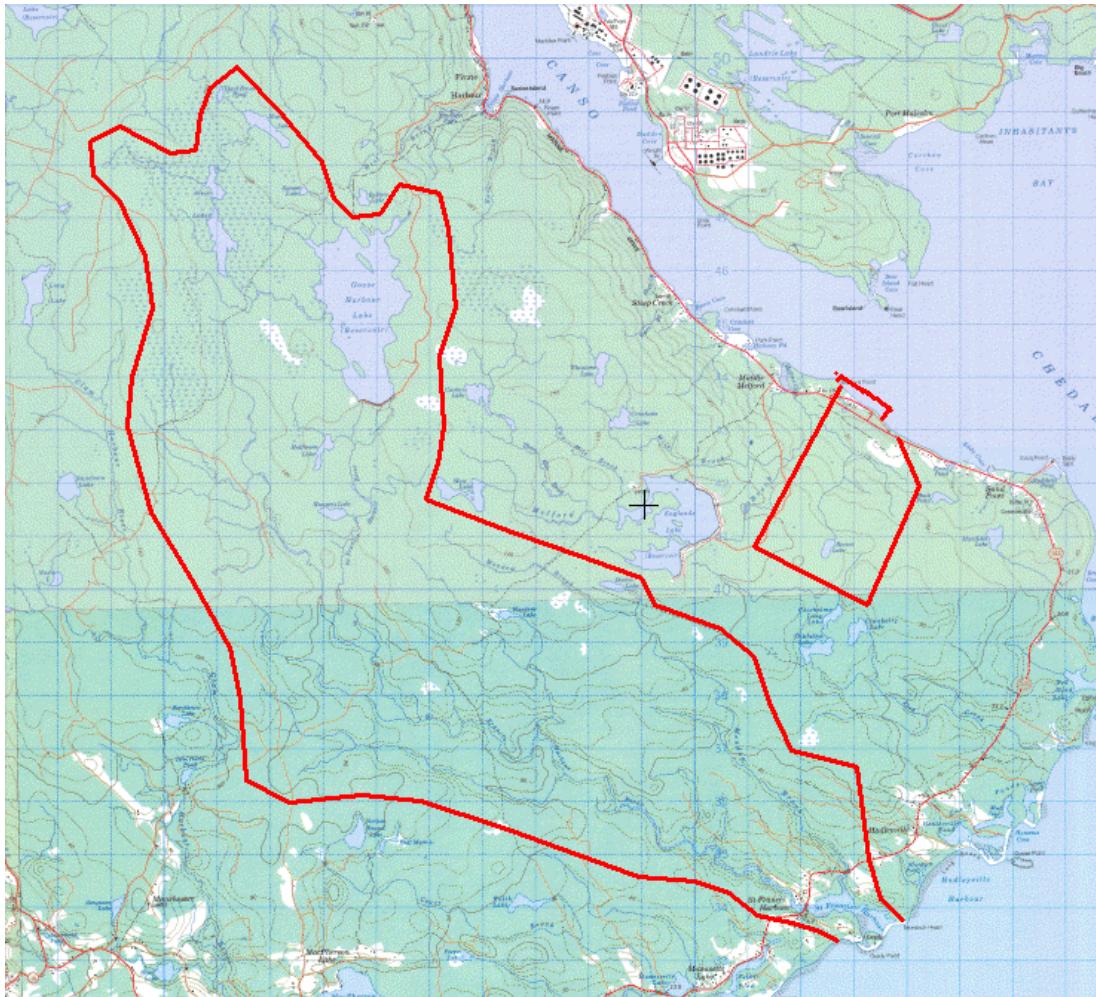
Fig 9 Location of proposed restoration watershed in relation to the project site. St Francis Harbour River estuary is located at 45 26.640N 61 17.345W (NAD 83) topo Map 11 F6
