Safety Notice Number: **000016**

Pot Hauler Requirements Under the Occupational Health and Safety (OHS) Legislation

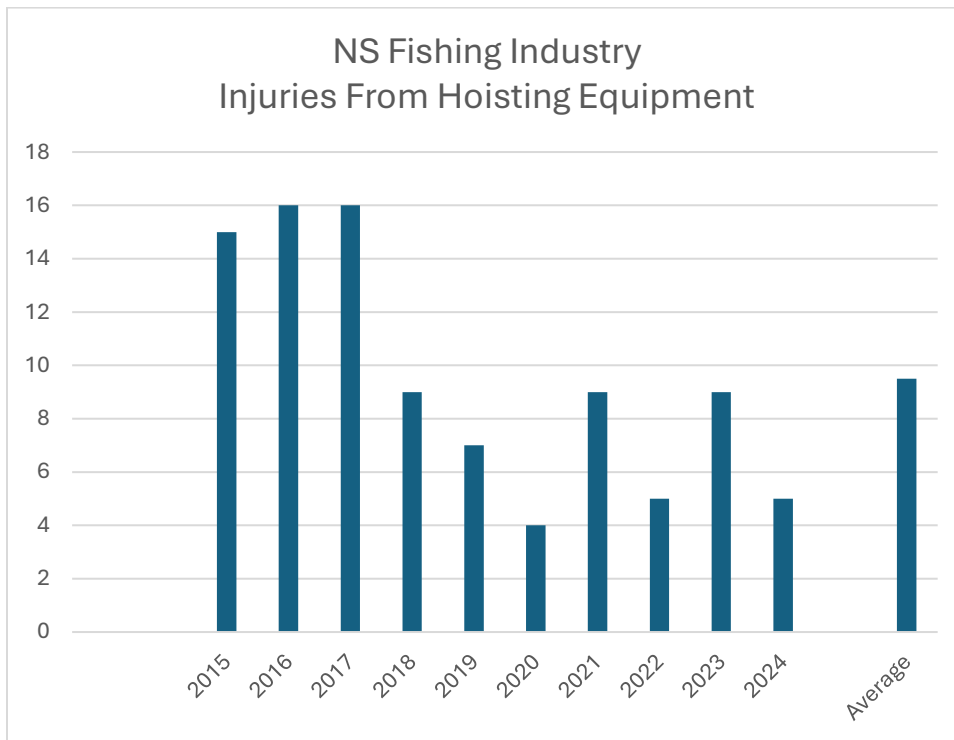
FIGURE 1: Nova Scotia Fishing Industry Injuries Involving Hoists

Between 2015 and 2024, an average of nine injuries involving hoists on fishing vessels were reported to WCB Nova Scotia each year¹.

The most common injury event was workers being struck by an object, accounting for approximately 50 per cent of reported injuries. Injuries involving workers being caught in or compressed by equipment accounted for approximately 18 per cent of reported injuries, while overexertion injuries accounted for approximately 16 per cent.
