Evaluation CBNS Sydney Subdivision

**Preliminary REVIEW of OPERATING, COSTS,
GEOTECHNICAL and INFRASTRUCTURE IMPROVEMENTS
RAIL LINE – Subsidized Portion of Sydney subdivision
MP 20.0 to 113.8 Nova Scotia**

CANARAIL Consultants Inc.

Date : August 31, 2015

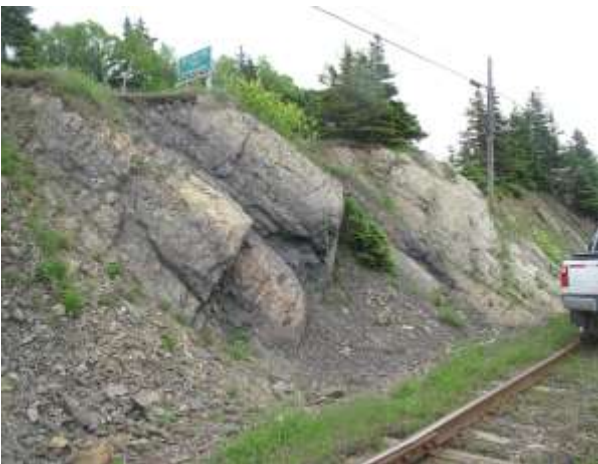
**Photo 22 – Mile 8.5: Non Subsidized Line
North Side of Line: Bedrock Outcrop**

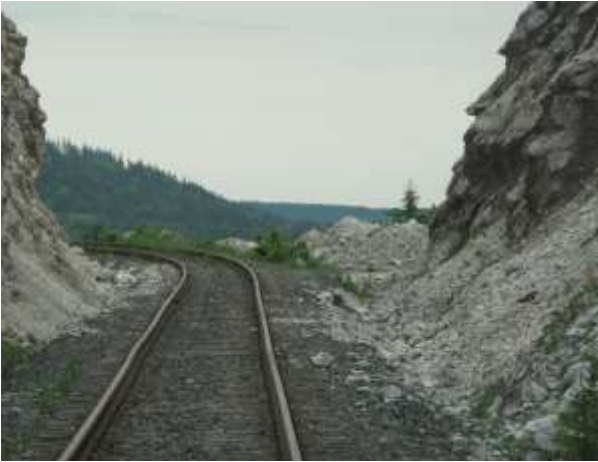
**Photo 23 – Mile 54.6: Subsidized Line
Westerly Looking Easterly: Bedrock Outcrop**
June 18, 2014

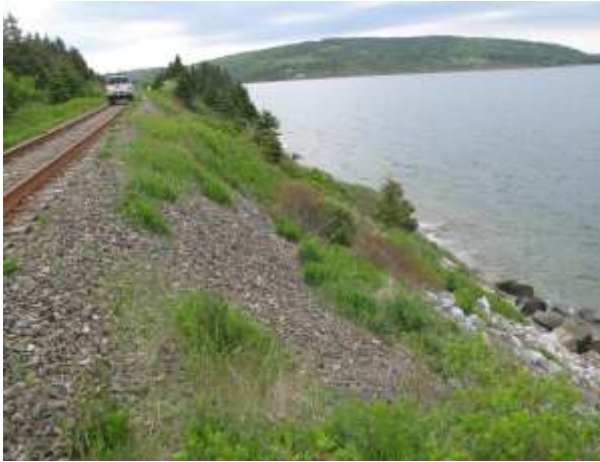
**Photo 29 – Mile 55.1: Subsidized Line
Westerly Looking Easterly**

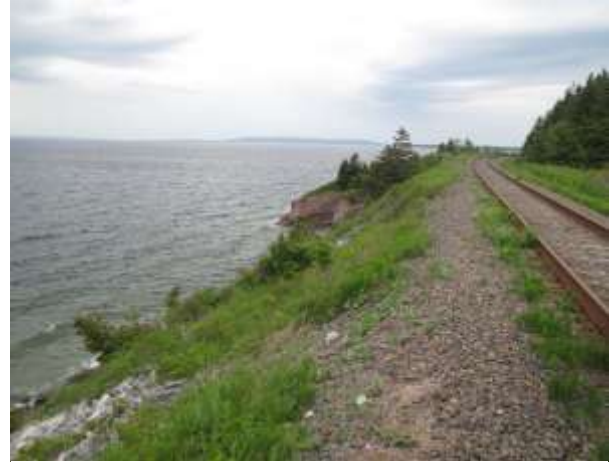
**Photo 30 – Mile 55.1: Subsidized Line
Easterly Looking Westerly**

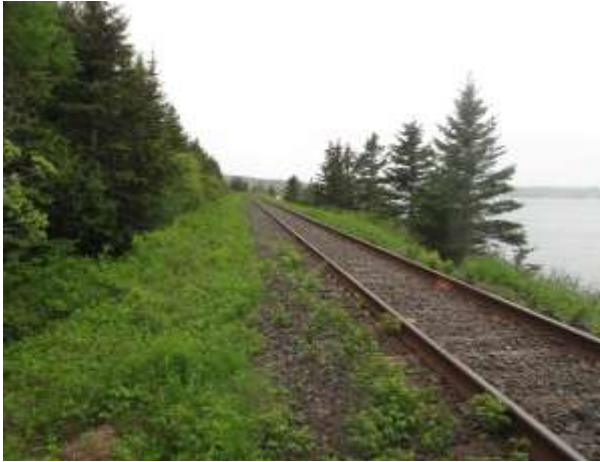
**Photo 35 – Mile 60.1: Subsidized Line
Easterly Looking Westerly**
June 18, 2014

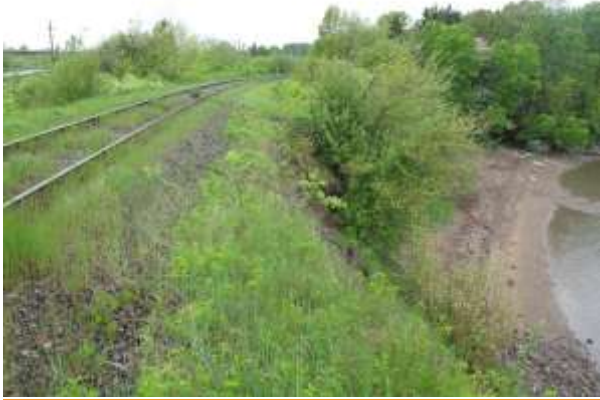
**Photo 47 – Mile 103.3: Subsidized Line
North Looking Southerly: East Side of Line**
June 18, 2014

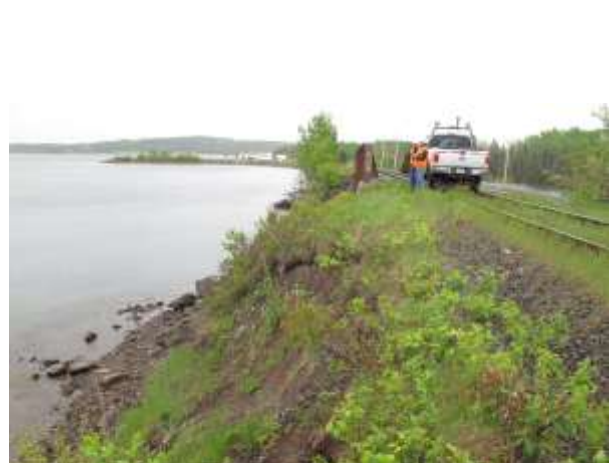
**Photo 50 – Mile 103.3: Subsidized Line
South Looking North: East Side of Line**
June 18, 2014

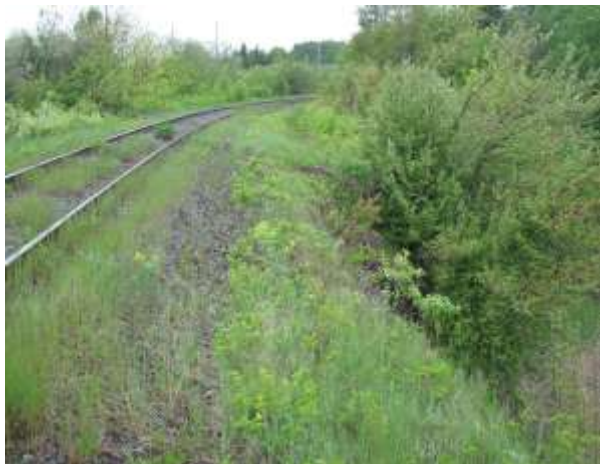
**Photo 51 – Mile 103.3: Subsidized Line
Area Between Line and Crest of Slope**
June 18, 2014

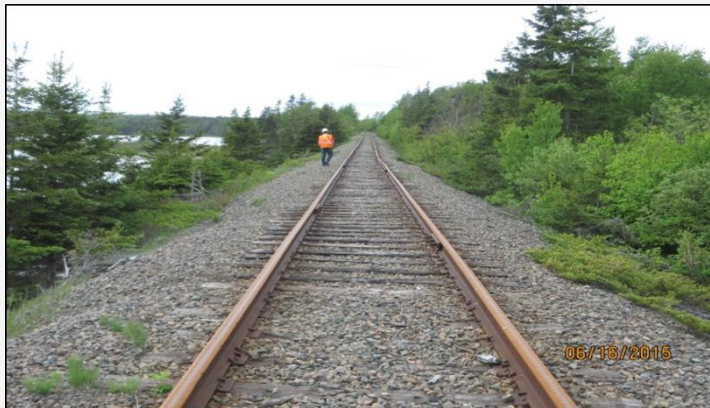
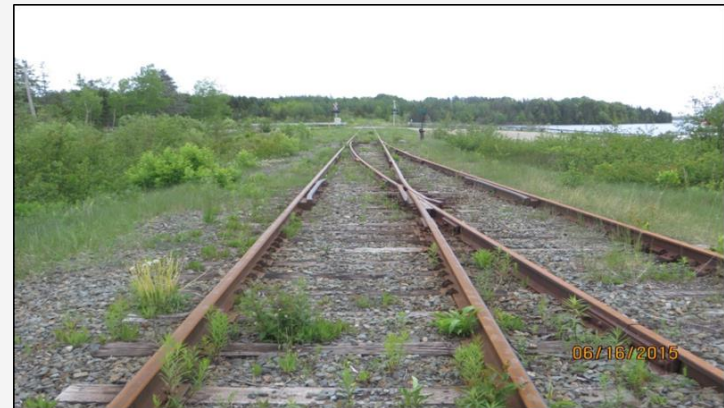
- Majority of rail (115 RE rail sections) installed circa 1975/1976
- Estimated : 65% Continuous Welded Rail (CWR) & 35% Jointed Rail
- Rail surface condition : Good
- Some aggressive rusting in a few locations, due to salt water
- No rail relay required over the next 5 years
- 9 passing sidings manual No. 10 – 115 lbs rail with 16 ft. - 6 inch (not received much activity over the past few years) all turnouts remain in track and functional with the exception of west turnout at Grand Narrows which it was removed. Status: Good

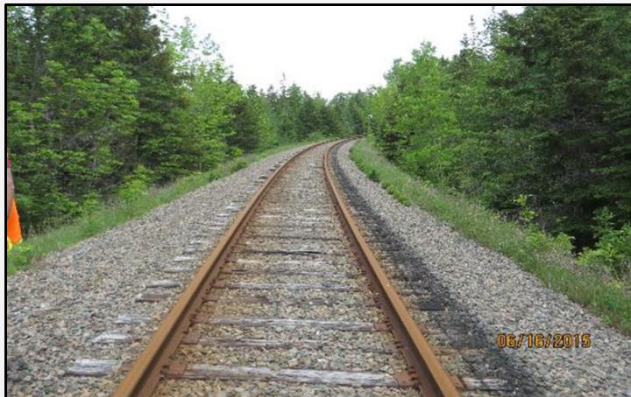
- Tie Management:
 - Tie Type – No.2 Treated Harwood – Length 8ft.
 - Track life: 40+ years
 - Defect ratio: \approx 40% in some tangent segments
 - 5-year wood tie program required
 - 15,000 ties/year
- Prior to the re-establishing train service, it is recommended to verify that tie conditions will support the dynamic impact of curving forces throughout the curvature, especially the sharper curves in those areas where tie defect density exceeds Transport Canada Guidelines.

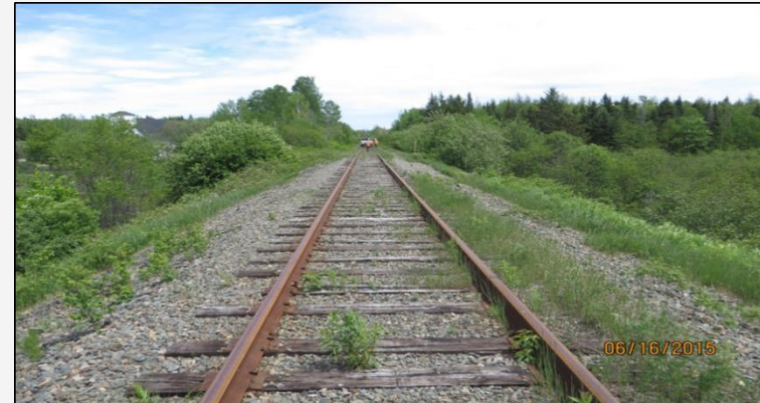
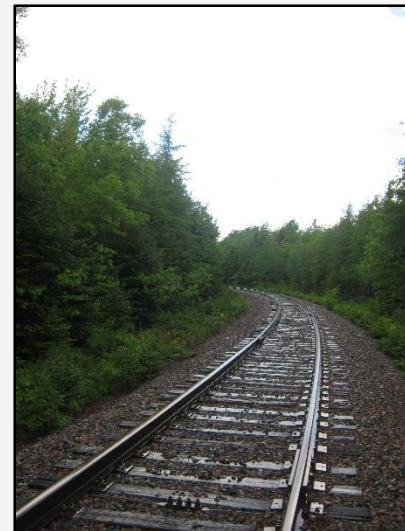
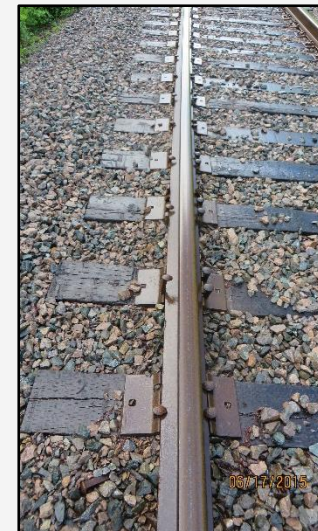
- In general, sufficient ballast cross section for Class 3 track
 - Tie cribs full
 - Shoulder ballast: 8-10 inches
- Weed and grasses contamination
 - In some segments, normally associated with areas where chemical weed spraying is prohibited
- Ballast requirements
 - For the next 5 years, associated with programs and minor surfacing requirement
 - 5,500 – 6,000 tons/year

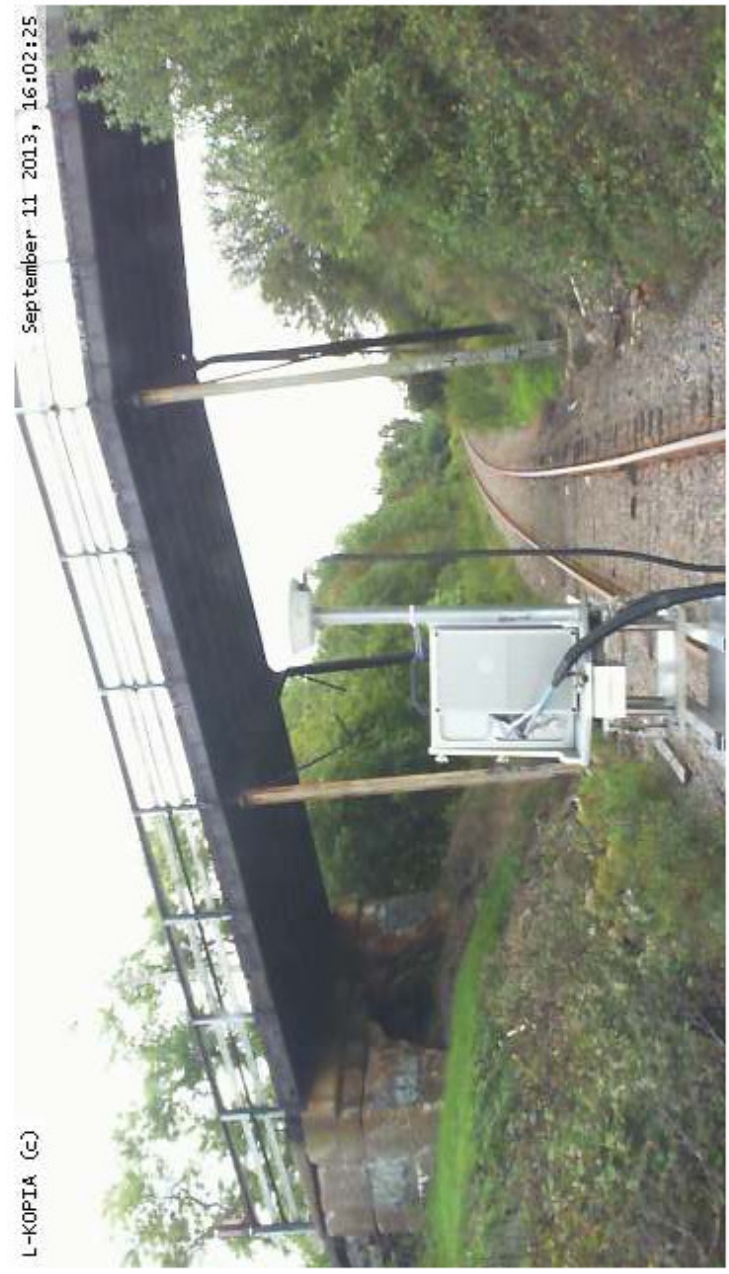
Client: CBNS Date: 09/11/13 S.ELE: 04.3" Curve: 2.00 Language: E Insert
 Trk. Seg.: SYDNEY SUB. Time: 16:02:34 Dist: 099.923 Struct.: OVERPASS (FAIRMOUNT ST) Check from top
 Info 1: Trk. No.: SNG MAIN Frame: 152 File: CBNS_SYDNEY_SUB_MAIN_001.CUS Check from bottom
 Info 2: Dir.: EAST

Dist. 099.923 To 99.928
 Lat. 46.19783904 To 46.19777679
 Long. -60.26144977 To -60.26148978
 Hgt. 22.01 To 20.32
